# Hydraway Edgedrain Experience in Ohio

KEITH T. HINSHAW

The purpose of this paper is to compare the effectiveness of the Hydraway™ edgedrain, which is manufactured by the Monsanto Company, with the Ohio Department of Transportation's standard 4-in. pipe underdrain without fabric wrap. The 650-ft-long test sections are contiguous, constructed at the same grade, and have separate outlets. The U.S. Geological Survey, Water Resources Division, installed equipment to measure the discharge from each test section. Preliminary results from the monitoring devices are not conclusive. There have been too many gaps in the data. For various reasons, such as damage from lightning, an automobile accident, and at times water backing up in the ditch, complete data for the most significant rainfall events are not available. Neither system has shown consistently superior performance over the other. The costs for the Hydraway on the two projects in 1985 were \$4.10 and \$5.50/ft. The costs for three projects in 1986 and 1987 were \$2.42, \$2.80, and \$2.85/ft. This compares to an average cost of \$2.50 to \$3.00/ft for the standard pipe underdrain. Collection of data will be continued until matchin

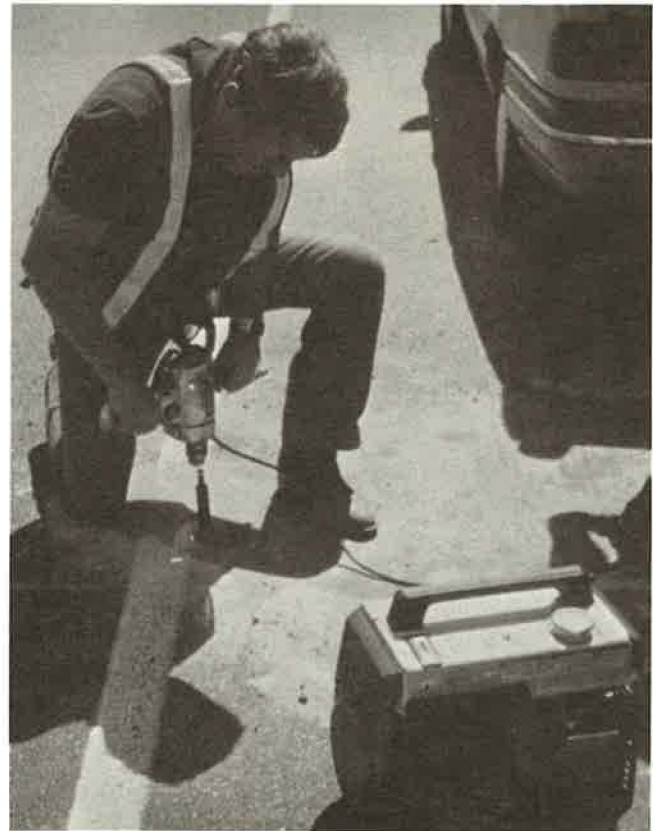
FIGURE 11 Drilling into the edg drain.

In June, 1987, Monsanto Company representatives installed 1/2-in. plastic inspection pipes at three locations along the 650-ft test section of their edgedrain on I-70 (Figures 11 and 12). The pipes were placed at each end and at the center of the 650-ft test section. Viewing of the inside of the edgedrain by use of a borescope is possible (Figure 13). In the upstream location there was no flow, but in the center and downstream locations there was approximately 6 in. of standing water, which was a concern because if there was an obstruction the flow data would be affected. A decision was made to dig up the outlet pipe in an attempt to determine the cause of the problem.

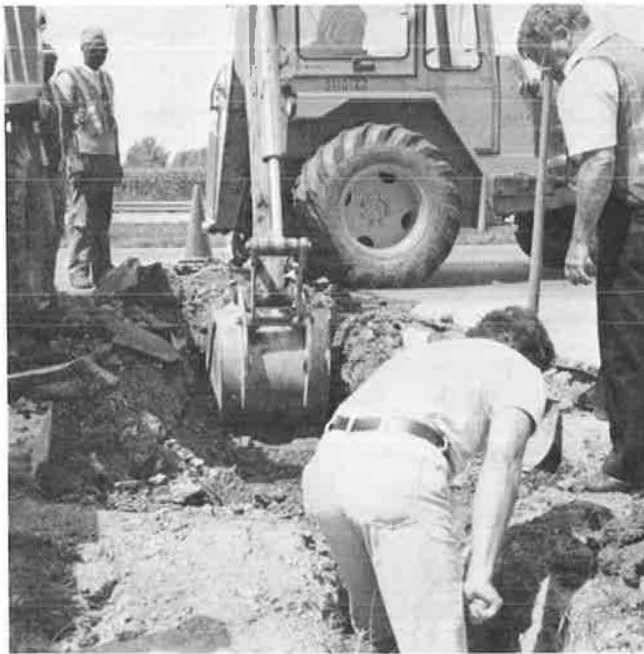
FIGURE 14 Digging up an outlet.

nance crew, the flexible polyethylene outlet pipe was dug up (Figures 14–16). There was a slight rise in the flexible pipe but not enough to be a major problem. It was suggested that a rigid outlet pipe would provide a straight slope without possibilities for variations. The existing pipe was removed, bottom of the trench regraded, and a new pipe installed. Before the new pipe was installed, a water hose, which was attached to a 500-gal tank, was connected at the upstream location. With only the pressure from the tank which was mounted on a flatbed truck, it took the water 35 min to flow the 640 ft (Figure 17).
