Tie Girder Fracture in Siouxland Veterans Memorial Bridge

JOHN M. HANSON, MICHAEL J. KOOB, AND GILBERT T. BLAKE

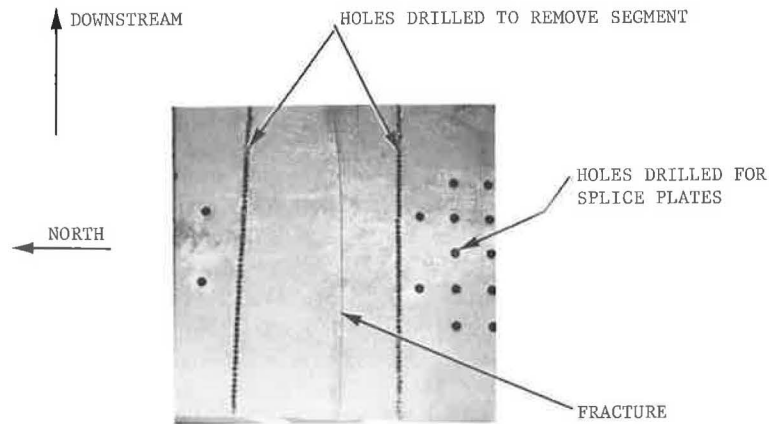
The fracture was located 6 ft 10 in. north of panel point 3 in the downstream tie girder, and extended in a nearly perpendicular direction across the top flange plate. The view shown

in Figure 5 was taken as a section of the flange containing the fracture was being cut and removed from the tie girder for laboratory testing. As a precaution against further propagation, IDOT personnel drilled a $1\frac{5}{16}$ -in.-diameter hole through the weld and web plate on each side of the tie girder to remove the crack tip, as shown in Figure 6. The measured widths of the crack varied from 0.05 to 0.08 in., as shown in Figure 7. There were no stiffeners or any other welded attachments in the vicinity of the crack.

FIGURE 5 Plan view of top flange, showing fracture.

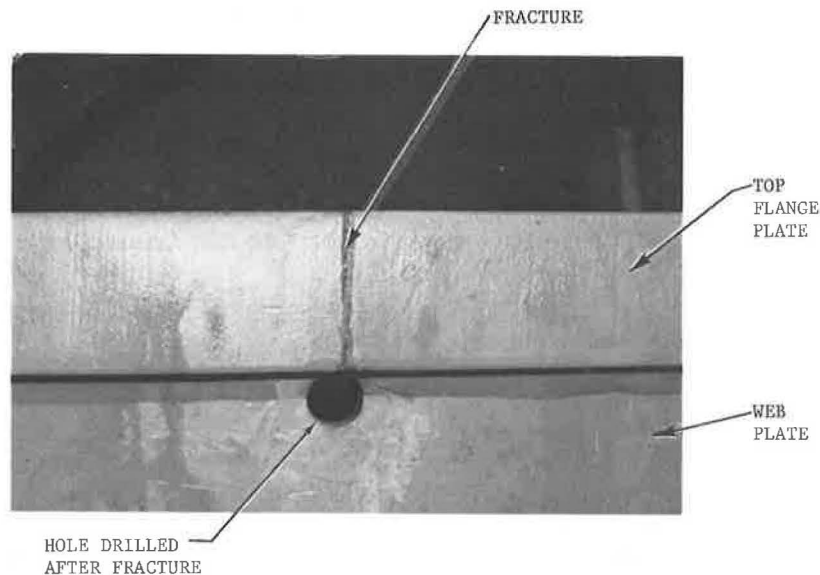
FIGURE 6 Elevation view of fracture.

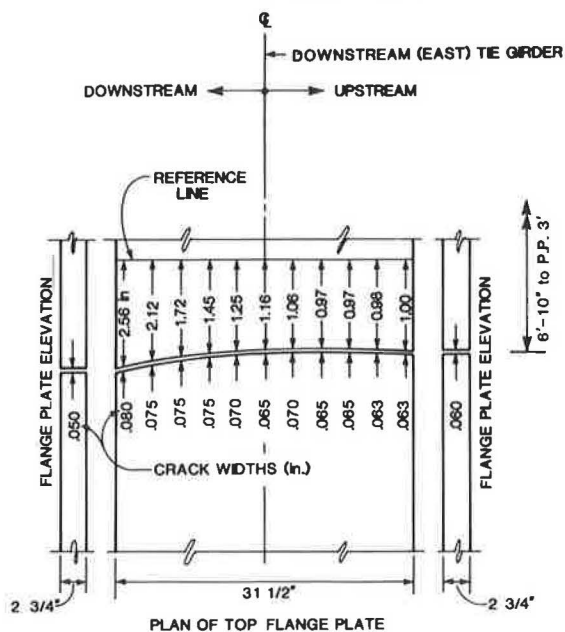
FIGURE 7 Geometry of fracture and measurements of crack width.

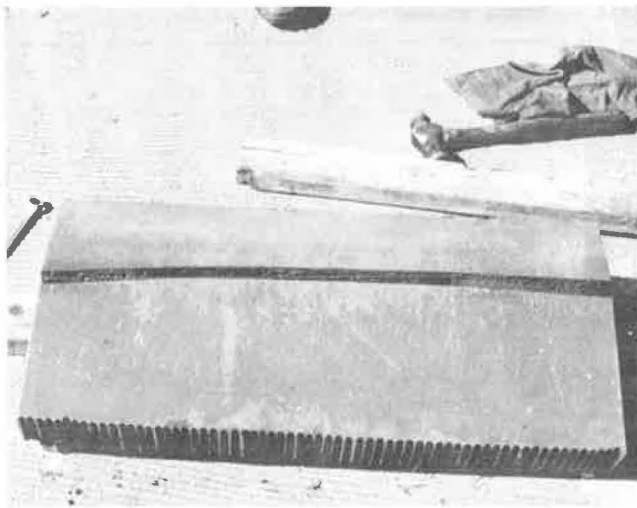
The section taken from the flange is shown in Figure 8. One piece was about 5 in. long (in the direction of the tie girder), and the other was about 9 in. long. The fracture occurred in a region where the flanges and web plates had a fabricated length of 70 ft 0 in.

FIGURE 8 Pieces of A588 flange plate with fracture.

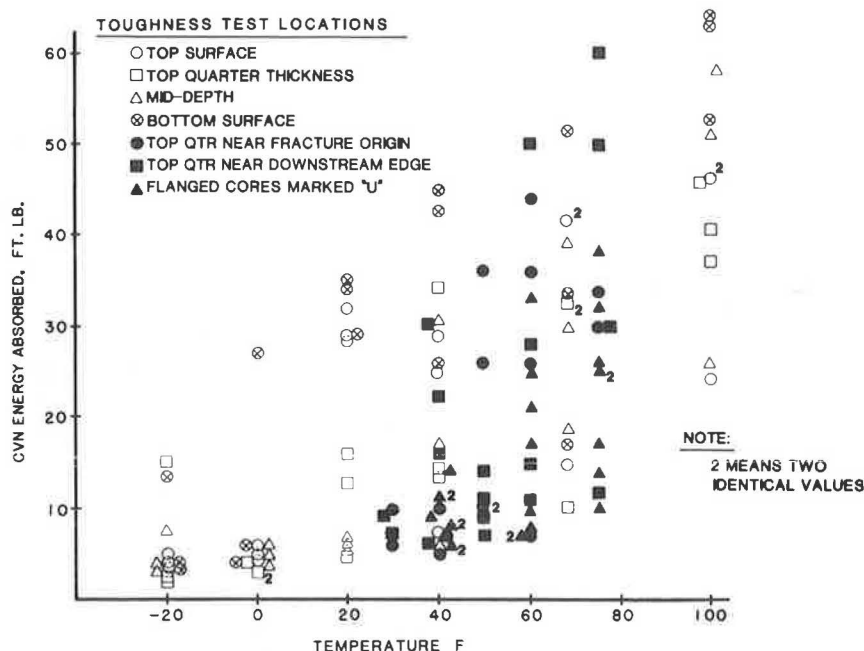
Charpy V-notch (CVN) impact tests were conducted on specimens taken at the top, upper-quarter thickness, center, and bottom of the two pieces of flange plate. Specimens from the four cores were taken at the upper- and lower-quarter thicknesses. The tests were conducted in accordance with ASTM A370 at discrete temperature levels from -20°F to 100°F . Results of the tests are plotted in Figure 9. They exhibit significant variability, even for specimens taken from the same location. Of the 27 specimens tested at 40°F , only 5 met the

30 ft-lb minimum requirement of IDOT's special provisions (SP-229).

FIGURE 9 CVN test values from flange plate next to fracture.

It was immediately evident from the results of the CVN tests on samples from the 2³/₄-in.-thick fractured plate (shown in Figure 9) that there was highly unusual scatter in the toughness properties of this material and that the material did not meet the specified minimum requirement of 30 ft-lb at

40°F. Some of the scatter was related to the position of the test specimen within the plate. According to the mill report for this plate, the CVN values at 40°F were 39, 39, and 43 ft-lb. These observations led to the conclusion that it was necessary to test representative samples of all the steel in the bridge.

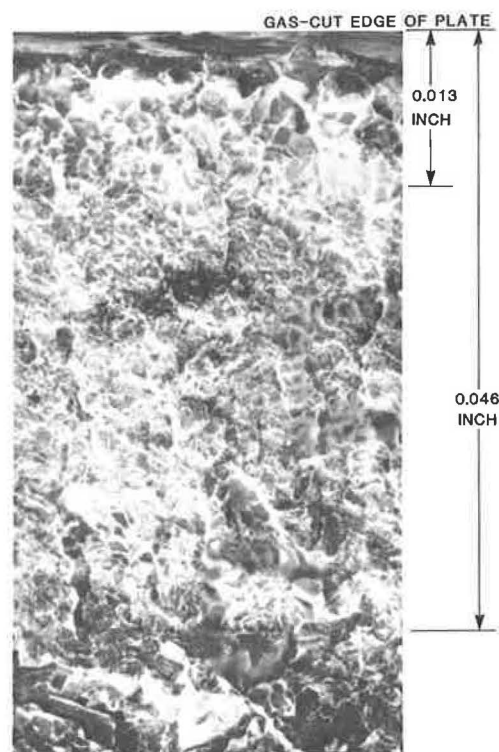
The report by the supplier also indicated that a magnetic particle examination revealed an additional crack on the downstream edge of the piece of plate. The crack was subsequently shown by metallographic examination to be 0.046 in. deep. It was located within the heat-affected zone of the gas-cut edge on the bottom corner of the plate. The crack surface, shown in Figure 11, exhibited intergranular cleavage and ductile tearing fracture characteristics.

FIGURE 11 Fractograph of crack at downstream edge.

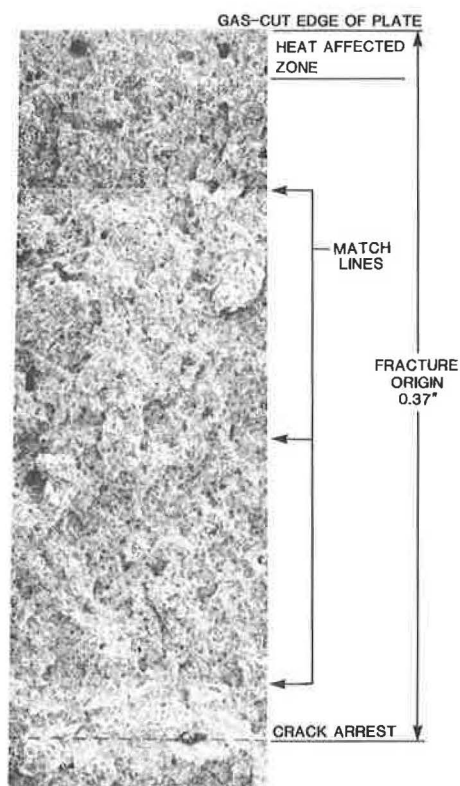
A report by the supplier stated that the fracture began in the heat-affected zone of the gas-cut edge of the flange plate on the upstream side of the girder and propagated as a cleavage crack that appeared to have arrested 0.37 in. from the plate edge, and then subsequently from the crack arrest region

across the flange width in a cleavage-fracture mode. Figure 10, provided by the supplier, shows the fracture surface.

FIGURE 10 Fracture at upstream edge of plate.

crack, about 0.37 in. deep, was present in the edge of the flange plate before the fracture occurred. Some time after this plate had been painted, the crack propagated in a brittle mode across the full plate width. Another crack was found, about 0.05 in. deep, in the opposite flame-cut edge of the 5-in.-long piece of removed flange plate. It is believed that a crack of about the same depth had existed initially in the edge of the plate where the fracture occurred.

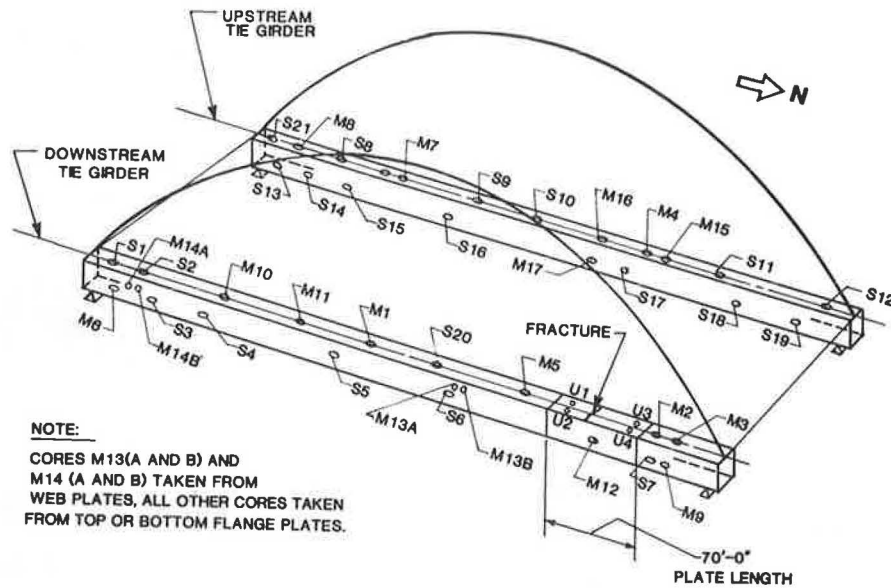
Some of the results of the CVN tests exhibited scatter and thus did not meet the acceptance criteria of Section 22.2.1 of ASTM 370. Consequently two additional M-type cores were extracted for testing. Subsequently, additional cores, identified by the prefix S, were extracted for further material testing. Locations of all cores, including the four cores near the

fracture marked U that were initially given to the supplier, are shown in Figure 12.

FIGURE 12 Core locations on girders.

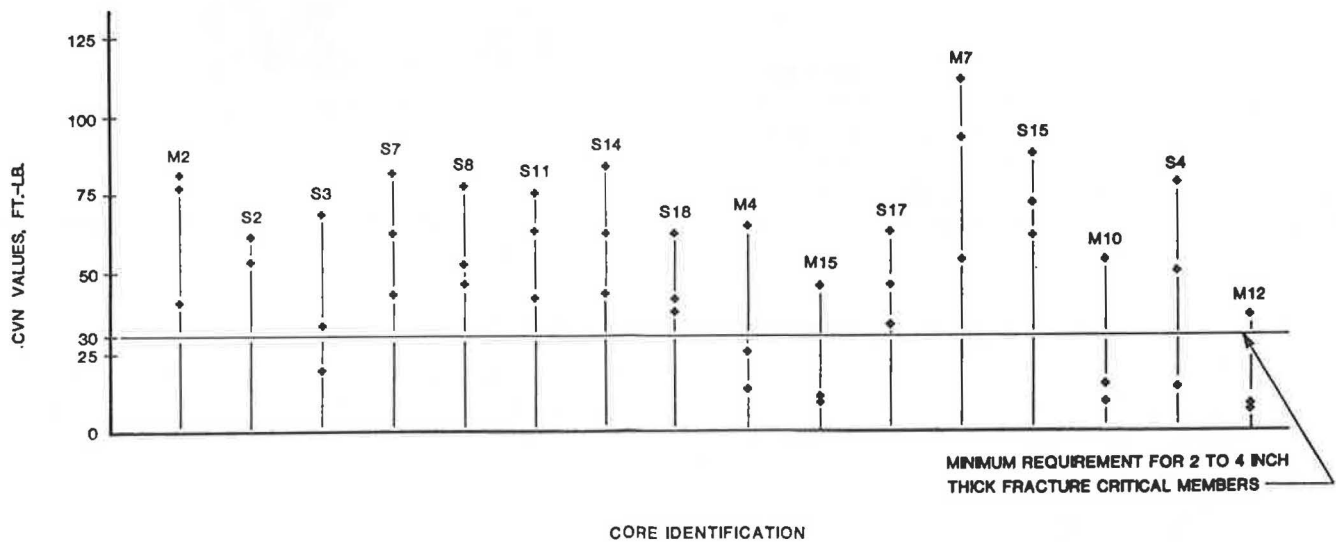
FIGURE 13 CVN values at 40°F for all 2³/₄-in. flange material.

tests for three specimens from each of the 2³/₄-in.-thick cores that were tested at 40°F is shown in Figure 13. CVN values were found to be below the IDOT's SP-229 requirement of 30 ft-lb at 40°F in specimens from six core locations in the 2³/₄-in. plate and five locations in the 2¹/₂-in. plate.

As shown in the plot of CVN values at 40°F for all of the 2³/₄-in.-thick flange material in Figure 13, a number of locations were found where the toughness did not meet the specified requirement. Locations where 2¹/₂-in.-thick plates did not meet the requirement were also found. At this point in the investigation, an offer was made to IDOT by the supplier of the fractured plate to replace all flange plates that had been furnished by the supplier. This offer was accepted. Work to replace these flange plates was completed in spring 1983.
