# Restoration of Joint Load Transfer

MICHAEL J. REITER, MICHAEL I. DARTER, AND SAMUEL H. CARPENTER

Load transfer at joints and cracks in concrete pavements greatly affects faulting, cracking, and spalling. The restoration of load transfer has been attempted recently by several highway agencies. The results of field performance studies of 369 restored joints and cracks located in 9 states are presented. Four retrofit load transfer devices were evaluated: round steel dowels, double-vee shear devices (without precompression or grooving), figure-eight devices, and miniature I-beam devices. Extensive field and office data were collected and analyzed. Models were developed to predict the relative performance of the devices. Results indicate that the round steel dowel bar did the best job of reducing faulting, and it showed no device or matrix failure. Additional research is under way to provide improved performance data. A recommended retrofit dowel design for joints and cracks is provided.

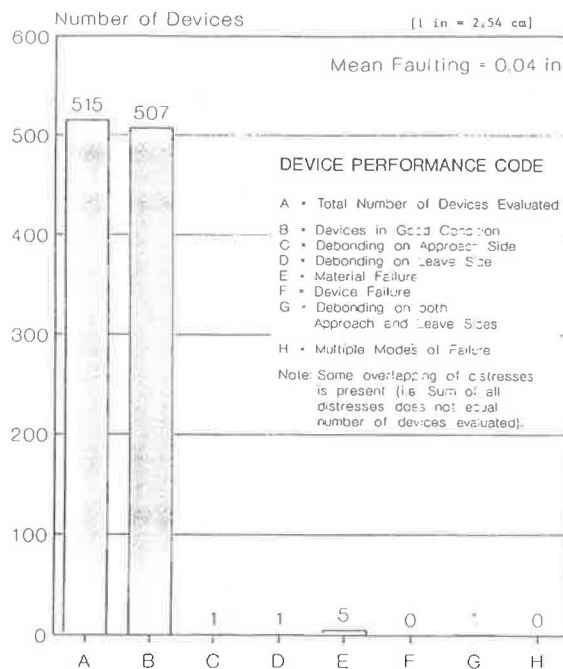
FIGURE 5 Distribution of retrofit dowel performance.

Of the 515 retrofit dowel bar load transfer devices inspected, 507, or better than 98 percent, were in good condition (Figure 5). The most prominent mode of failure identified was material failure (1 percent or five devices) wherein the backfill matrix had been cracked or become loose and dislodged by traffic. Less than 1 percent of the joints were debonded on the approach, leave or approach, or leave side. None of the joints restored with retrofit dowel bars exhibited device failure or multiple modes of failure. Multiple modes of failure refers to the existence of two or more of the failure mechanisms given in Table 1 at any one device. The one

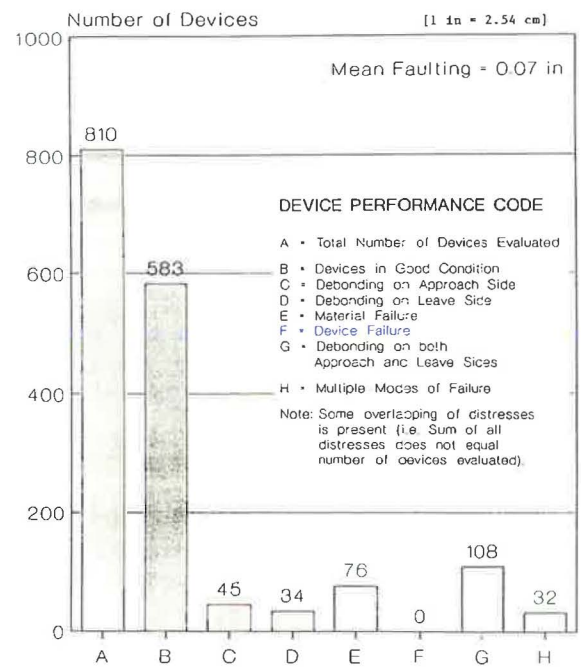
**FIGURE 7** Distribution of double-vee shear device performance.

Of the 810 uncompressed, ungrooved shear load transfer devices inspected, 583, or 72 percent, were in good condition (Figure 7). The most prominent mode of failure identified was debonding on both the approach and leave sides of the same device, which was found on 108, or 13 percent, of the devices. As was stated previously, this failure mode was recorded separately from the individual modes of debonding failure. Again, the Florida study is evaluating the use of device precompression and core wall grooving as remedies to this debonding mode of failure. None of the joints restored with

shear devices exhibited device failure. Multiple modes of failure were identified at 4 percent of the devices.

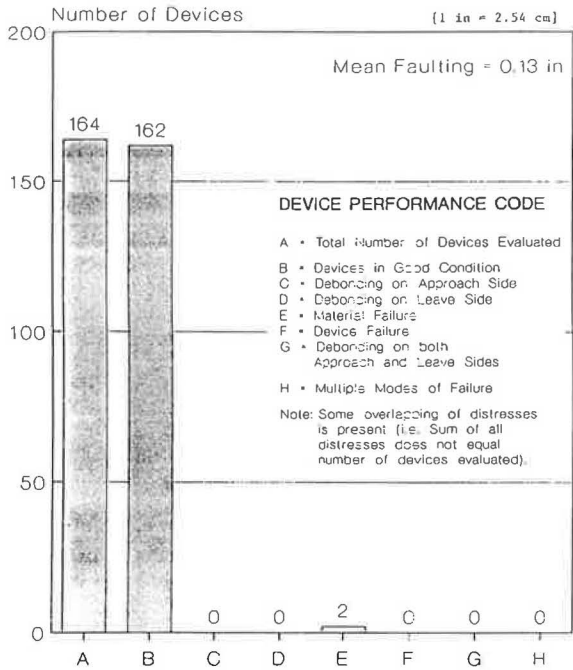
FIGURE 8 Distribution of I-beam device performance.

Of the 164 I-beam load transfer devices inspected, 162, or better than 98 percent, were in good condition (Figure 8). The most prominent mode of failure identified was material failure (about 1 percent or two devices) wherein the backfill matrix had been cracked or become loose and dislodged by traffic. None of the devices were debonded on the approach, leave, or both approach and leave sides. Also, none of the joints restored with I-beams exhibited device failure or multiple modes of failure.

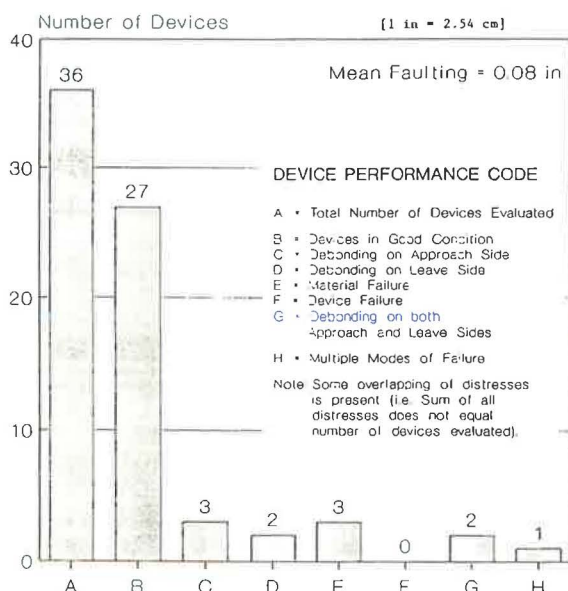
FIGURE 10 Distribution of figure-eight device performance.

Of the 36 figure-eight load transfer devices inspected, 27, or 75 percent, were in good condition (Figure 10). The most prominent failure modes identified were debonding on the approach side and material failure. Both of these failure modes occurred at 8 percent of the devices. None of the joints restored with figure-eight devices exhibited device failure. Multiple modes of failure were identified at approximately 3 percent of the devices.

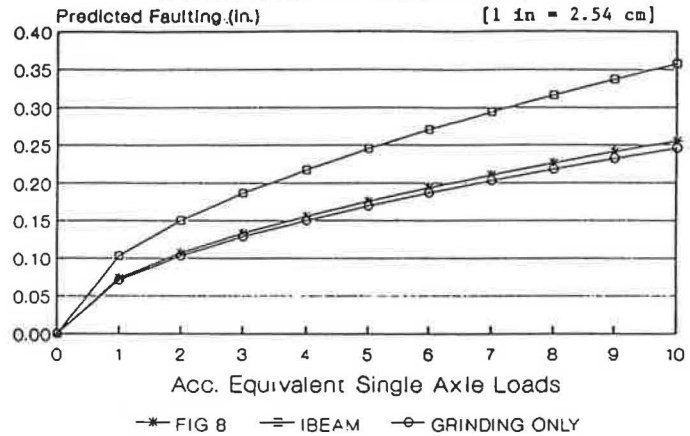
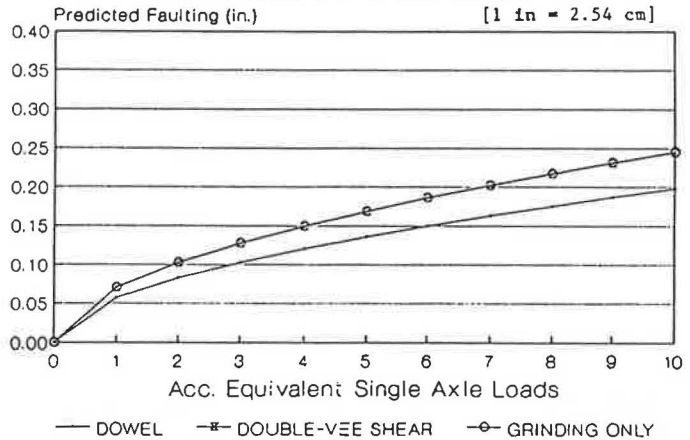
**FIGURE 11** Sensitivity plot depicting model-predicted faulting vs. accumulated 18-kip (80-kN) ESALs for JRCP.

Faulting of both the jointed plain and jointed reinforced pavements increased rapidly initially and then leveled off as the pavements accumulated more loadings. This type of curve has been found for all types of new and restored pavements as well as full-depth repairs (11). The figure contains five curves for

The plot shows that the retrofit dowel bars reduce faulting significantly from that obtained with grinding alone. The double-vee shear devices and figure-eight devices have practically no effect, and the I-beam devices appear to increase faulting. This increase, however, must not be taken literally because there is no physical reason for this result. It should only be concluded that the device has no effect on faulting according to the available data. These results are in response to the coefficients that were derived from the regression analysis. Similar results are shown in Figure 12 for JPCP, but without the I-beams because these devices were used only on JRCP. If 0.13 in. (0.33 cm) and 0.26 in. (0.66 cm) are used as faulting criteria for JPCP and JRCP, respectively, the following allowable loadings result from this model:

The extension of life obtained with retrofit dowels is significant (almost double). Diamond grinding addresses only the symptoms of pavement deterioration (excessive faulting) without addressing the source of the deterioration, which may require load transfer restoration, subdrainage, and the like. If diamond grinding is used as a temporary repair strategy, it has been shown that faulting will develop at a rate greater than that of initial new pavement faulting (7). Load transfer restoration appears to be an effective means of extending the life of a restoration project.
