Investigation of the Failure of a Hydraulically Placed Embankment

ARA ARMAN AND PAUL M. GRIFFIN

A study was performed to determine the causes of differential subsidence of a hydraulically constructed sand embankment in a fresh water swamp. Among other test methods, an electric cone penetration test (ECPT) was used to determine the cause(s) for embankment, and thus pavement, distress. Because very little historical design and construction information was available to the authors for analysis, the approach used was of a forensic nature rather than that of a well-defined research study. The electronic cone penetrometer, in combination with other tests, proved to be an invaluable tool in determining the condition of the sand embankment. Consolidation test results and embankment and subgrade profiles obtained by ECPT and borings eliminated the possibility of continuing settlement of subgrade soils. The problem is within the hydraulically placed sand fill. It was determined that the sand embankment when hydraulically placed was not sufficiently densified and that in later years the top 6 ft of the embankment, which is above the water table, experienced various degrees of densification

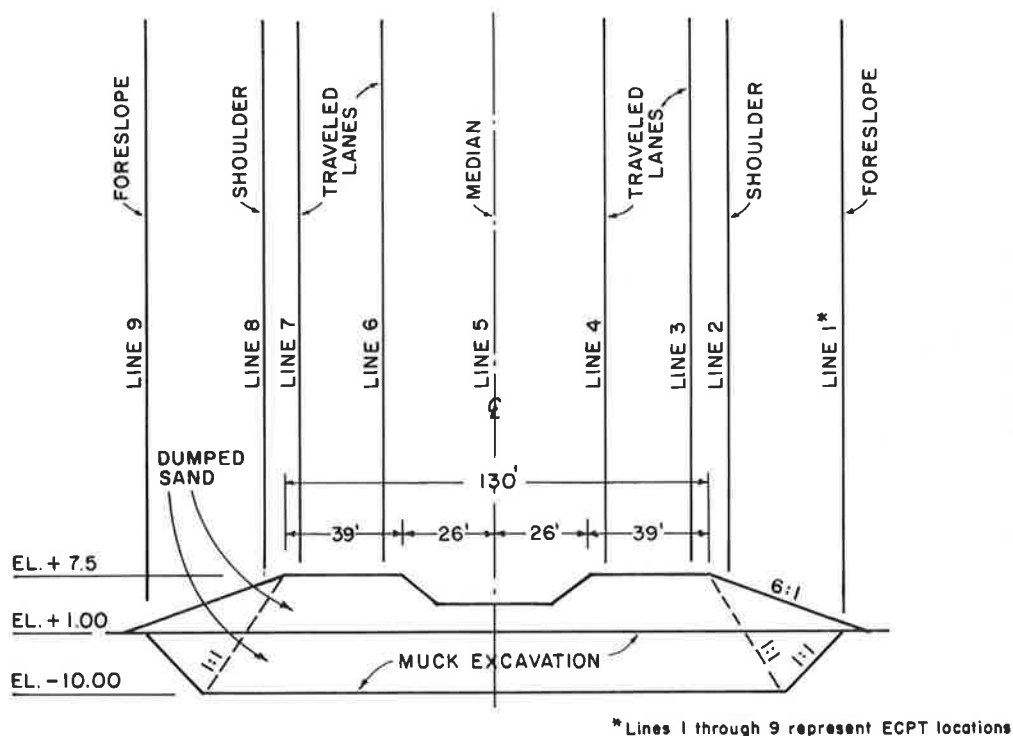
FIGURE 1 Embankment profile and ECPT locations.

In contrast to the above, the sand under traveled lanes (lines 3, 4, 6, and 7, Figure 1) appears to be very dense to dense from 0 to 6 ft, after which the density appears to drop drastically to medium to loose. Typical ECPT tip resistance in the top 3 ft of the embankment at the shoulder is about 140 TSF, while under the traveled lanes (lines 3, 4, 6, and 7) it is about 450 TSF or higher.

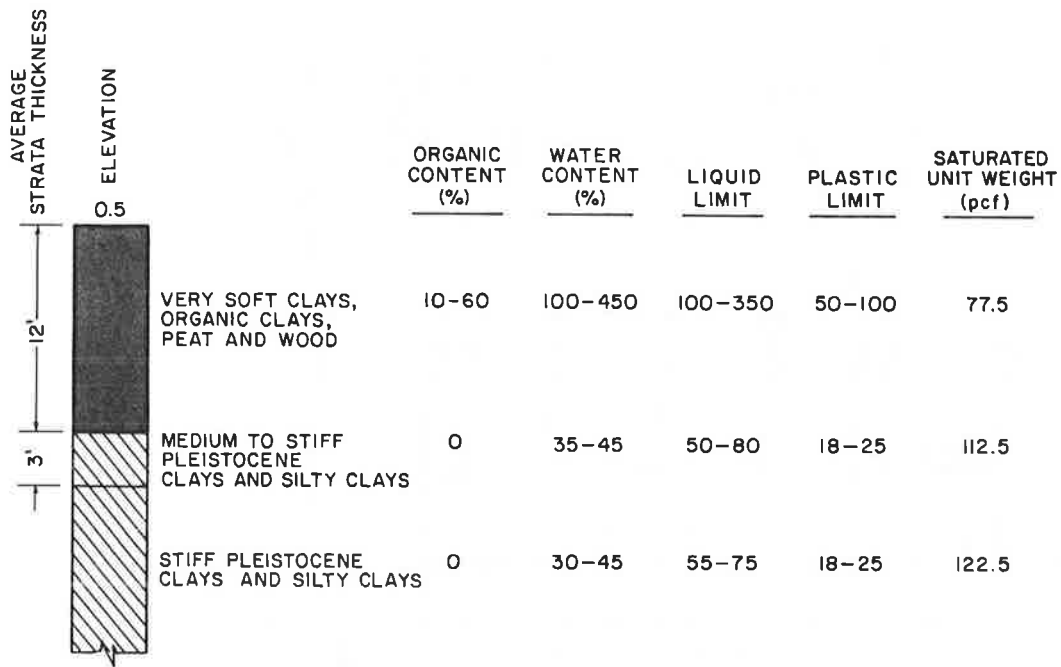
FIGURE 2 Typical subgrade soil profile.

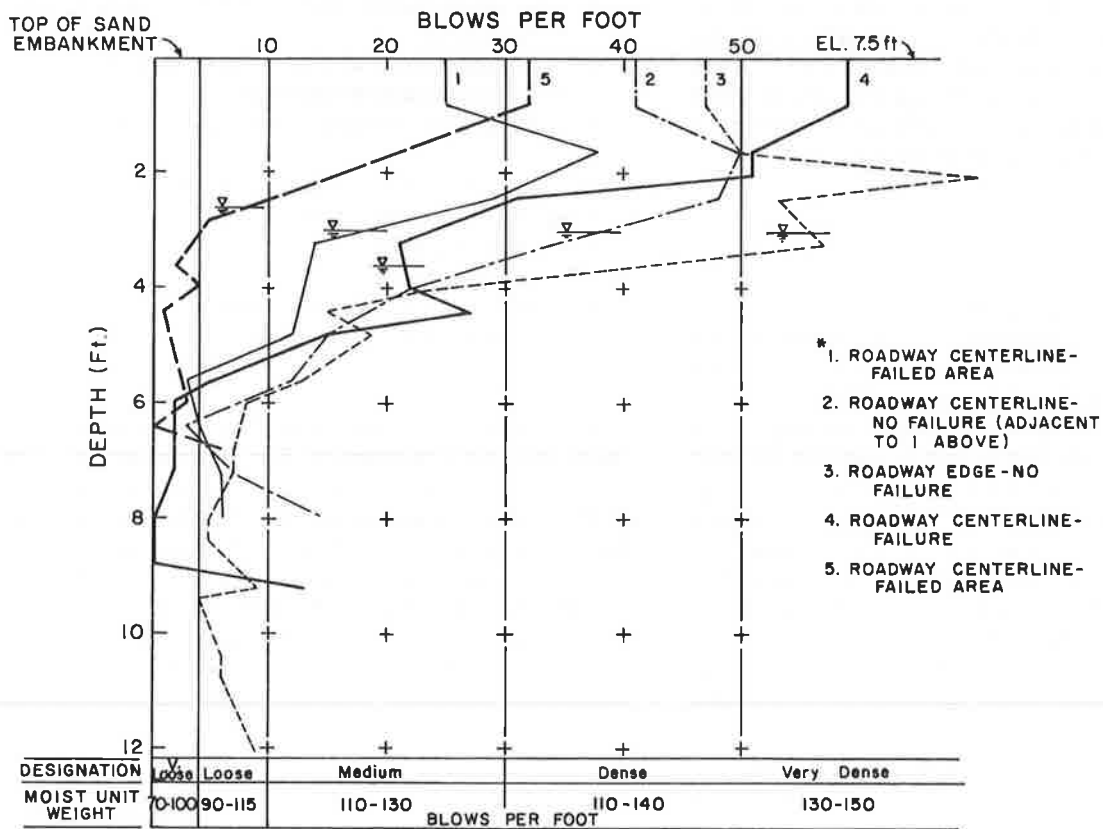
FIGURE 3 Standard penetration tests.

The number of blows obtained from SPT tests varies from an average of about 35 in the top 6 ft of sand embankment to 6 blows in the 6- to 9-ft depth and 2-0 blows below 9 ft (Figure 3). Typical sand gradations show that the sand is uniform in size with about 95 percent retained on No. 200 screen and with negligible percentages of clays and colloids. Field exploration identified the location of the water table at about 6 ft below the top of the embankment.

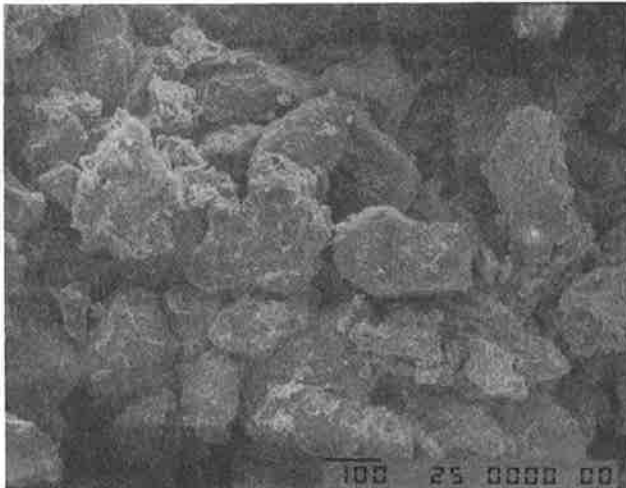
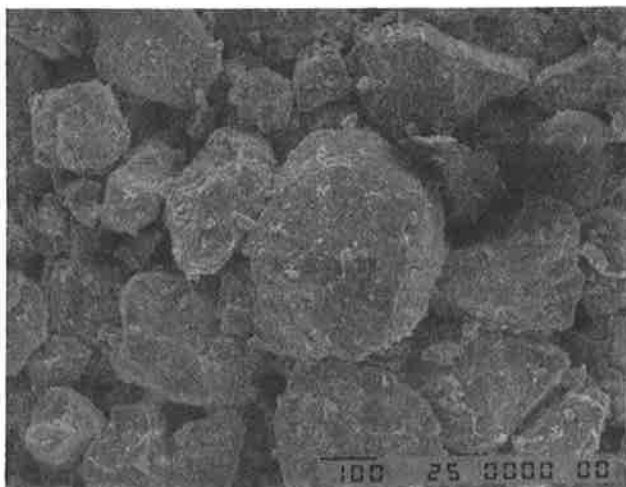
FIGURE 4 Scanning micrographs of sand (100 magnification; scale shown represents 100 microns).

Scanning electron micrographs of sand specimens obtained from a representative site (Figure 4) show the rounded and/or polished nature of the sand typical of the

Mississippi River sands of this area. A note of caution should be incorporated into this latter discussion: Specimens used to perform scanning electron microanalysis are not necessarily representative specimens, because the area or the sample size viewed is very minute. These images should be considered indicators rather than definitely representative specimens.

Considering the polished and rounded shape of Mississippi River sand particles and the evidence that adequate densification was not obtained during placement, it is concluded that sand under travel lanes densified gradually under heavy traffic loads and impacts, causing serious pavement distress.

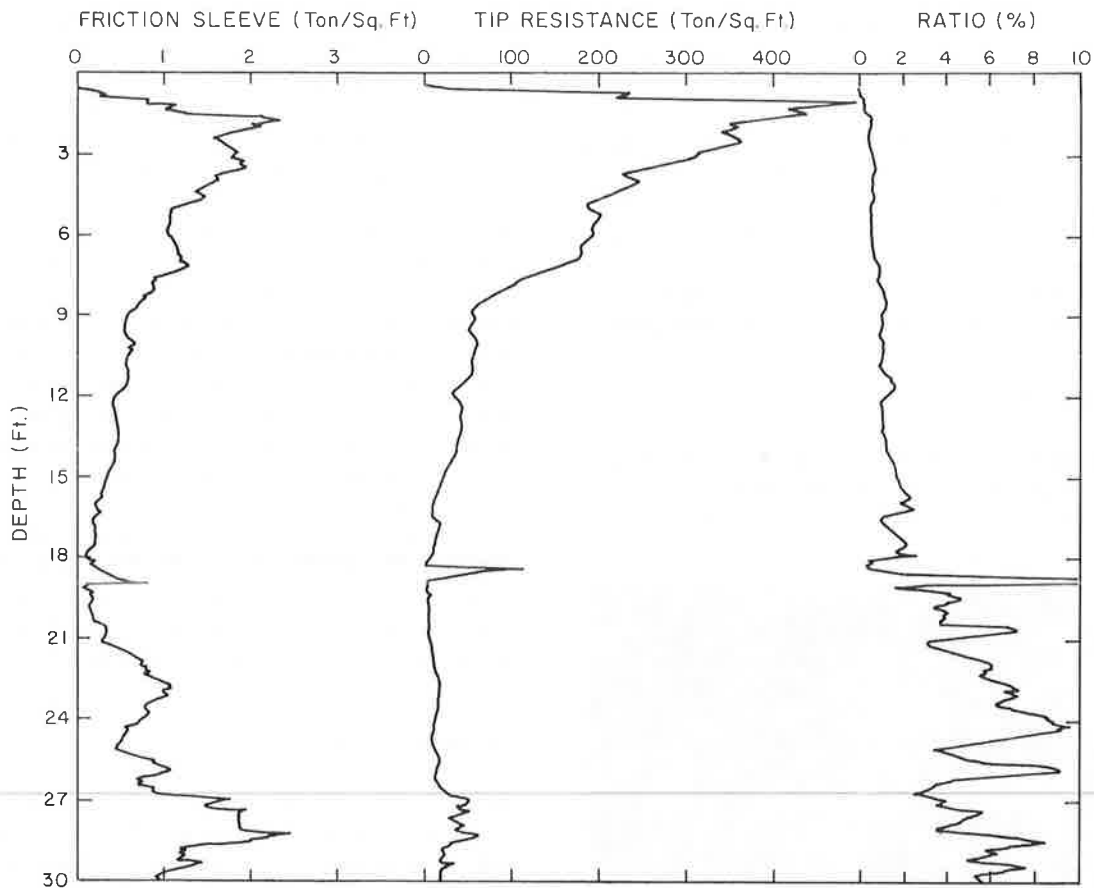
Density tests performed in the median showed that the dry unit weight of the sand embankment above the water table is in the vicinity of 100 lbs per cubic ft, or about 84 percent of standard proctor density for this sand (Table 1). The water level at the median is shown to be 4.2 ft below the surface, which in turn is about 2 ft below the top of the embankment section under the roadway pavement. These data place the water table in the embankment at about 8 ft below the pavement surface, or 6 ft below the top of the embankment. The moisture content of the sand in the top 3 ft of the median indicates the presence of capillary moisture; consequently, pseudo-cohesion induced by these capillary forces exhibited itself in the form of relatively higher strengths at the surface layers (Figure 5).

FIGURE 5 Typical ECPT results for the median.

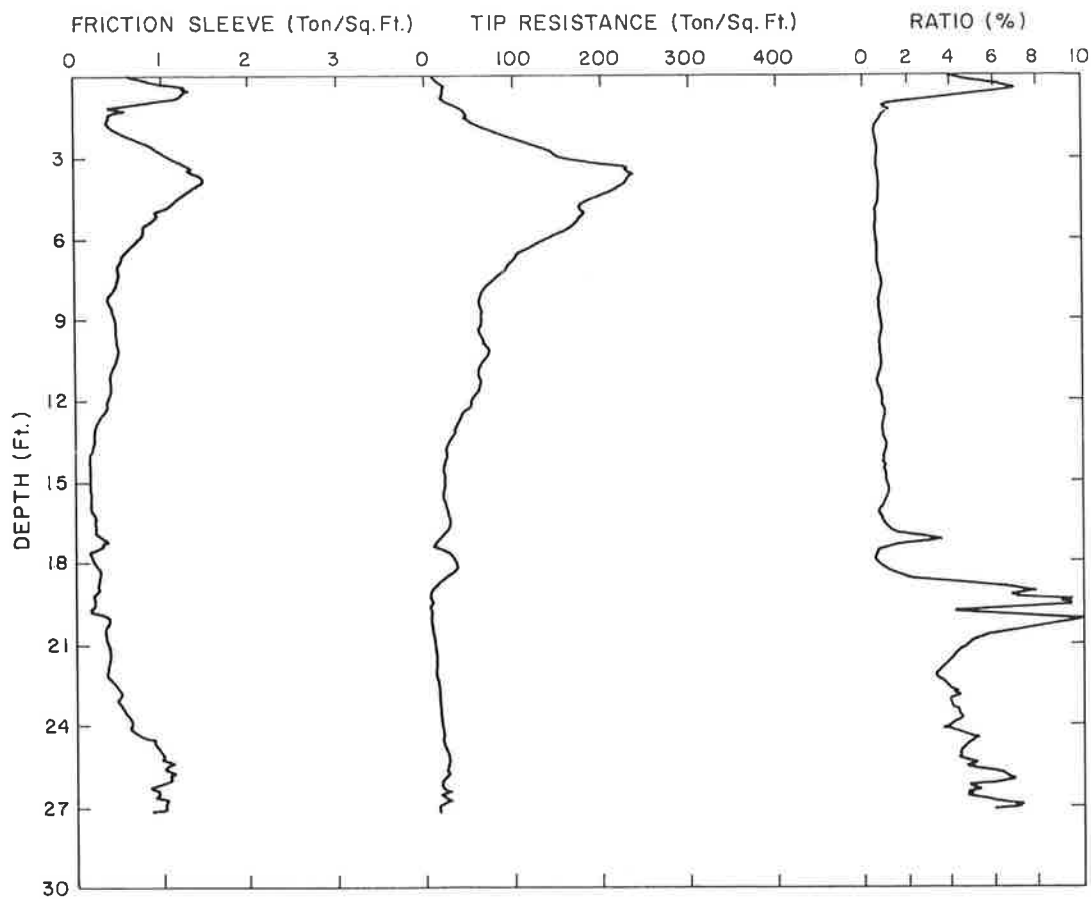
FIGURE 6 Typical ECPT results for traveled lanes.

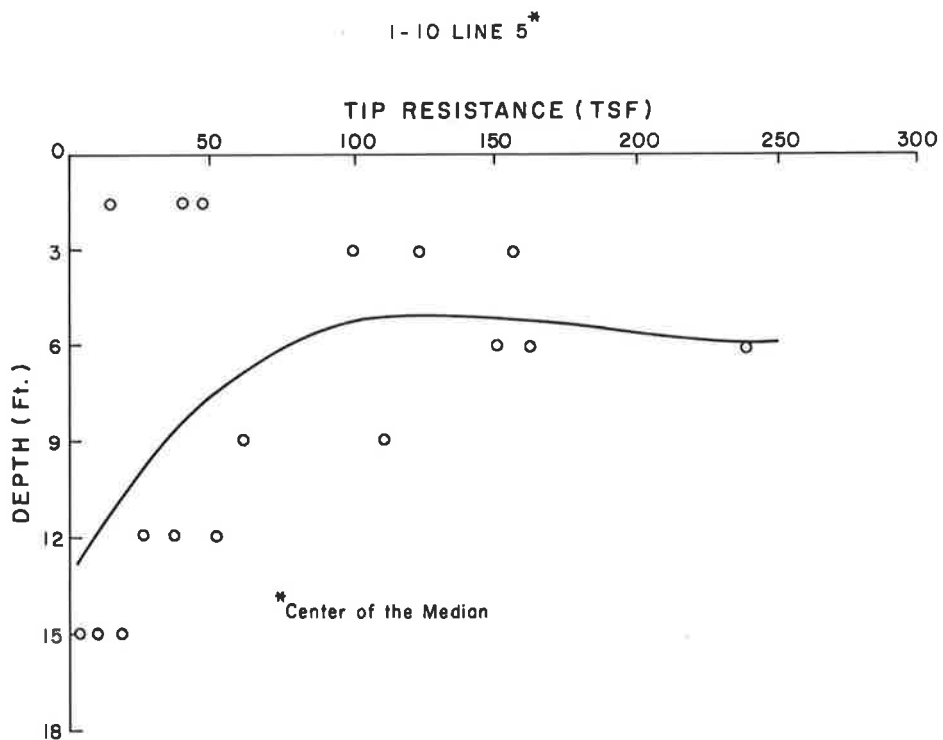
FIGURE 7 Summary of ECPT results for the median.

The ECPT results of line 5 (Figure 7), located at the center of the median, indicate the presence of loose-to-medium to dense sands at depths of 0–6 ft.

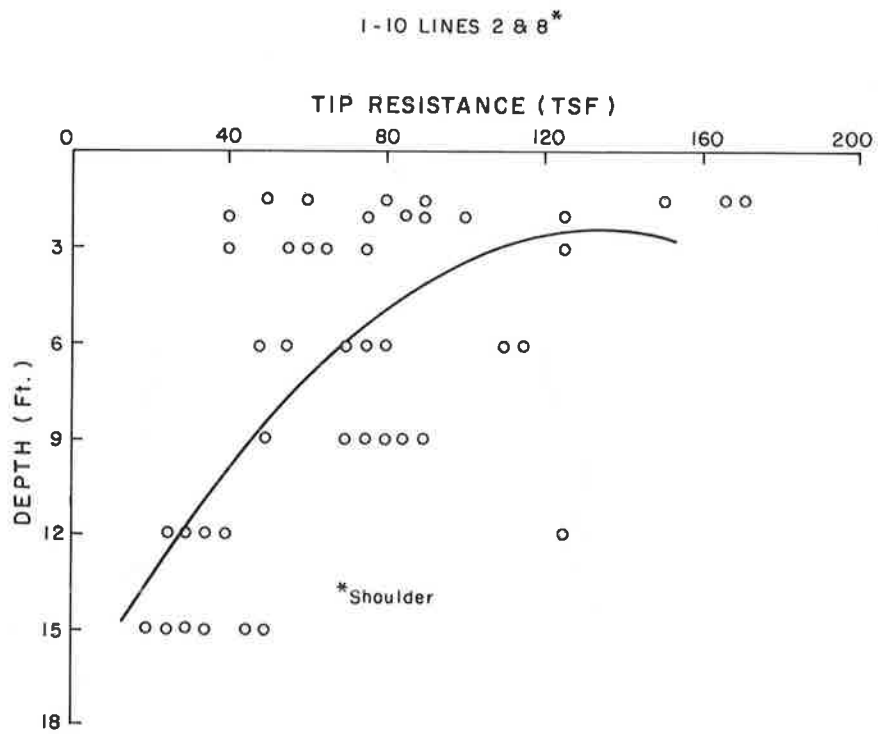
FIGURE 8 Summary of ECPT results for the shoulder.

Typical tip resistances in the top 6 ft of the median vary from 50 TSF to about 150 TSF, similar to those at shoulders (Figure 8). The top 3 ft of the shoulder material appear to be slightly denser than the comparable layers at the centerline of the median.

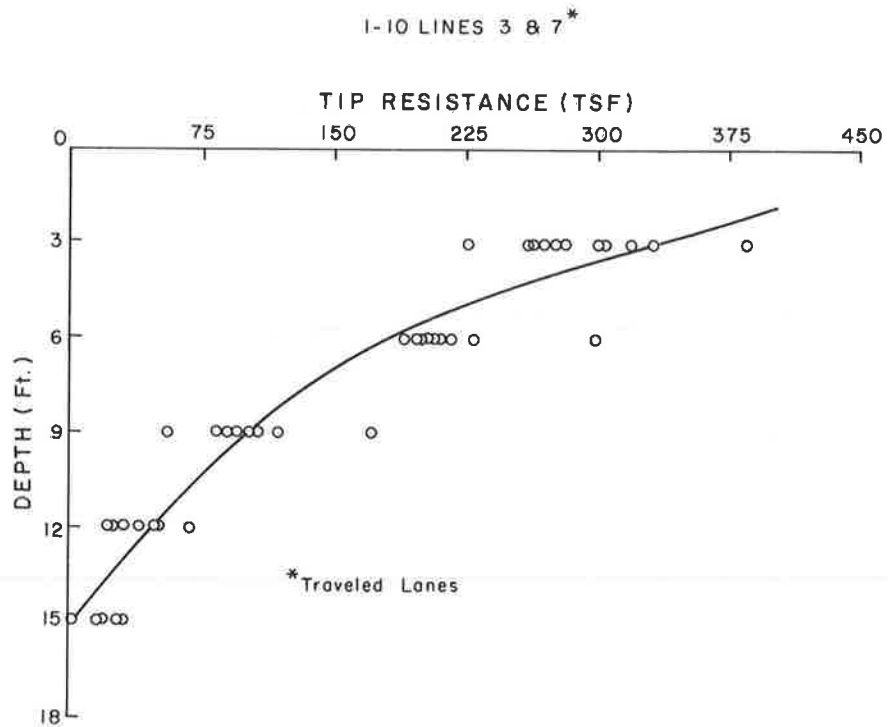
The summary of ECPT results fitted with third-order polynomial curves (Figures 7, 8, and 9) shows that in sites 1 and 2, the density of the sand in the embankment, and thus the dimensional stability, varies substantially based on the location across the roadway. Test results also show that the sand in the embankment under the shoulders (identified as lines 2 and 8, Figure 1) is of medium density in the 0- to 3-ft depth, is loose from 3 to 6 ft, and is very loose from 6 to 15 ft.

FIGURE 9 Summary of ECPT results for traveled lanes.
