Considerations for Stabilizing Drained Failures of Slopes

WILLIAM M. ISENHOWER

Three drained slope failures bordering I-37 in San Antonio, Texas, occurred during the fall and early winter of 1986. One failure resulted from adverse natural seepage conditions, whereas the other two failures resulted from a broken water main and a disrupted surface drainage system. The latter two failures were stabilized by eliminating the water entering the slopes. Several procedures were considered for stabilization of the first failure. Use of horizontal drains was judged to be the most effective in raising the long-term factor of safety for the slope. The design of horizontal drainage systems is reviewed and sample calculations are provided to illustrate that many combinations of drain length and spacing can result in approximately equal gains in factor of safety with time and that longer drains that can achieve higher long-term factors of safety can be only marginally more expensive than systems with shorter drains. A second finding is that there is a limit on the benefit of increasing drain length to increase long-term factors of safety.

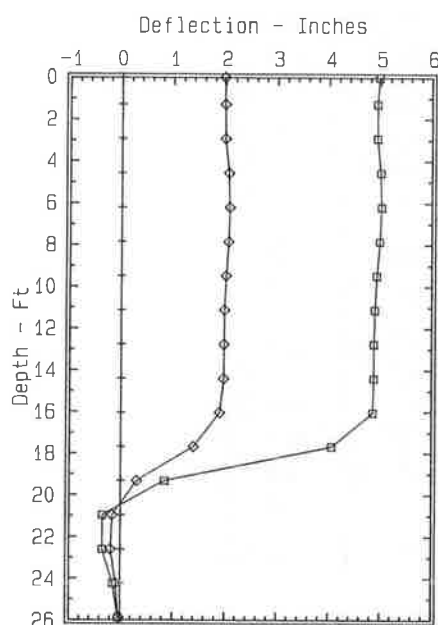
FIGURE 2 Slope indicator.

By middle to late fall, it had become apparent that the first slide (slide 1) was in the area south of the section being monitored. It is interesting to note that the progression of this failure was slow, occurring over several months. In early December, a 30-ft slope indicator casing was installed at the downhill edge of the entrance ramp, roughly in the middle of the slide mass. Slope indicator measurements were taken with time, and the measurements are summarized in Figure 2. The slope indicator measurements found a slip surface at a depth of 20.5 ft.

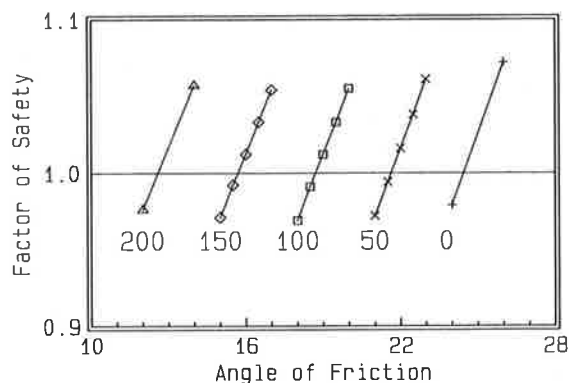
FIGURE 3 Single surface analyses.

1. Values of effective stress shearing parameters (c' and ϕ') were assumed, and the factor of safety for the observed failure surface was evaluated. Holding cohesion constant, values of ϕ' were varied until the factor of safety equal to 1.0 was bracketed. The value of ϕ' corresponding to a factor of safety of 1.0 was calculated using linear interpolation. This procedure was repeated for several assumed values of cohesion. Values of ϕ' versus c' for the single surface analyses are plotted in Figure 3.

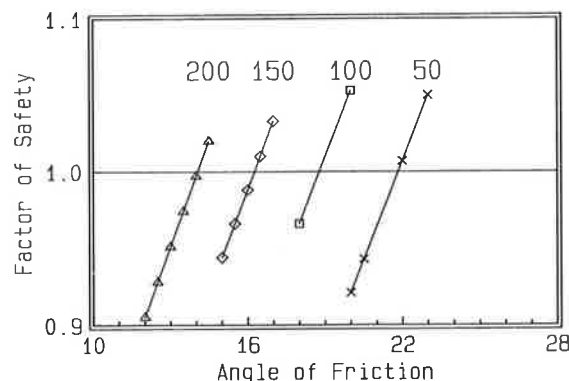
FIGURE 4 Search analyses.

2. The procedure used in step 1 was repeated, using the search mode for critical failure surface of the program to find the combinations of c' and ϕ' for a factor of safety of 1.0. These combinations of ϕ' versus c' were plotted together with the values found in step 1. The back-

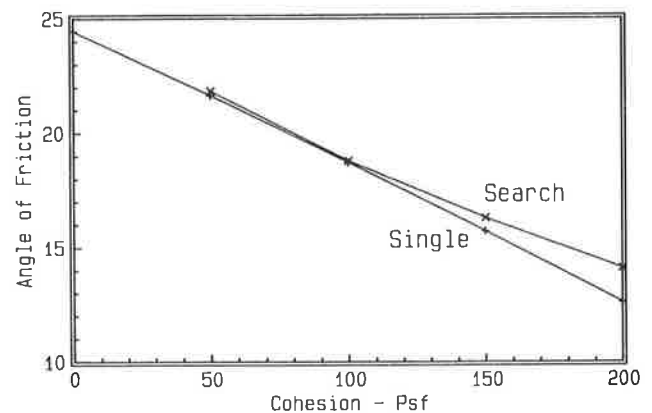
FIGURE 5 Back-calculated shearing parameters.

The results of the analyses made for the two steps discussed above are shown in Figures 3 to 5. The water table was assumed to be that shown in Figure 6, where the line of seepage was near the slope profile. The comparison of the single-surface and search modes of analysis found $c' = 100$ psf and $\phi' = 18.8$ deg. The value for ϕ' is reasonable compared with published correlations of angle of friction with plasticity index.
