# Washington State DOT Meets the Challenge of Hazardous Waste

OSCAR R. GEORGE AND MARK G. UTTING

Geotechnical exploration during design of the \$100 million Tacoma Spur Freeway (SR 705) revealed unexpected coal tar contamination. This discovery was traced to a long-abandoned coal gasification plant which operated on the site around the turn of the century. Further discoveries during construction included two large, buried tanks filled with tar waste, and copper contamination from ore spilled in an old train derailment. A three-year cooperative effort by the Washington State Department of Transportation (WSDOT) and the Washington State Department of Ecology (WDOE), assisted by a hazardous waste consultant, ensured that design and construction proceeded with minimal delay. Solutions produced by the joint effort included three specially designed on-site concrete vaults for storing 26,450 tons of problem waste and the removal of 15,900 tons of extremely hazardous waste to a hazardous waste facility in Arlington, Oregon. In addition, 1300 tons of copper-contaminated soil were removed and transported to a smelter in El Paso, Texas, for recovery of the ore. Total project cleanup costs w

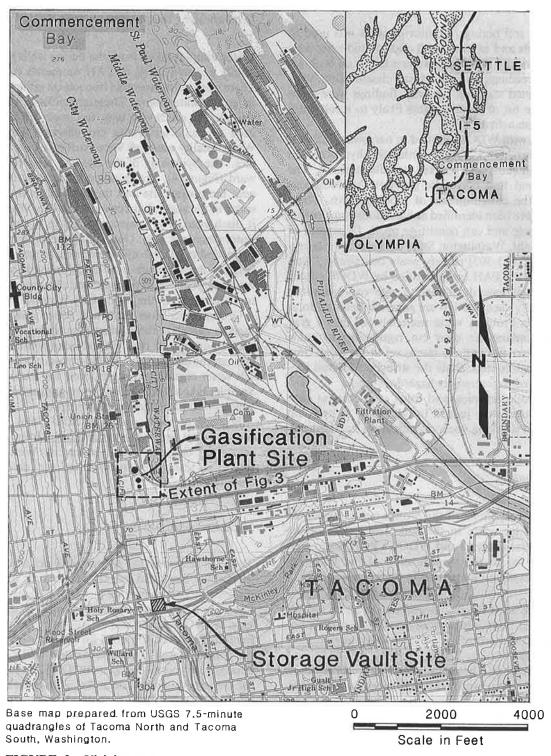
FIGURE 2 Vicinity map.

Most of the plant was located between South 21st and South 23rd Streets next to A Street (Figure 2). Review of historical files and SANBORN insurance maps revealed

that two gas holding tanks and a tar pump area had been used during plant operations from 1884 through 1924. A third tank was built on the site sometime between 1928 and 1930. Figure 2 shows the tank locations.

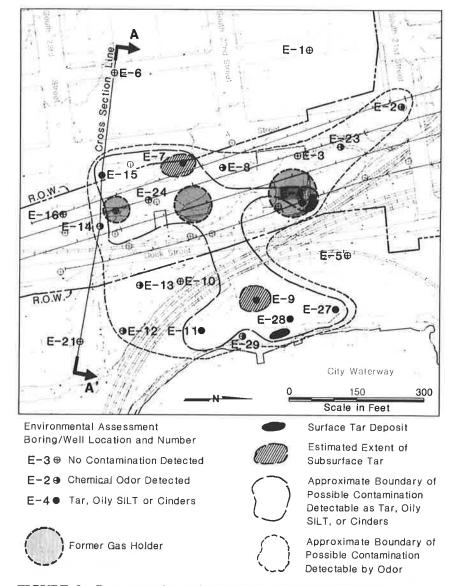
FIGURE 3 Pre-excavation estimate of subsurface contaminants.

The extent and distribution of these materials were initially estimated based on the results of the soil borings and lab results (Figure 3). Levels and types of contamination were estimated by interpolation between the borings, resulting in an estimate of 40 to 100 cubic yards of tar and 4,500 to 6,000 cubic yards of oily silt or sand.

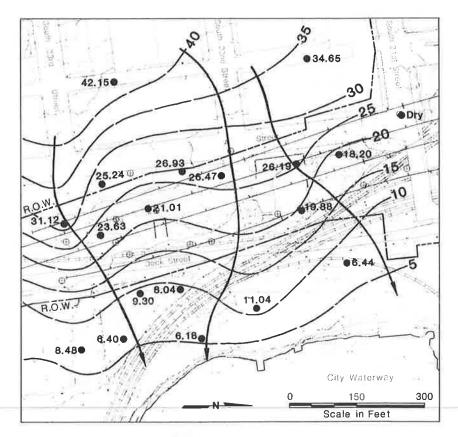
FIGURE 4 Water table elevation contour map.

Water samples taken from the boring wells indicated only mildly elevated levels of PAH or metals contamination. There were no measurable impacts on either surface water or groundwater users. These conclusions were based on water levels, soil boring logs, and in-site hydraulic test data used to characterize the groundwater flow conditions. Water quality analyses were performed on selected samples. The hydrology of the site was relatively straightforward (Figure 4). Precipitation infiltrated the areas in or near the project site and then flowed as shallow groundwater in the general direction of the City Waterway, where it discharged. The project site lies in a regional groundwater discharge area. Underlying the project site was low permeability glacial till, preventing contaminated water beneath the site from flowing downward to contaminate water supply wells in the area, and allowing contamination to discharge from the site to City Waterway.

Groundwater flow rates and water quality data were used to calculate the loading rate to the Waterway. This analysis indicated that groundwater contamination concentrations entering the Waterway were below the existing salt water chronic exposure levels for marine organisms. Samples taken from the Waterway indicated no detectable concentrations of these contaminants.
