# Full-Scale Vehicle Crash Tests on Nebraska Rural Mailbox Designs

RONALD K. FALLER, JOHN A. MAGDALENO, BYRON A. WARLICK,  
WILLIAM H. WENDLING, AND EDWARD R. POST

The Nebraska Department of Roads, in conjunction with the Federal Highway Administration, has developed a new mailbox support system that could be used to accommodate a wide range of mailbox sizes. To be considered a safe appurtenance, the system had to be subjected to full-scale crash tests, as provided in recommended procedures published by the Transportation Research Board, March 1981. The major concern was to find whether the support system would keep the mailbox attached to the post and would not allow detached elements to penetrate the passenger compartment of a vehicle. Four full-scale crash tests were conducted with an 1,800-pound vehicle. Two tests with the post embedded in weak soil were performed at 20 mph and 60 mph, respectively. Two tests with the post embedded in strong soil were conducted at the same speeds. Three of the tests used a support system that held two mailboxes (Size 1-A). One test used a system that supported one mailbox (Size 2). After analyzing the results of the crash tests, it was eviden

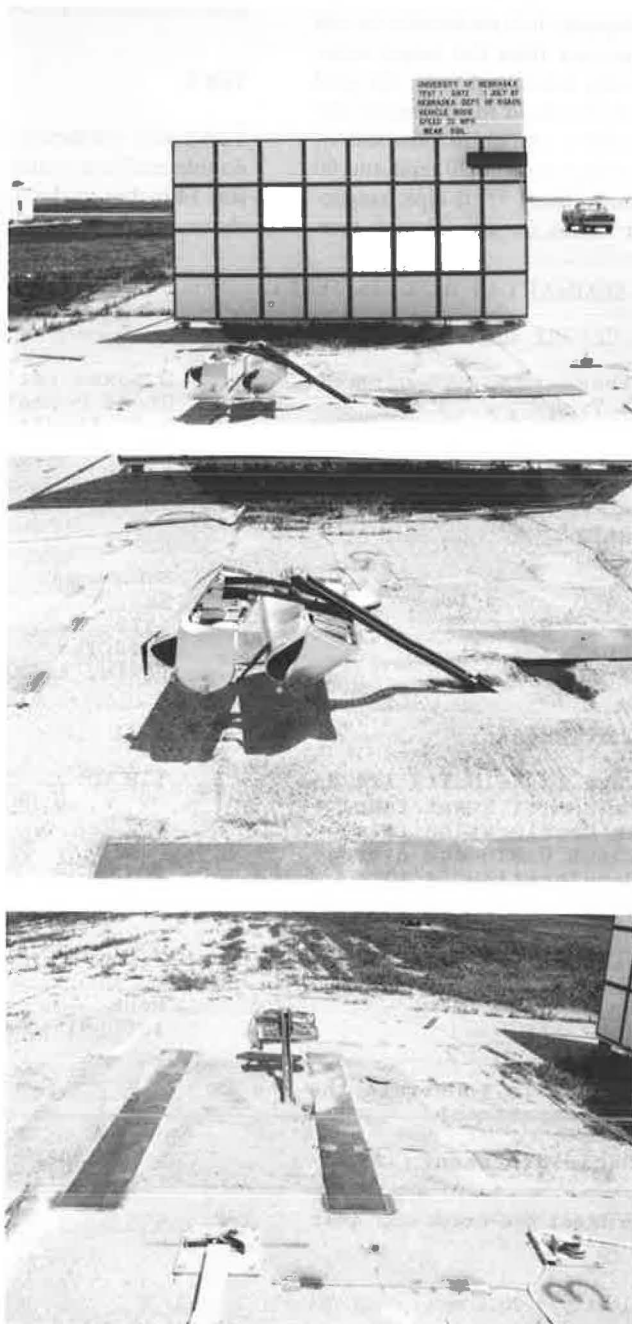
FIGURE 5 Damage to mailbox system, Test 1.

4. Upon impact, the post first wrapped around the bumper, and then the mailbox hit the front end of the hood. The car then continued to push the mailbox and post to the ground. While the car continued to move over the mailbox and post, the retainer strap held the top section of the post to the base post, which was not pulled out. Photos of the damage to the mailbox system are shown in Figure 5.

The vehicle received no damage with the exception of a small dent in the bumper. The damage was classified according to TAD and VDI scales, and the results are given in Table 3.

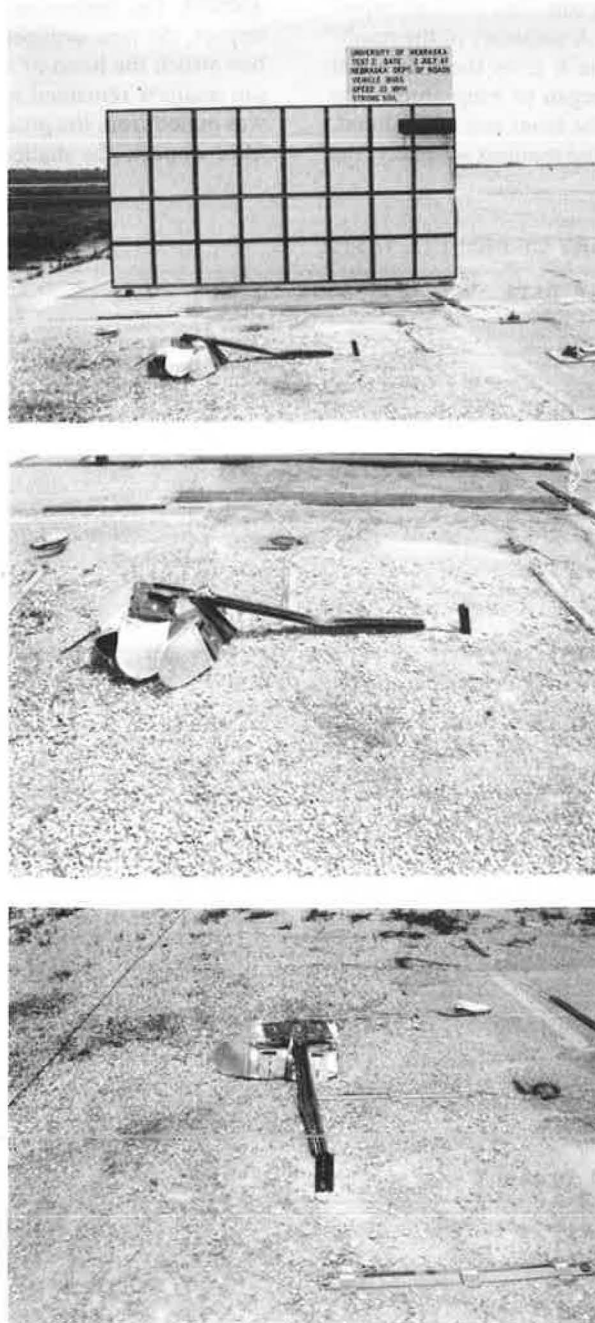
FIGURE 6 Damage to mailbox system, Test 2.

Test 2 was performed at an impact speed of 21.3 mph on the double mailbox system in the strong soil. The point of impact was 14 inches to the right of center. A summary of the results of Test 2 is given in Table 5. Table 6 gives the time-event summary. Upon impact, the post began to wrap around the bumper, and then the mailbox hit the front end of the hood. As the car continued to travel over the mailbox assembly, the

top section of the post broke away from the base post, which remained in the ground. This demonstrated the breakaway or slip feature. Photographs of the damage to the mailbox system are presented in Figure 6.

The only damage to the vehicle was a small dent in the front end of the hood and a minor dent in the bumper and front lower right fender. Table 5 gives the TAD and VDI damage ratings.

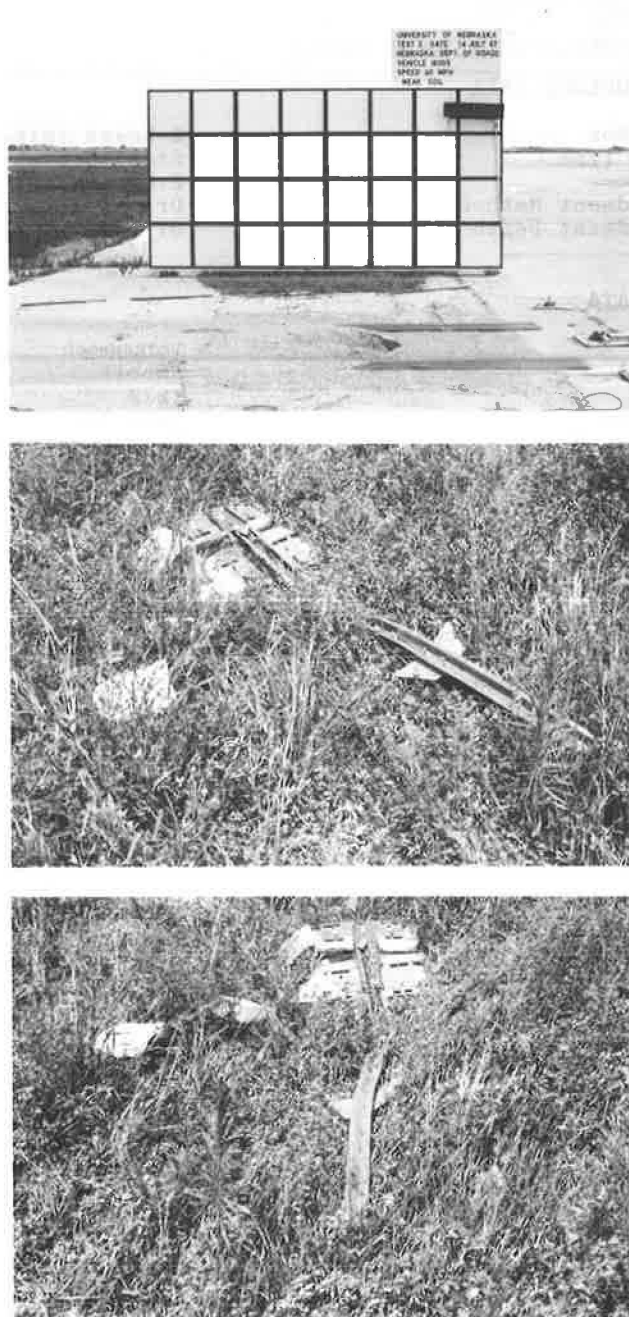
FIGURE 7 Damage to mailbox system, Test 3.

Test 3 was conducted at an impact speed of 63.6 mph on the double mailbox system in the weak soil. The point of impact was center of bumper. The results of Test 3 are shown in Table 7. The time-event summary is given in Table 8. After impact, the post wrapped around the bumper while the mailbox struck the hood of the car. As the car traveled forward, the mailbox remained on the hood while the post assembly was pulled from the ground. At approximately 0.090 seconds after impact, the mailbox assembly started to lose contact

with the hood. The base post, top post, and mailbox all remained intact after they came to a rest 366 feet away, when they were run over by the vehicle. Damage to the mailbox system is shown in the photos given in Figure 7.

The most noticeable damage to the vehicle was a punctured

and dented hood and a fractured plastic grill plate. The TAD and VDI damage ratings are given in Table 7.

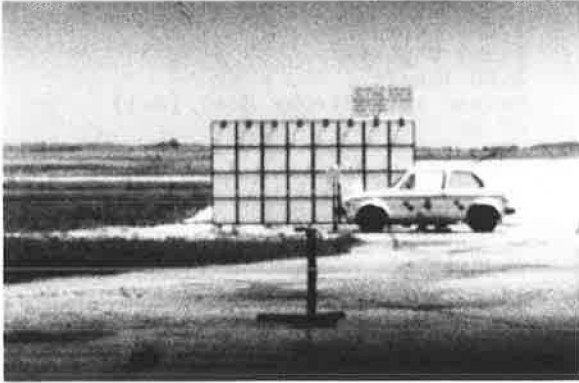
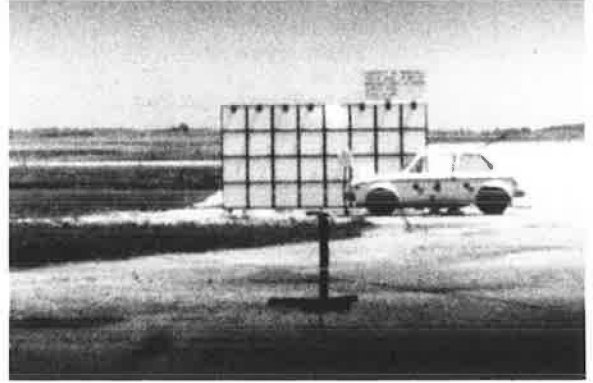
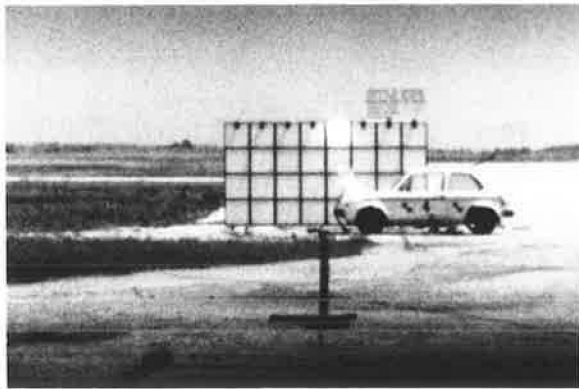
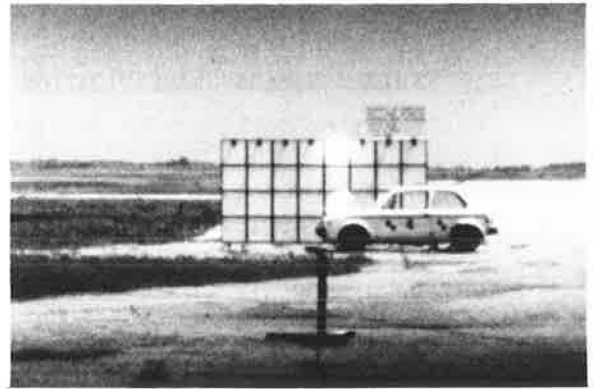
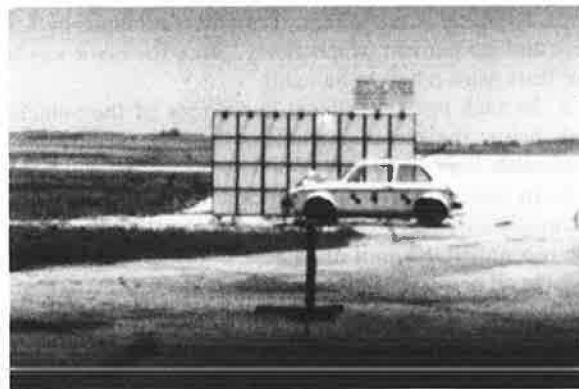
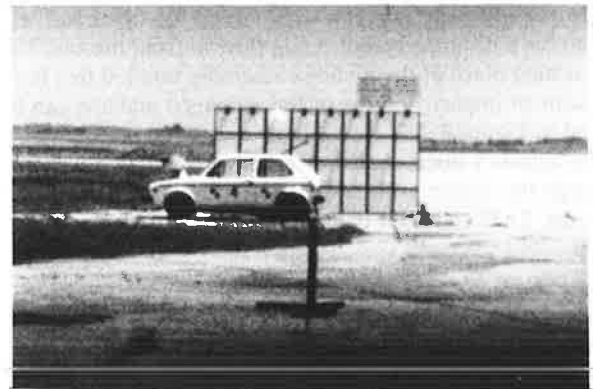
**FIGURE 8** Sequential photographs, Test 4.

Test 4 was performed at an impact speed of 64.5 mph on the single mailbox system in the strong soil. The point of impact was the center of bumper. A summary of the Test 4 results is given in Table 9. The sequential photos are shown in Figure 8 and a time-event summary is given in Table 10. As the vehicle moved through the impact, the mailbox post wrapped around the bumper, and then the top section of the post

separated from the base post. The base post remained embedded in the soil. The mailbox then struck the hood and was carried for a distance before being thrown from the car. The final resting place of the mailbox assembly was 130 feet from the point of impact. Photos of the damaged mailbox can be viewed in Figure 9.

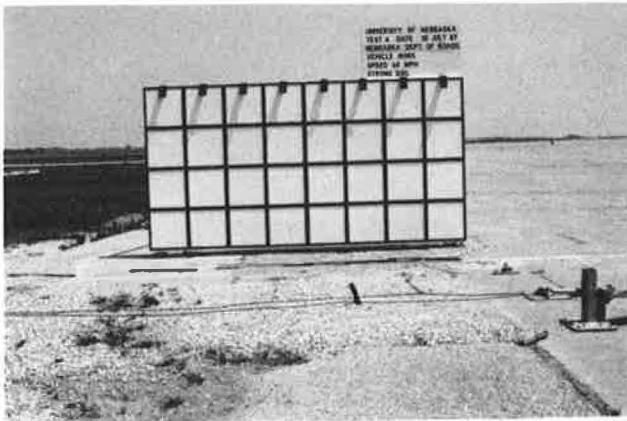
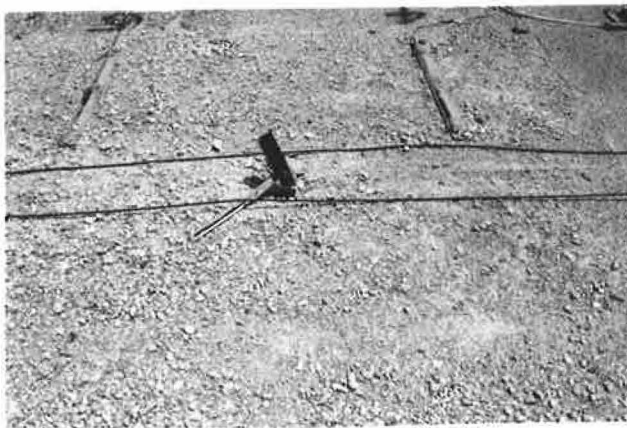
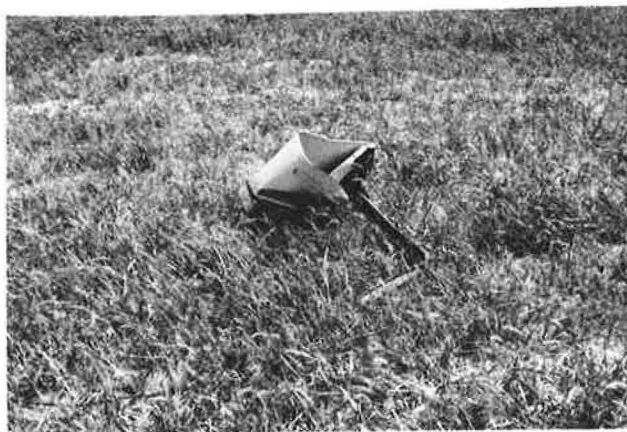
FIGURE 9 Damage to mailbox system, Test 4.

The vehicle's hood received the most significant damage, although the center grill area received some dents. Table 9 gives the TAD and VDI damage ratings for Test 4.

In order to more securely tighten together the mailbox support system, it was suggested that the circular holes in the platform and L-shaped bracket be either punched to a larger size diameter or punched square so the carriage bolt shank can fit in the hole.

Also, it was suggested that the support system, consisting of the platform plates, the adapter plate, and L-shaped brackets, be treated with some type of protective surface coating such as paint or zinc plating. This would reduce the effects of rust on the system and possible mailbox detachment due to weakened steel parts.
