Marquam Bridge Repair: Latex-Modified-Concrete Overlay and Joint Replacement

JOHN D. HOWARD

The Marquam Bridge in Portland, Oregon, provides a crossing of the Willamette River for the north-south I-5 freeway. After 17 yr of service, the bridge, which was opened to traffic in 1966, had a badly worn deck and numerous deck expansion joints in need of repair. The bridge has a daily traffic count of approximately 86,000 vehicles. Because of lack of capacity of detour routes, complete closure to traffic could be permitted only during night hours. To correct the deck and joint problems, a contract was awarded in May 1983 for a latex-modified-concrete overlay and joint repair. On a previous job with a 3-percent grade, the tendency of the finished surface to shift downhill during the early cure stages was noted, and it was thought that this tendency could be a major problem on this structure with ramps on 6-percent grades and 0.10 ft/ft supers. Type III cement was suggested; it was tried and was found to be a workable solution. Narrow pour widths required by traffic staging were as significant a factor to surface irregularities as were the steep slopes. The pour widths also restricted the

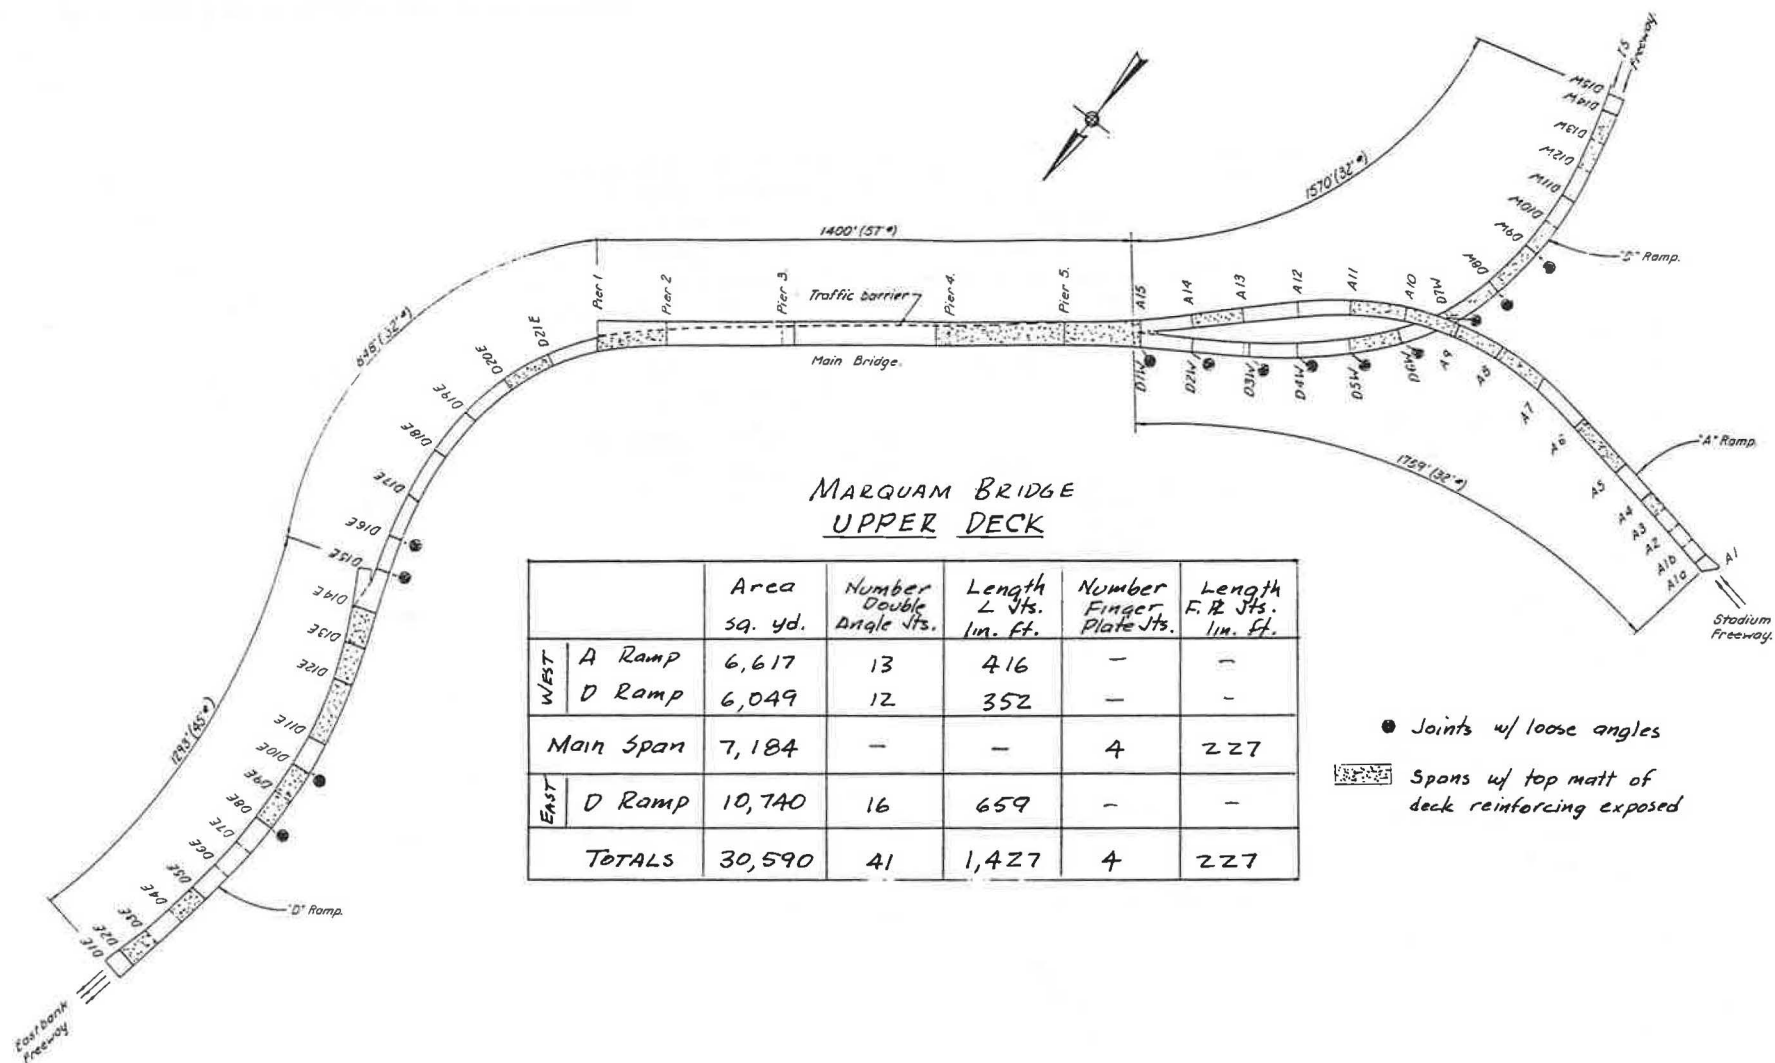
Prior to and after award of the contract, surveys were made to determine the extent of work needed to be done. (Overlay contract was awarded May 10, 1983.) Both surveys found significant wear throughout the structure, with a number of spans that had the top mat of reinforcing exposed and a number of locations with loose angles at the joints (Figures 4 and 5). Based on the elevation of the armored corners at the joint, approximately 0.5–1 in. of rutting in the wheel tracks occurred during the 17-yr life of the deck. Bridge plans showed 1.5-in. cover on the top mat of reinforcing, which apparently was not available in some cases. Where the steel was exposed, it showed very little rusting and appeared to be well bonded. Checks on the chloride content found 1–2 lb/yd³ in the top 1 in. These minimal amounts are the result of using very limited amounts of chlorides in the sanding materials during the winter months. The first survey showed some small areas with delaminations. These were checked with cores through the deck and no problems were found.

FIGURE 4 Upper deck—loose angles and exposed reinforcing.

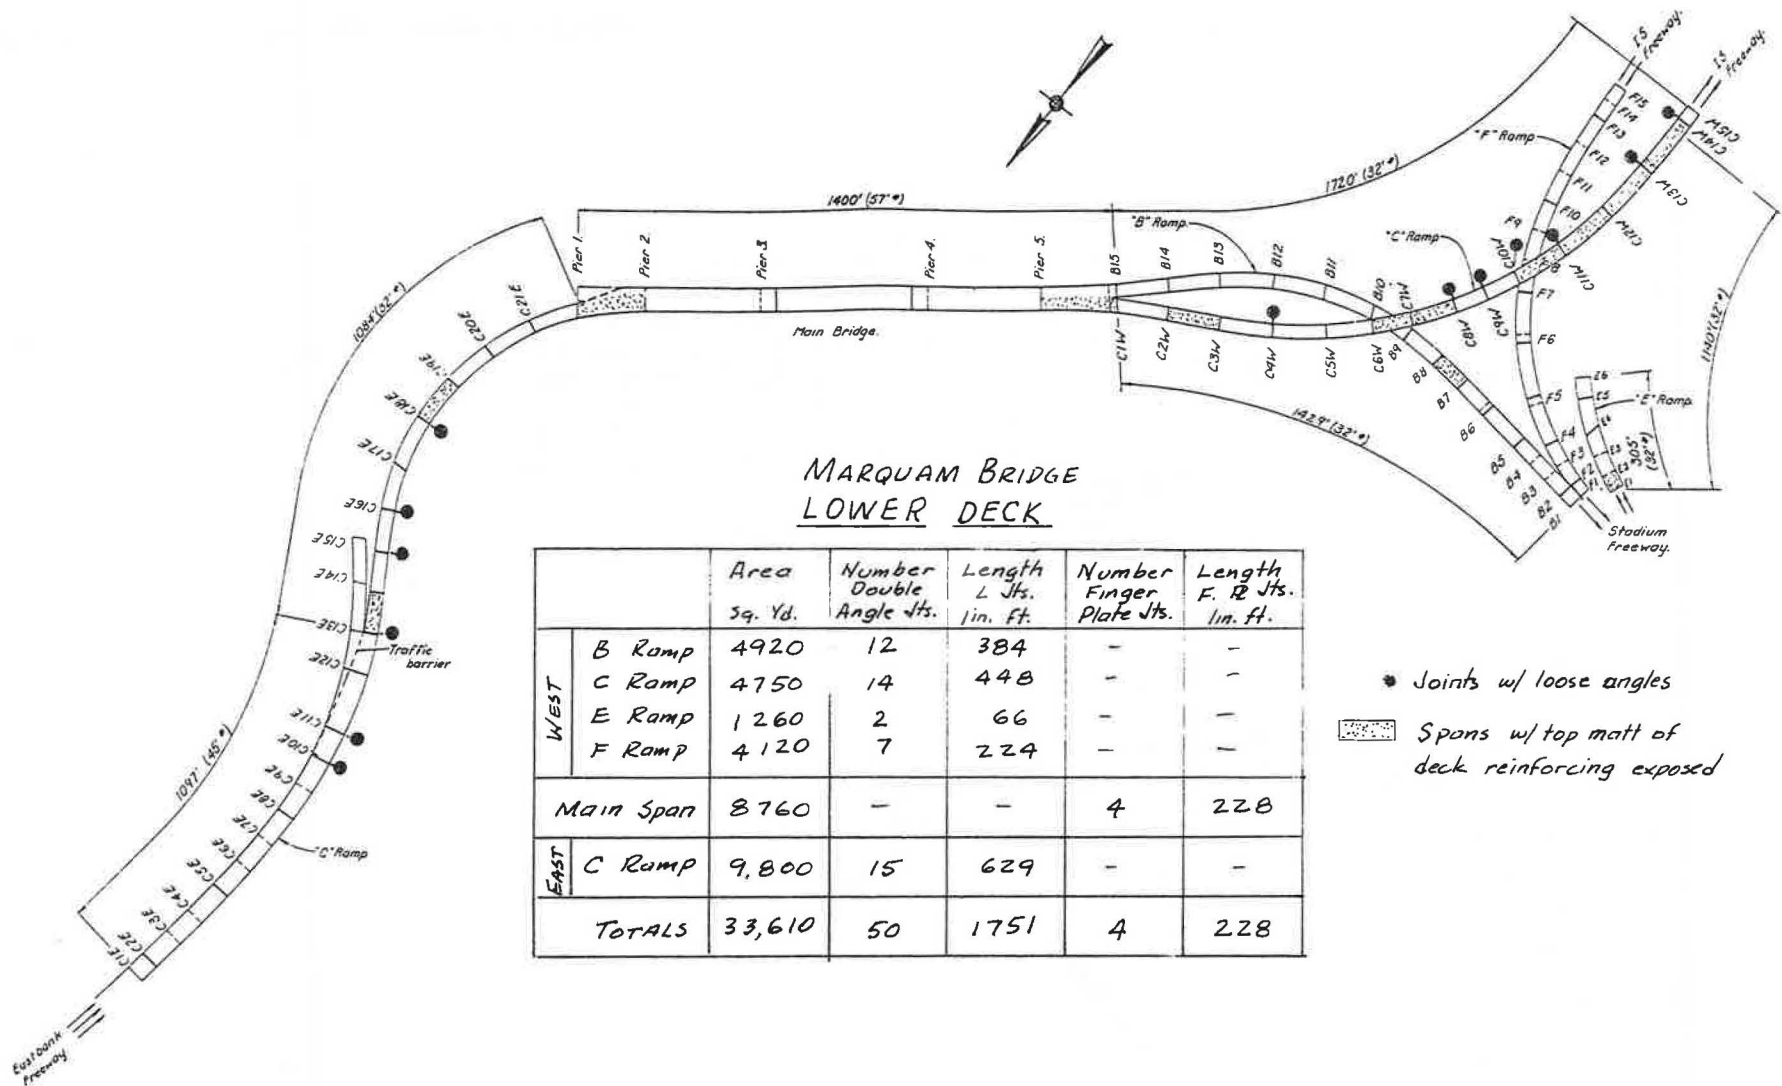
FIGURE 5 Lower deck—loose angles and exposed reinforcing.

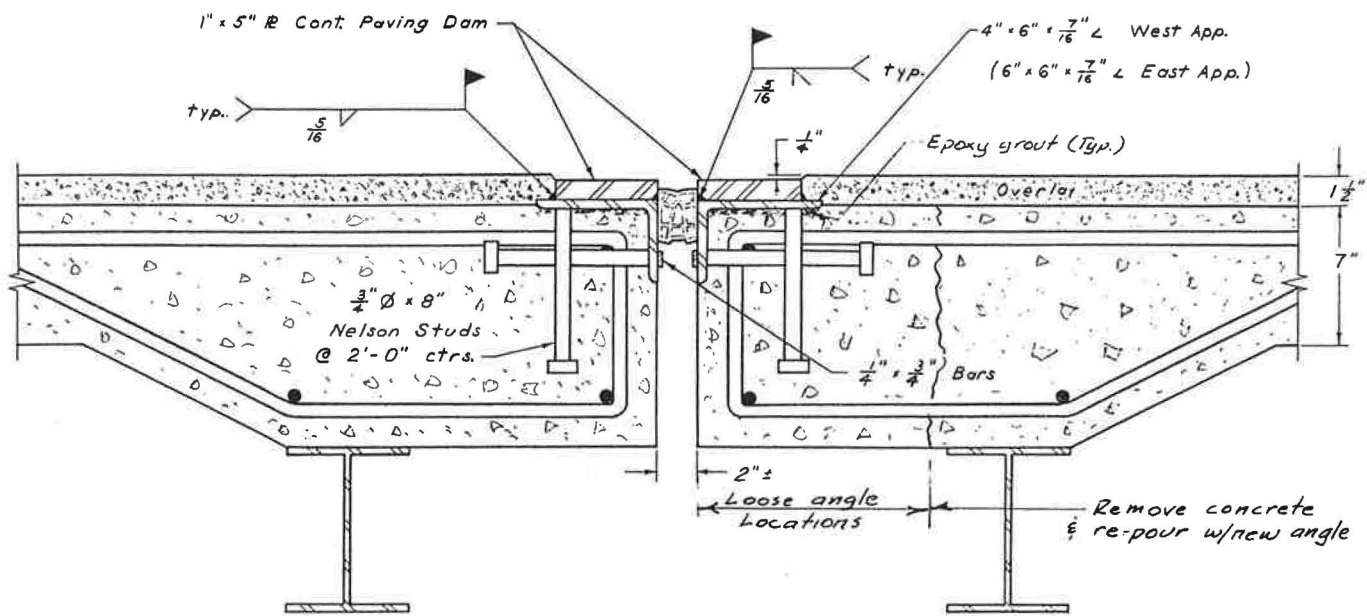
TYPICAL DOUBLE-ANGLE JOINT

Figure 6 shows a detail of the double-angle armored corner joints. Poor consolidation of concrete under the horizontal leg plus traffic created a void which was found at all locations. Where it was severe, flexing of the angle between the studs caused the stud welds to fracture. At these loose angle locations, the overlay plans specified removing all of the joint and replacing it with a strip seal. A recheck found only portions of the joints needed removal so it was decided to use the Figure 6 detail throughout.

FIGURE 6 Typical double-angle joint.

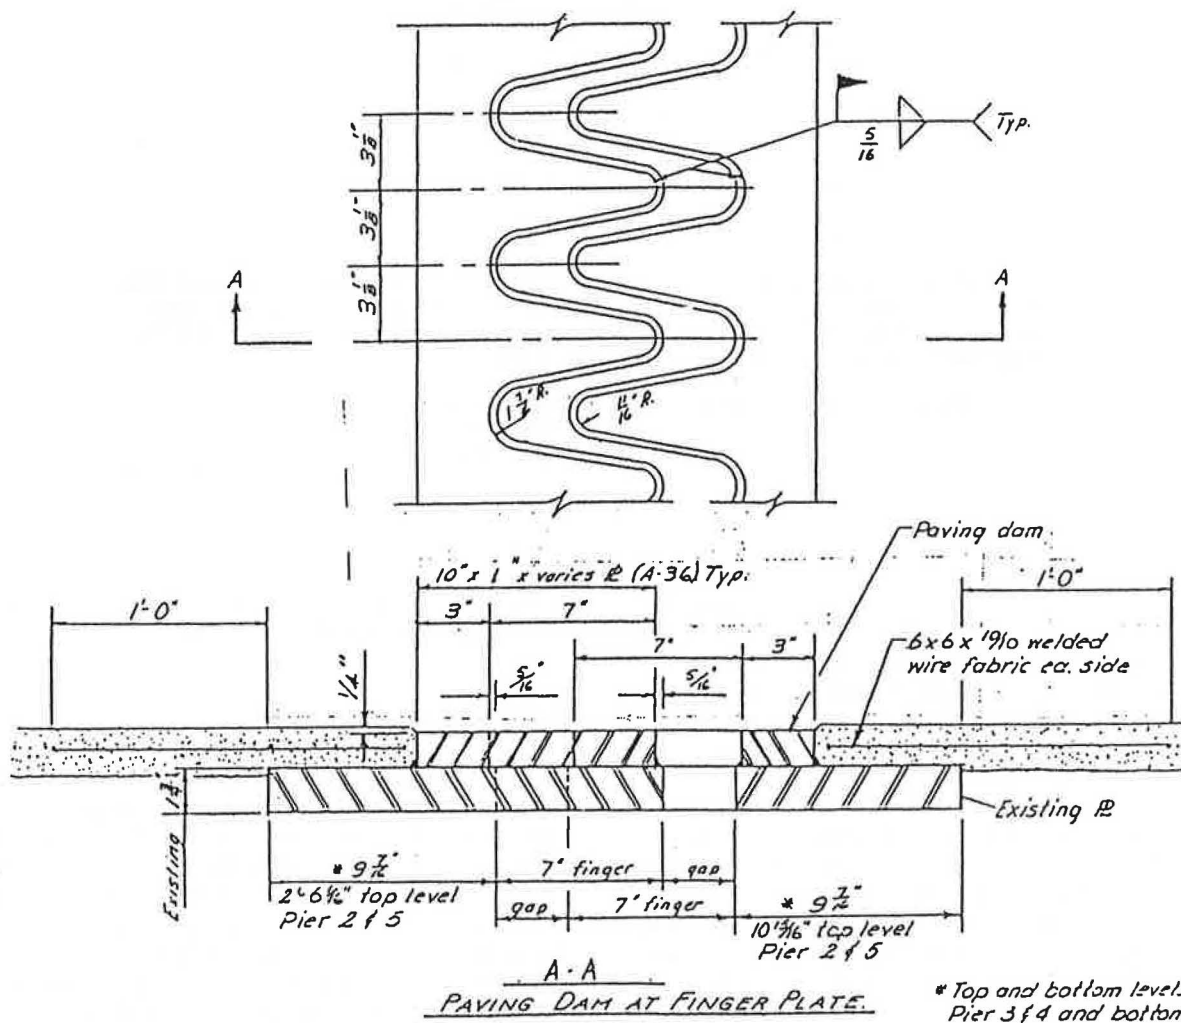
Figure 7 shows the paving dam detail for the finger plate joints on the main span. The existing plates are part of the structural steel stringer system and were all found in good condition.

FIGURE 7 Paving dam at finger plate.

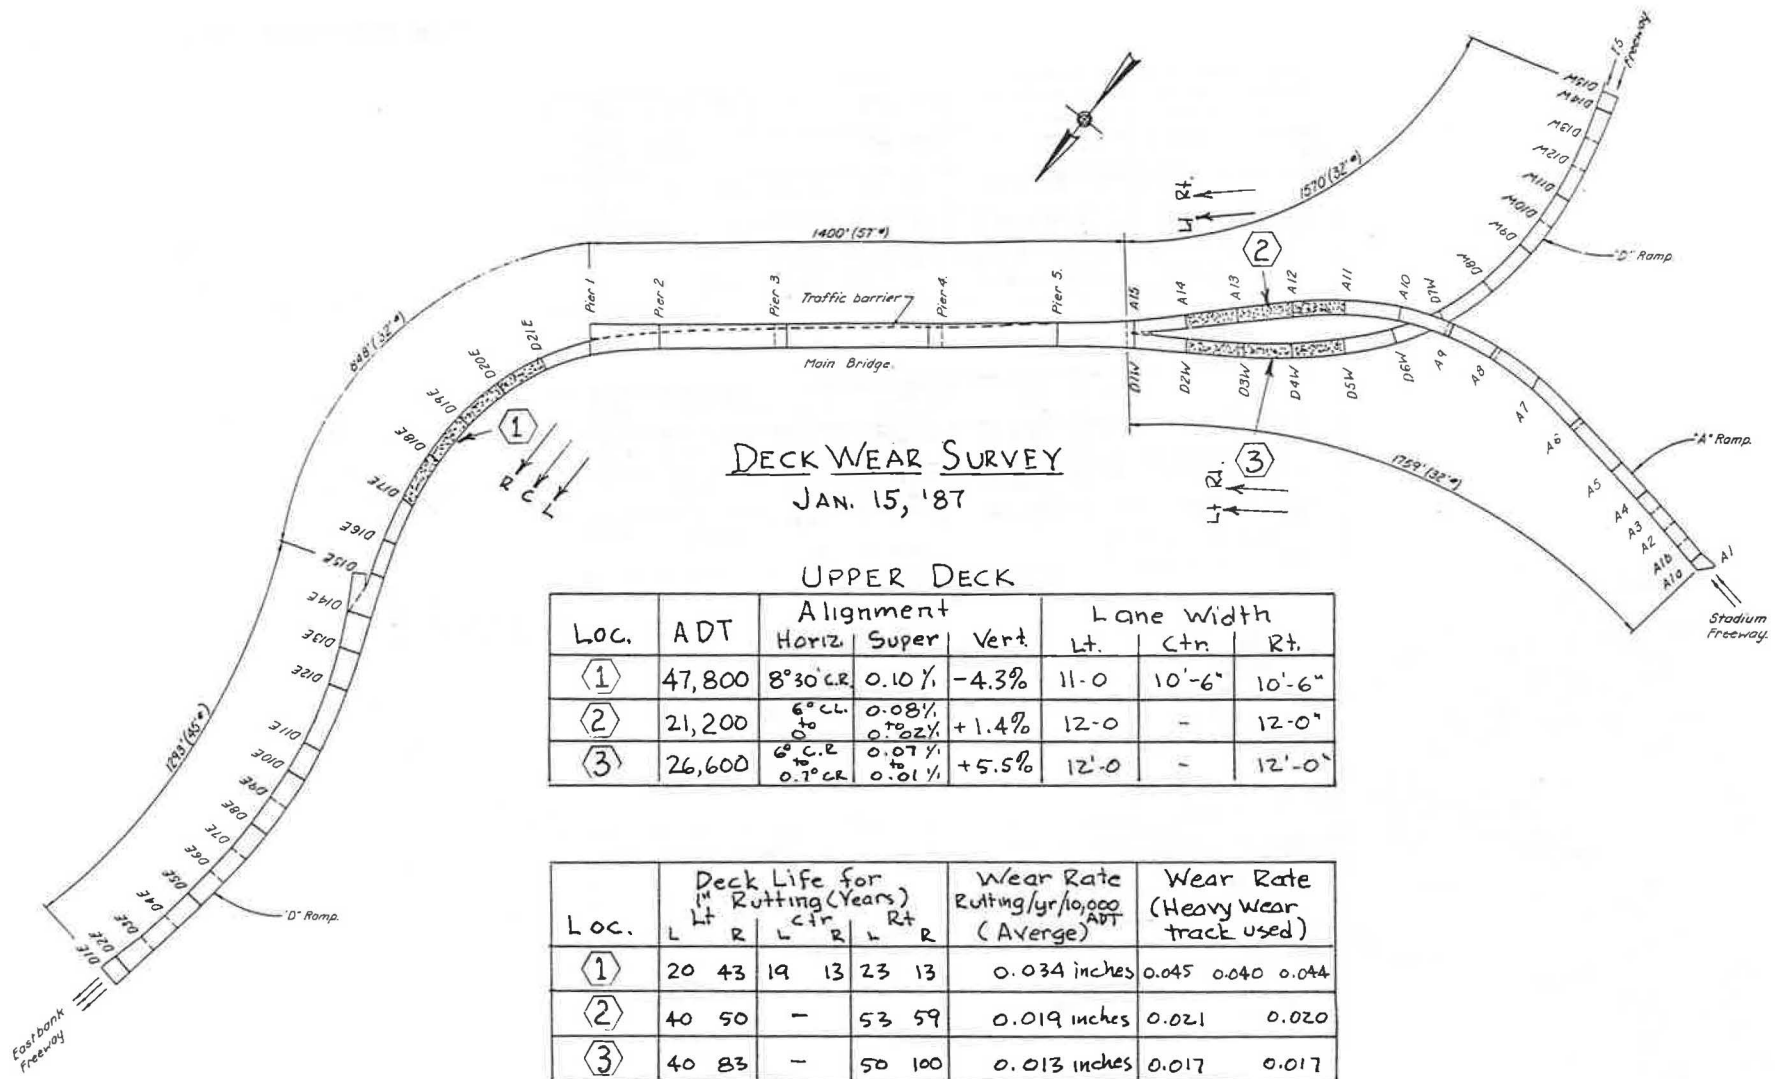
FIGURE 10 Deck wear survey—upper deck.

The traffic count, alignment, and lane width, which could be possible factors in the wear, are shown in Figures 10 and 11. At about 20-ft intervals, the depth of the wheel tracks was measured, averaged, and prorated to give the years for a 1-in. rut shown in the lower block. Of significance is the much heavier wear found at several locations in the outside wheel track. As expected, the narrow lanes on the east ramps show the shortest life. By comparison, the original deck after 17 yr had an estimated 1-in. wear in this area. During the 17

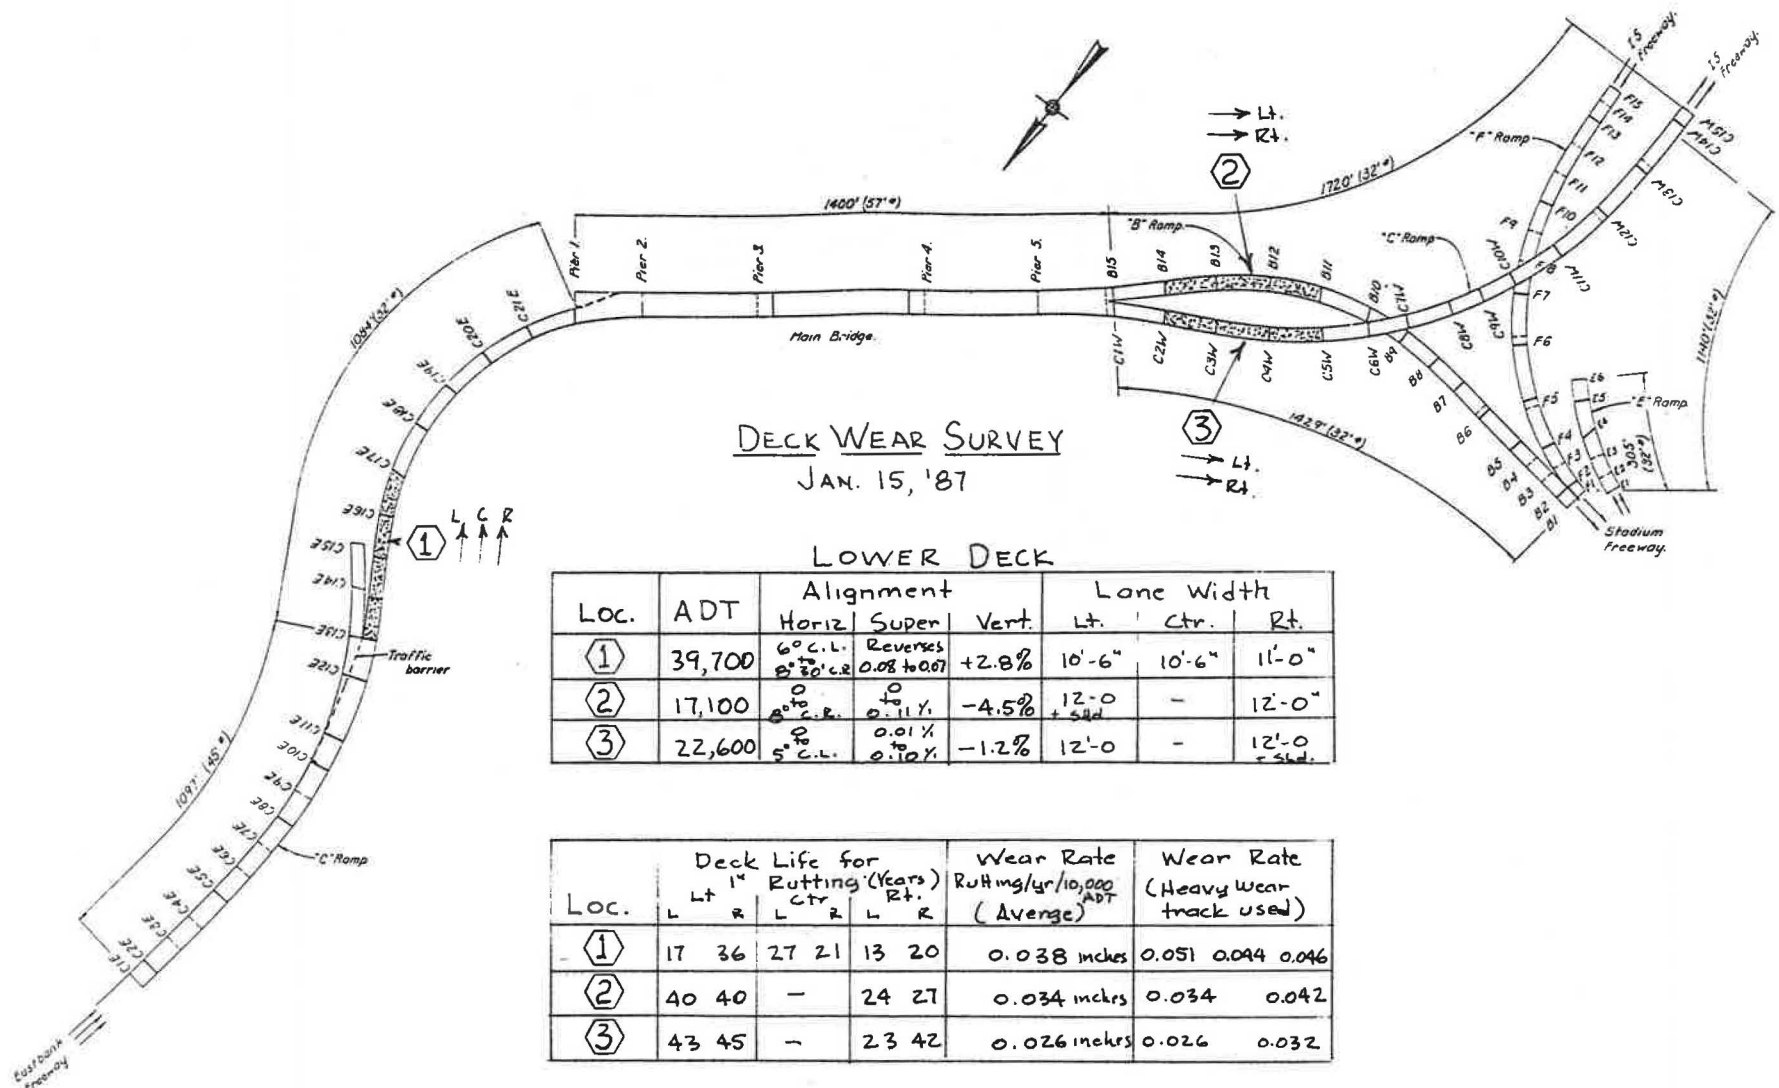
FIGURE 11 Deck wear survey—lower deck.
