Collapse of a Segmental Post-Tensioned Concrete Bridge

R. J. WOODWARD

This paper describes an investigation into the collapse of a single-span, segmental post-tensioned concrete bridge. The structure consisted of precast units stressed together both longitudinally and transversely. It was built in 1953 and collapsed at approximately 7:00 A.M. on December 4, 1985. There had been no evidence of distress before failure, and there was no traffic on the bridge when it collapsed. The investigation showed that the bridge had deteriorated because of corrosion of the tendons where they passed through the segmental joints. Corrosion had occurred because the tendons had been inadequately protected at the joints, and this had enabled chlorides to enter the ducts. It is believed that de-icing salts were the major source of chlorides, although it is possible that dune sand had been included in the mortar used to fill the transverse joints. The results cause concern about the condition of other post-tensioned concrete bridges in which tendons pass through joints.

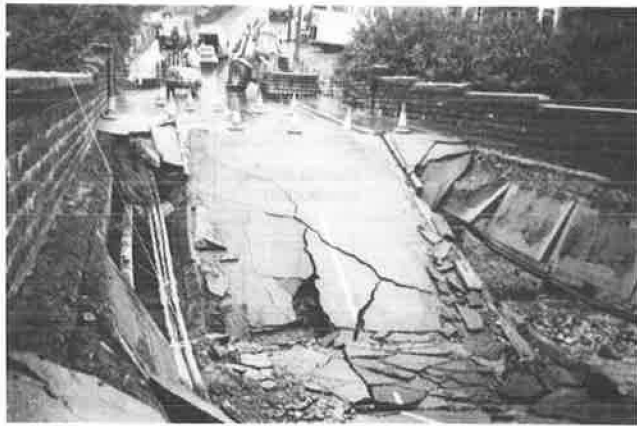
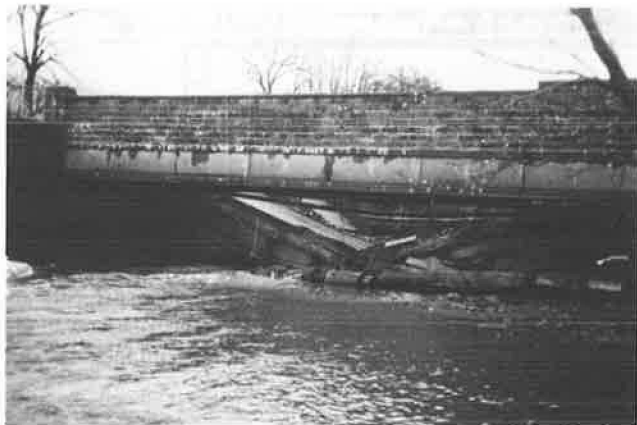
The deck collapsed when there was no traffic on the bridge; all nine internal beams failed (Figure 2). The line of failure is shown in Figure 3. The edge beams and blockwork parapets remained standing and apparently unaffected, despite the inward and downward forces exerted by the top transverse, prestressing tendons as the central deck collapsed. Some of the slabs that spanned the gap between the I-beams and the edge beams were left hanging from the edge beams.

FIGURE 2 Ynys-y-Gwas bridge after collapse (photographs courtesy West Glamorgan County Council).

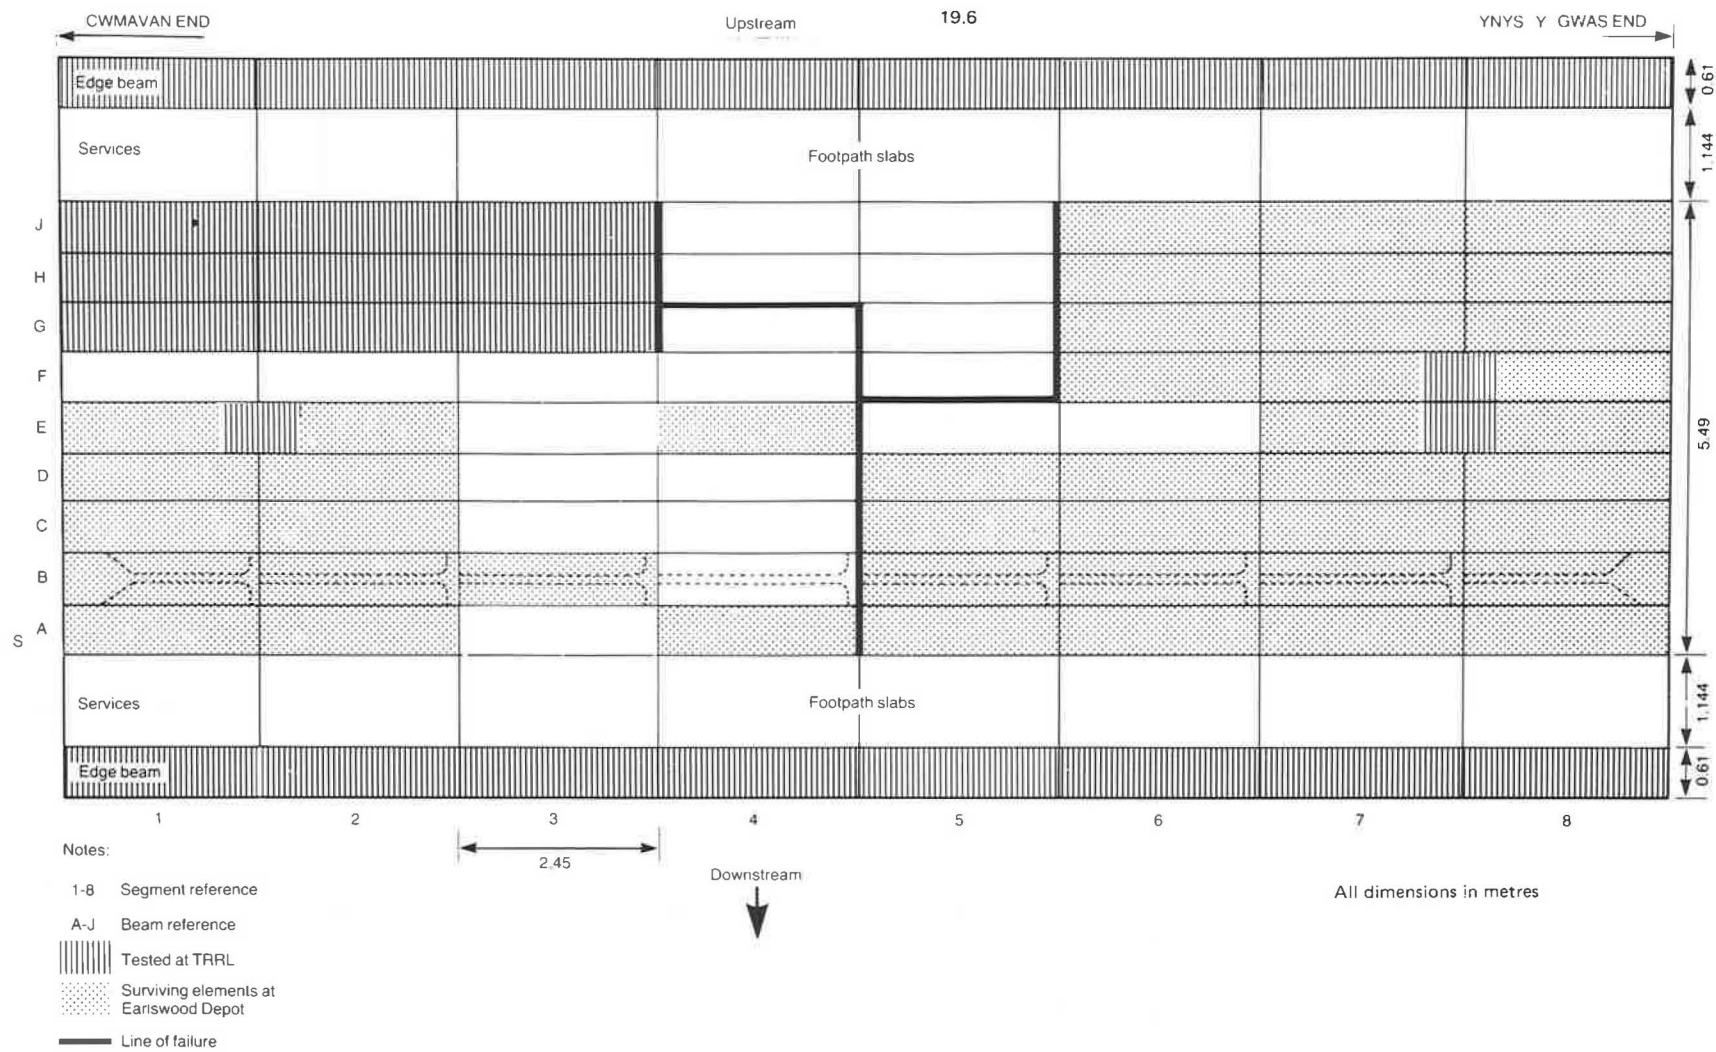
FIGURE 3 Ynys-y-Gwas bridge (1953-85) plan view of deck.

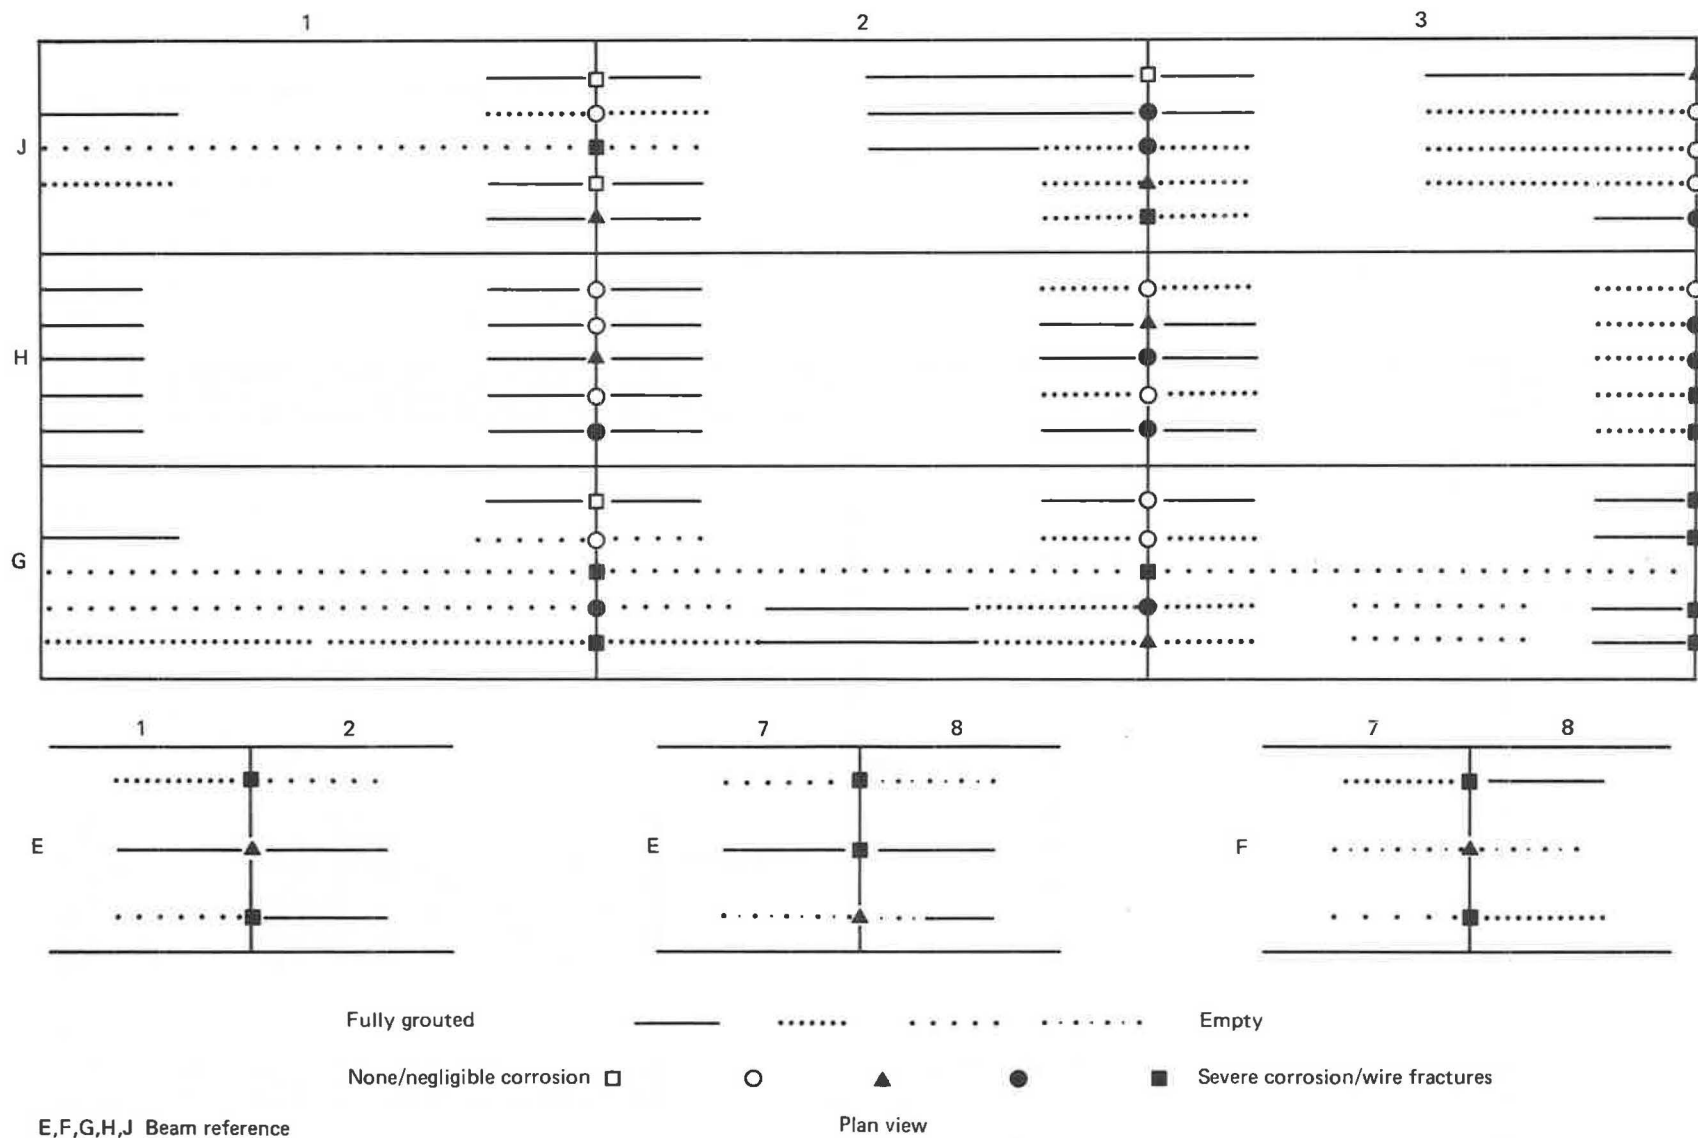
FIGURE 4 Condition of longitudinal tendons and grouting of ducts, I-beams.

Eighteen of the 24 ducts examined in the I-beams were either fully grouted or contained small air pockets, either at the top of the duct or in the center between the wires. Of the other six ducts, four contained large voids with exposed wires and two were empty for part of their length (Figure 7). The largest voids were found near the anchorages in deflected ducts, although not all deflected ducts contained voids.

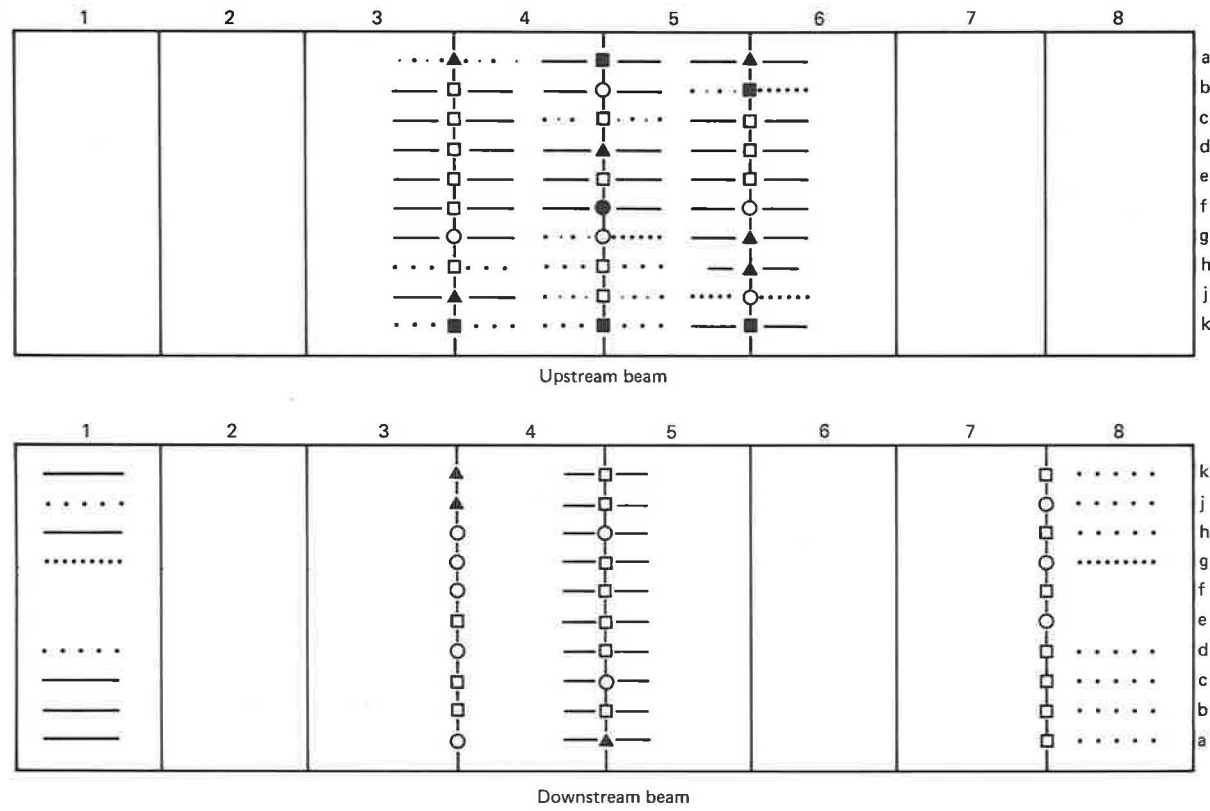
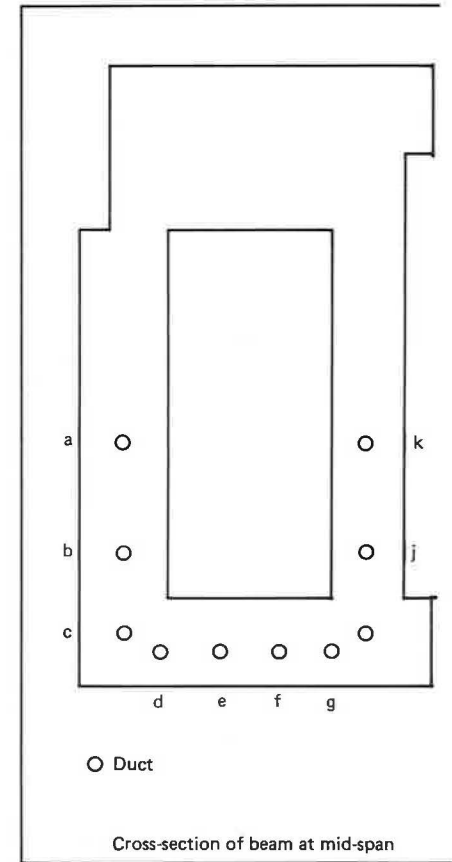
FIGURE 5 Condition of tendons and grouting of ducts, edge beams.

Holes were drilled into eight of the ten ducts in the end segments in the downstream edge beam. The ducts were inspected using a borescope, and the volume and continuity of voids were measured using the vacuum/pressure method just described. The results obtained are summarized in Table 1. Exposed wires were observed in ten of the sixteen holes drilled; they were covered with a layer of cement paste, and there was no evidence of corrosion. The continuity measurements showed that voids in the deflected ducts were isolated at the high points, whereas voids in the two straight ducts examined were continuous along the length of the beam. When the beam was demolished, all ducts appeared to be well grouted at midspan, although it was difficult to detect whether small voids were present because the ducts were unlined. It was not possible to measure void volumes in some ducts because of high air leakage, presumably through the joints. An attempt was made to locate points of leakage by pressurizing the ducts, painting soap solution on the joints, and looking for air bubbles, but without success.

The grouting in the upstream edge beam was examined at the middle three joints as the beam was broken up. Voids were found in the deflected ducts but, with one exception, the four straight ducts appeared to be fully grouted.

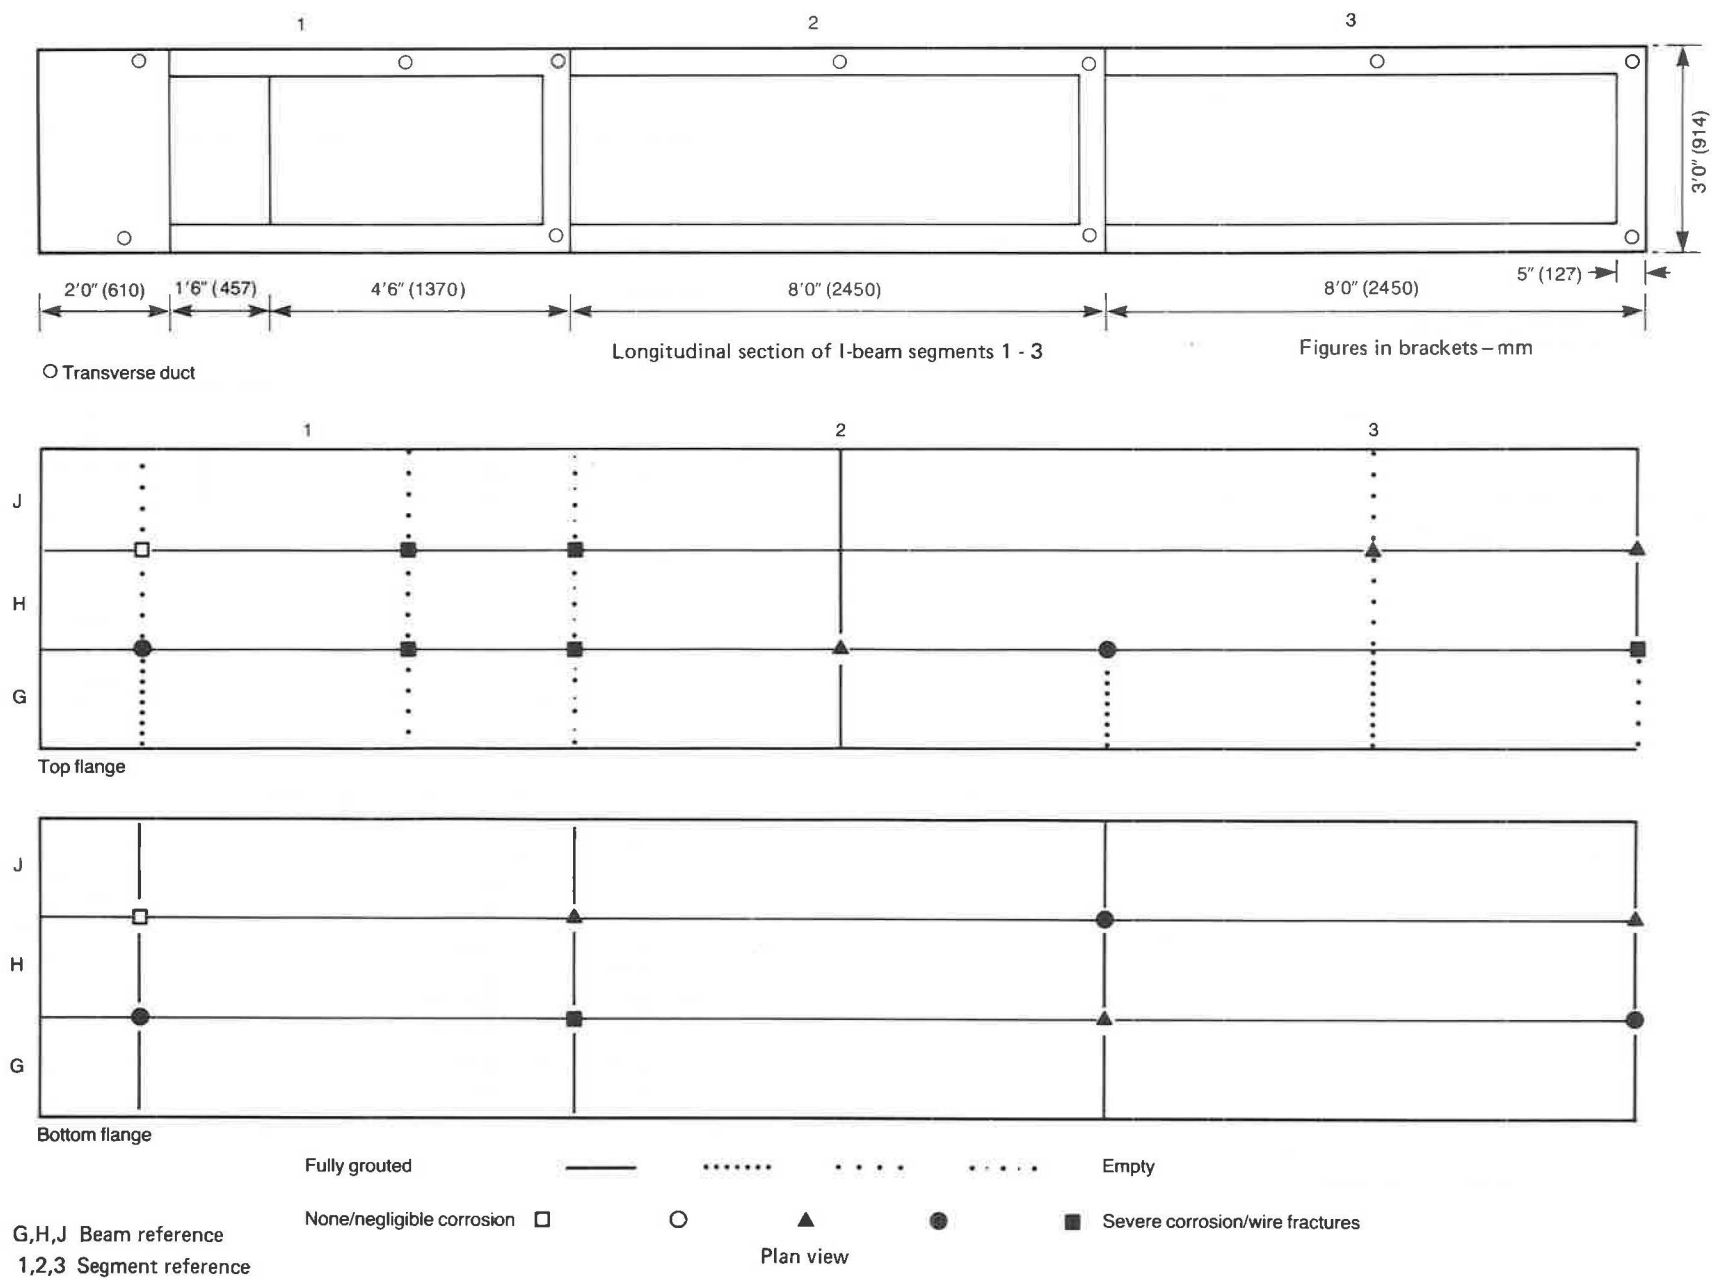
FIGURE 6 Condition of transverse tendons and grouting of ducts.

Eight of the fourteen transverse ducts examined were either fully grouted or contained only small air voids. Of the other six, three contained large voids with exposed wires and three were almost empty. Grout stains on the concrete adjacent to where ducts crossed some of the longitudinal joints indicated that leakage had occurred during construction.

A summary of the condition of wires at the joints examined appears in Figure 6.

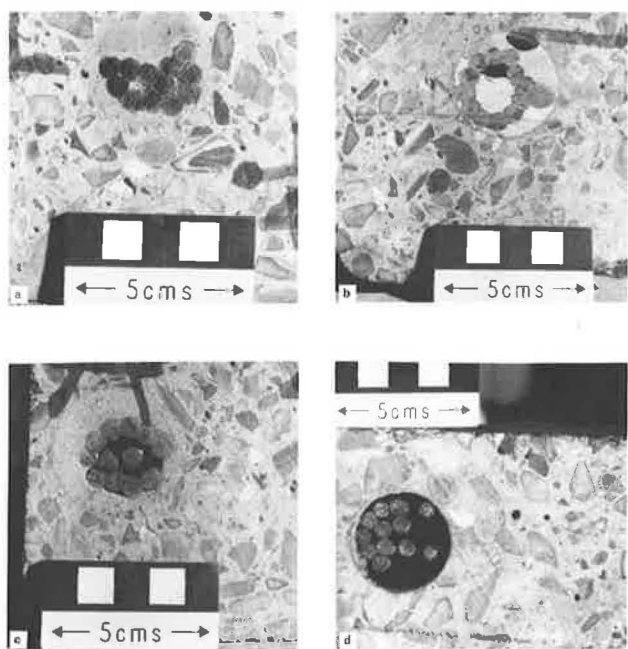
FIGURE 7 Examples of grouting. (a) Fully grouted, (b) small air voids, (c) void in center between wires, (d) empty.

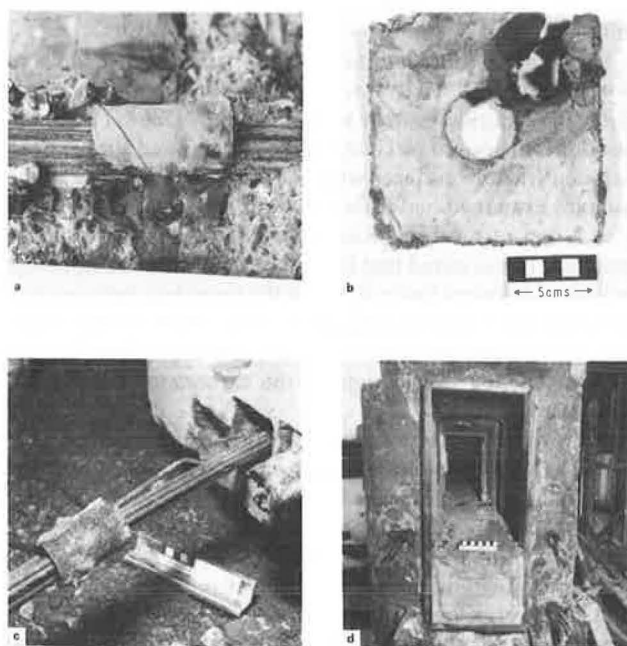
Grout was found in the bottom of the hollow box in both edge beams. It was about 15 mm deep in the downstream beam and 190 mm deep in the upstream beam (Figure 8d). It presumably had leaked from the ducts during construction.

FIGURE 8 Protection of tendons at joints. (a) Cardboard tube over tendon, (b) asbestos packing with localized rust staining around hole through which tendon passed, (c) steel sleeve with corroded wires underneath, (d) leakage of grout from transverse joints into box section edge beam.

The metal sleeves that were meant to have covered the tendons where they passed through transverse joints were found at only a small number of locations. Most ducts were surrounded by a flakey laminar material that looked like cardboard, and in several cases cardboard tubes could clearly be seen (Figure 8a). Where metal covers were observed, they did not appear to have offered much protection (Figure 8c). A soft, pasty substance was found at several of the transverse joints. Analysis of the material showed that it was a clayey soil; it may have been used to position the sleeves that covered the tendons where they crossed joints.

The squares of white fibrous material that had been placed between the beams at the positions of the transverse ducts were identified as asbestos. They were found at all the joints examined. They were usually damp despite the otherwise dry surroundings, indicating that they were acting as sponges, soaking up any moisture that penetrated the waterproofing

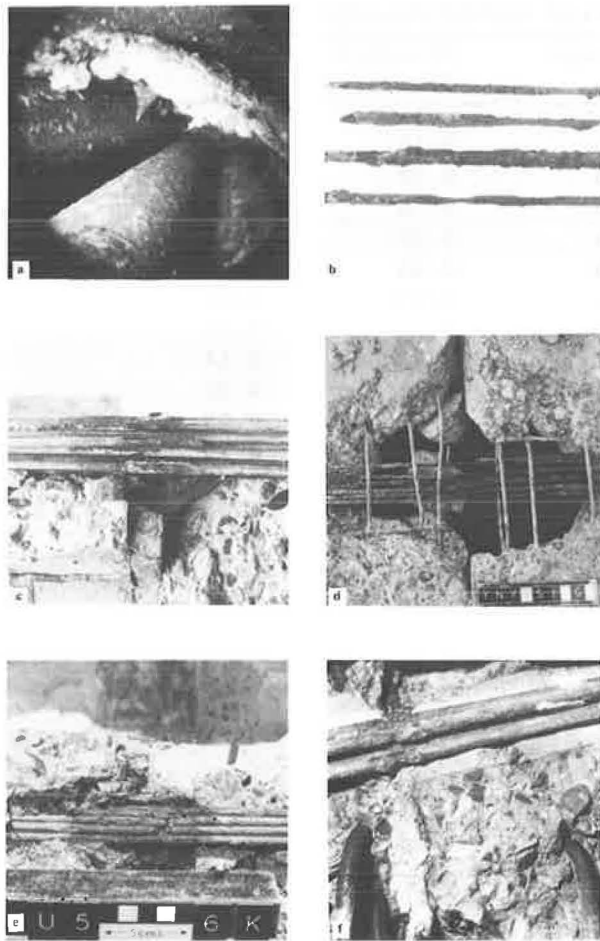
There was no serious corrosion within the segments. Wires viewed through holes drilled into longitudinal ducts were in good condition (Figure 9a). Exposed wires in large voids were covered with a layer of cement paste that varied from large patches to a few speckles dotted over the surface. There were patches of light surface rust on some wires, but these may have been present since construction. Patches of cement paste adhered to wires taken from the ducts, and while some uncoated lengths were covered with a layer of surface rust, others were in pristine condition.

Most wires were corroded where they crossed the joints. The condition of wires at the failure section varied from surface corrosion with no loss of sectional area to severe loss of section, the latter usually being accompanied by heavy scaling and pitting. Those with little or no loss of section had suffered ductile fracture. It was difficult to determine which of the other wires had fractured as the bridge collapsed and which had corroded through before collapse.

Several joints away from the failure section were carefully broken up to expose the wires. The amount of corrosion varied considerably, even on wires in the same duct. On the majority it extended over lengths of 50 mm to 100 mm (Figures 9c and 9d), but on some it covered up to 250 mm. It appeared to progress from slight surface scaling and pitting to severe,

FIGURE 9 Condition of tendons. (a) Wires in poorly grouted duct within a segment, (b) wires from poorly grouted duct within a segment, (c) corrosion on wires at joint, (d) wires in poorly grouted duct at joint, (e) fractured wires at joint, (f) wires in well-grouted duct at joint. (a, c, e, longitudinal tendons; b, d, f, transverse tendons.)

In poorly grouted ducts corrosion that had started at the joints extended along the width of the beams (Figure 9d). It varied from extensive surface rust to heavy scaling, loss of section, and fracture. Loss of section was usually almost uni-

form around the circumference of the wires. Most fractures occurred at the joints, although some were found within the segments, and short lengths of wire that had corroded through at both ends were found in some ducts (Figure 9b).

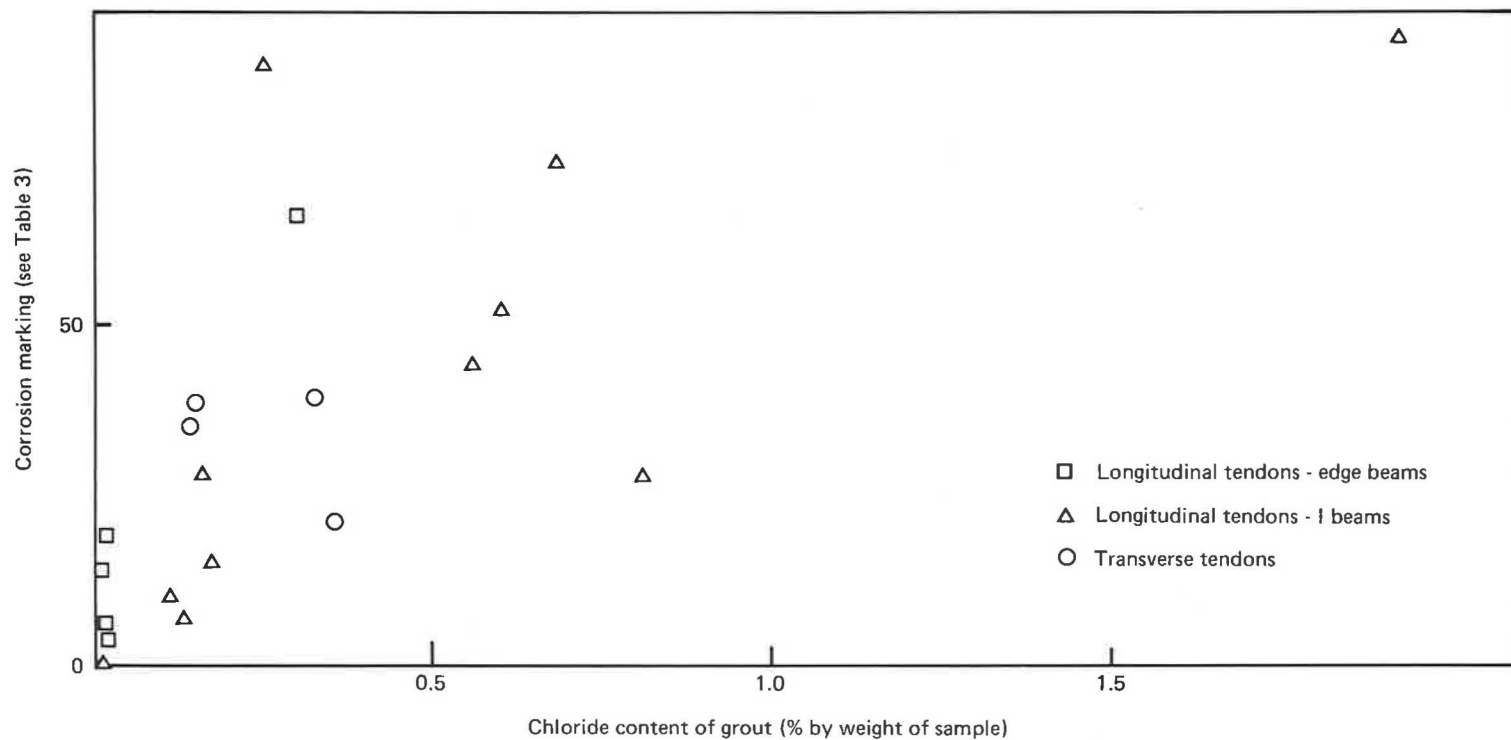
The effect of chlorides on corrosion is illustrated in Figure 15, which shows increasing corrosion as the chloride content in grout adjacent to the tendons increases. There is considerable scatter on these results, and this is partly because the chloride content measured is an average value and the concentration adjacent to the steel may differ from this. In

FIGURE 15 Degree of corrosion of tendons versus chloride content of adjacent grout.
