# Crack and Seat Method of Pavement Rehabilitation

AMY M. SCHUTZBACH

This paper describes a research project that evaluated the effectiveness of the crack and seat method of pavement rehabilitation. The process involves cracking a Portland cement concrete pavement into pieces measuring 1½ to 2 ft and firmly seating the pieces into the subgrade prior to overlaying with asphalt concrete. Cracking and seating is designed to reduce or retard reflective cracking by minimizing the movements in the underlying concrete that create stress in the overlay. Six construction sections located throughout the state of Illinois were cracked and seated between 1983 and 1987. The majority of the projects were thickened edge pavements constructed 55 to 65 years ago, with longitudinal edge bars for reinforcement. One pavement did contain reinforcing mesh. The pavements were cracked with either a spring arm or a guillotine hammer and then seated with a heavy rubber tire roller. The desired crack pattern consisted of hairline cracks, thereby maintaining aggregate interlock. Overlay thicknesses ranged from 3 to 7½ in. of asphalt concrete. After construction, the projects were visually surveyed and teste

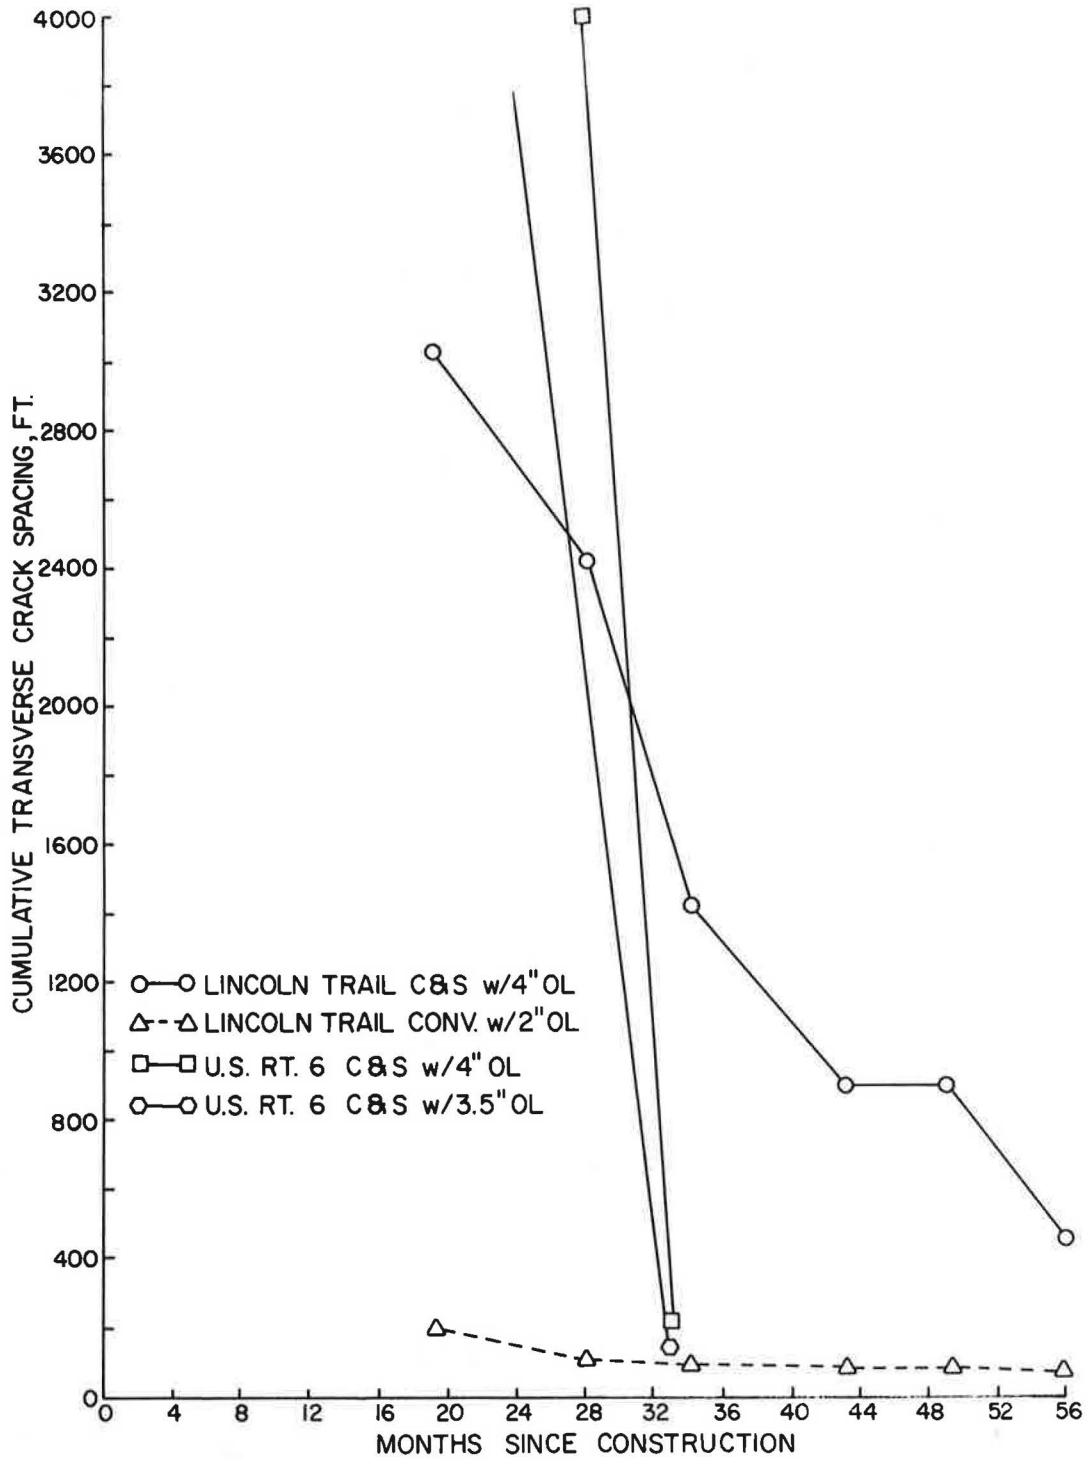
FIGURE 5 Transverse crack spacing versus time for Lincoln Trail and U.S. Route 6.

control section because of differences in overlay thickness, cracking and seating did significantly reduce the amount of transverse cracking, as can be seen in Table 2. There was a slight increase in the amount of longitudinal cracking, which may be attributable to the type of pavement breaker used and the crack pattern it produced. Other states have noted that continuous longitudinal cracking should be avoided because of its tendency to reflect through the overlay (2). Prior to the last survey, all the cracks had been routed and sealed.

Two years after construction, both the 3½-in. and 4-in. crack and seat overlay sections were in excellent condition. After the third year in service, both sections had an increase in transverse cracking, and the 3½-in. overlay experienced a large increase in longitudinal and widening cracking, as illustrated in Table 6. To some extent the increase in cracking can be attributed to segregation in the asphalt concrete overlay mix-

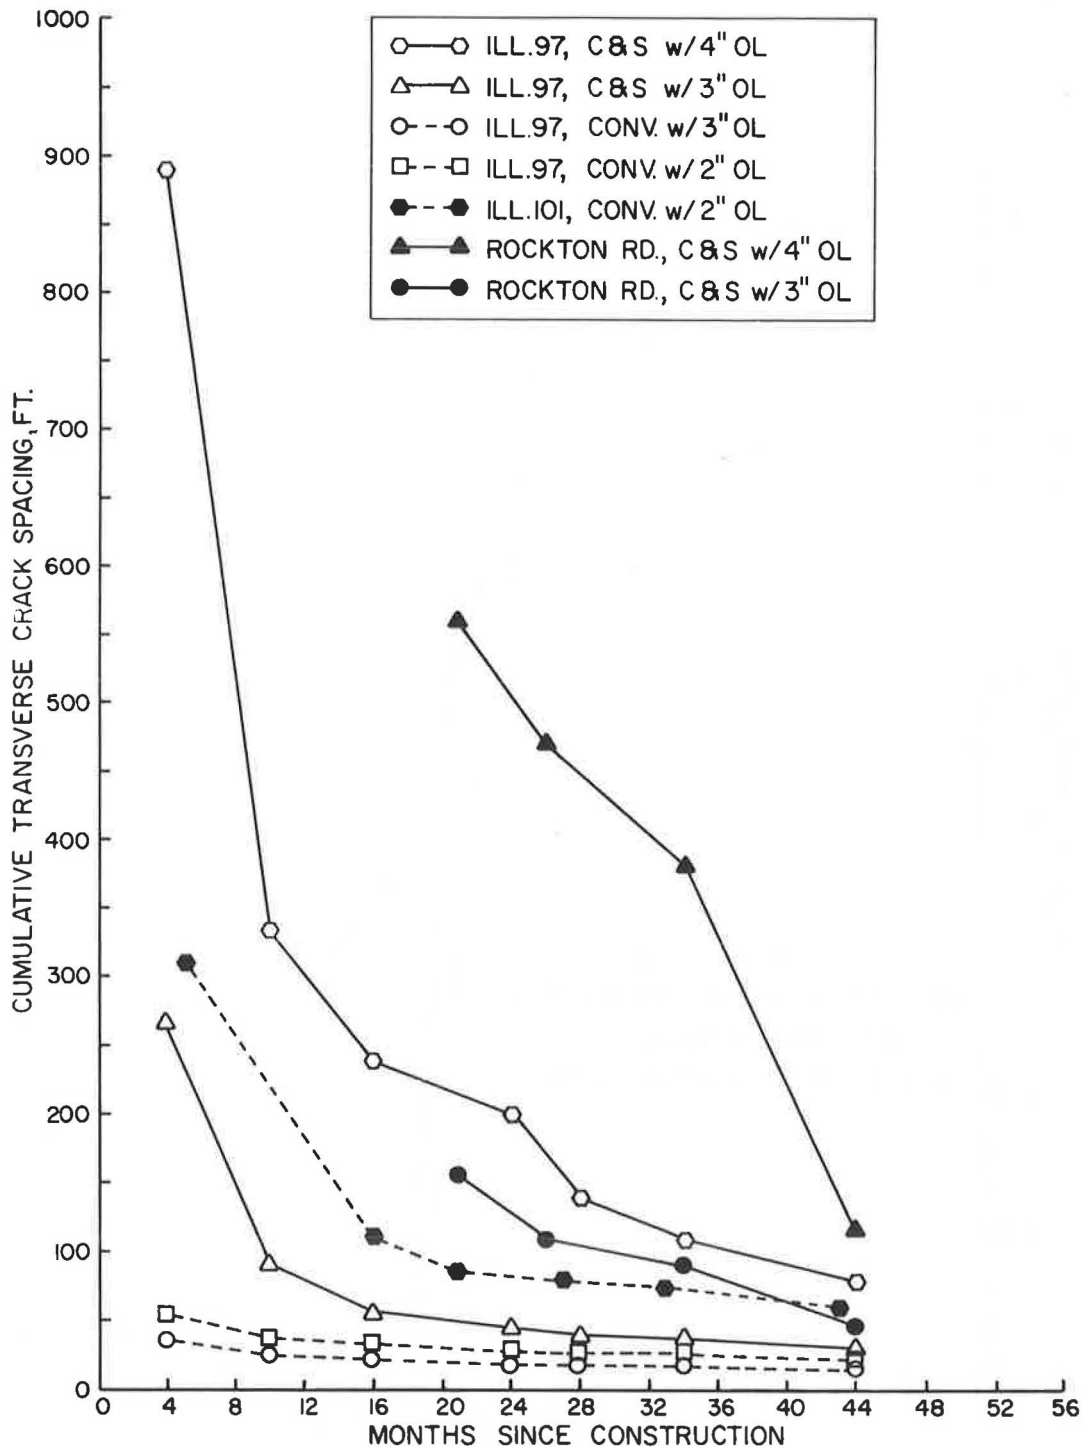
FIGURE 4 Transverse crack spacing versus time for Illinois Routes 97, 101, and Rockton Road.

A comparison of Figures 4 and 5 shows Illinois Route 97 to be the most poorly performing section. After 4 years in service, transverse and longitudinal cracking are present in both the crack and seat and control sections. The majority of patches are reflecting through the overlay in the control sections. Table 3 shows that there is less transverse and widening cracking present in the crack and seat sections than in the control sections. While there is more longitudinal midlane cracking in the crack and seat section, it appears to be a result of mix segregation in the paver auger during laydown.

shows a transverse crack spacing of 5,500 ft, compared with the 2-in. overlay control section, which has a 60-ft crack spacing. While the two sections are not directly comparable owing to differences in overlay thicknesses, it is evident that the crack and seat section is performing as was expected. Table 4 details the progression of reflective cracking.

Table 5 contains reflected crack survey data from Rockton Road. As expected, the 4-in. overlay outperformed the 3-in. overlay, at least in terms of transverse crack spacing. As previously noted, the 4-in. overlay section had a history of water problems and frost-susceptible soils. These conditions may explain the increased longitudinal cracking found in the 4-in. overlay section. The geotextile fabric placed at full width over the leveling binder in the 4-in. overlay section did not appear to be beneficial in controlling longitudinal cracking.

indicates that the transverse crack spacing in the crack and seat section with a 3-in. overlay is approximately double that in the control section with a 3-in. overlay. A comparison of the two sections, as shown graphically in Figure 4, shows that for the 3-in. overlay section, cracking and seating delayed the degree of reflective cracking for approximately 3 years.
