Evaluation of Concrete Pavement Restoration Techniques on I-65

A. SAMY NOURELDIN AND REBECCA S. MCDANIEL

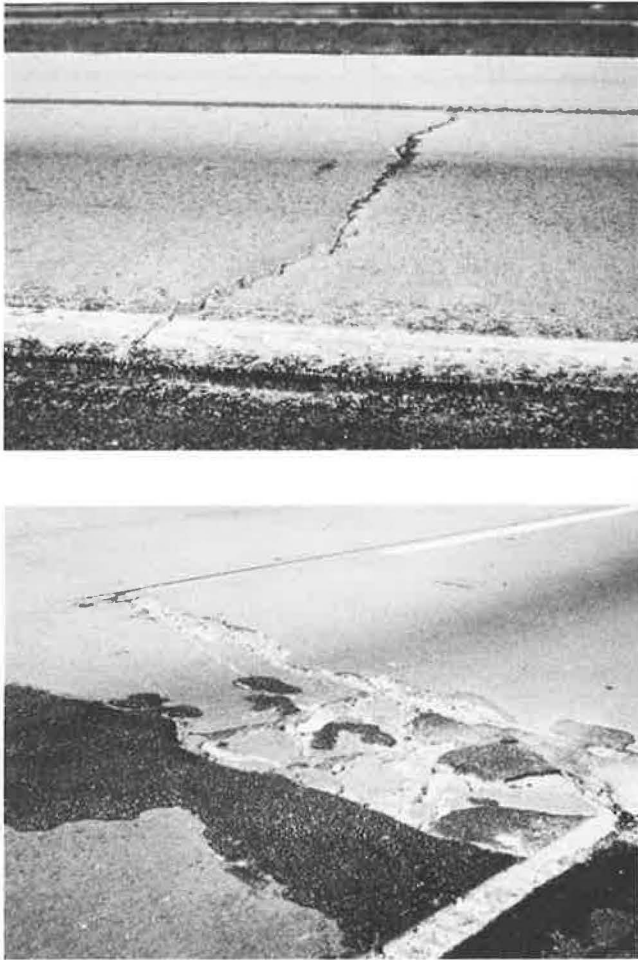
The 30-mile portion of I-65 (two lanes per direction) under study has 7,920 slabs in the northbound (NB) direction and 7,920 slabs in the southbound (SB) direction. Defects were present in 10.7 percent of the SB slabs (848 slabs) and 6.5 percent of the NB slabs (511 slabs). The major type of distress noted was the presence of "transverse cracks" near the mid-slab for a large number of slabs. Some other corner breaks,

FIGURE 1 Major distresses noted on I-65 portion under study. (top) Faulted crack. (bottom) Broken-up slab.

minor surface imperfections, and faulted and broken-up joints were noted (Figure 1). A rough ride and near slippery conditions were experienced when traveling at speeds higher than 55 mph during rainfall.

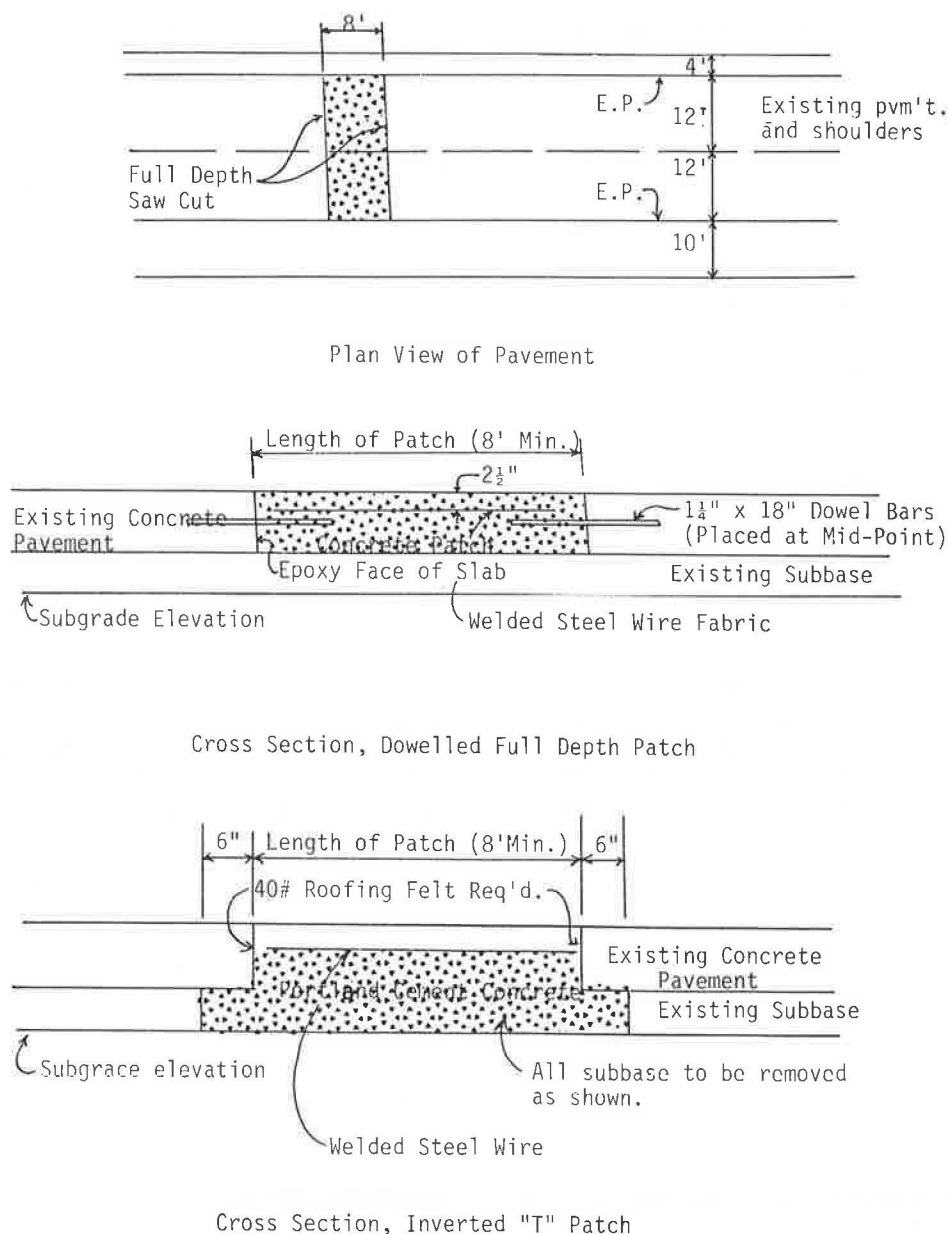
FIGURE 2 Concrete patch details.

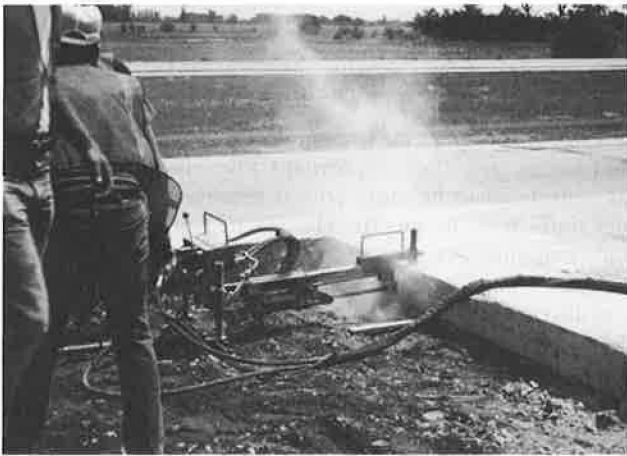
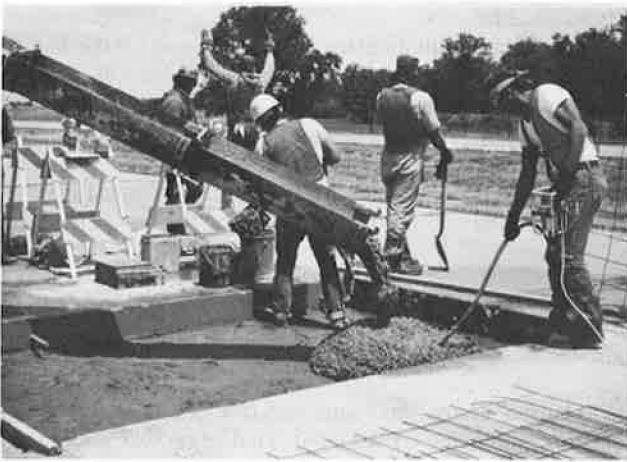
FIGURE 3 Construction of doweled full-depth patches. (top) Drilling dowel holes for doweled full-depth patch. (bottom) Pouring concrete in doweled full-depth patch.

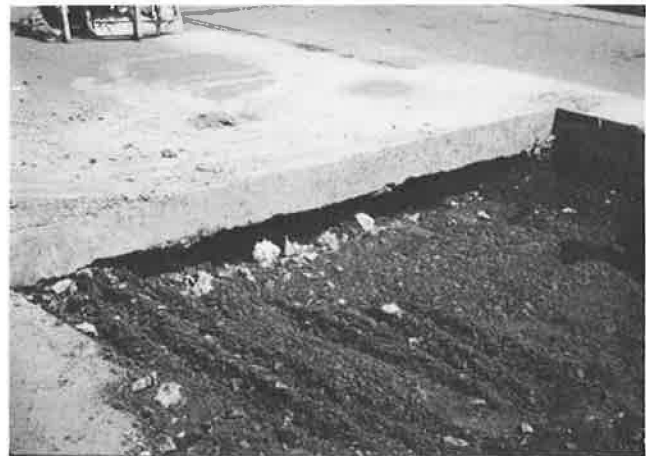
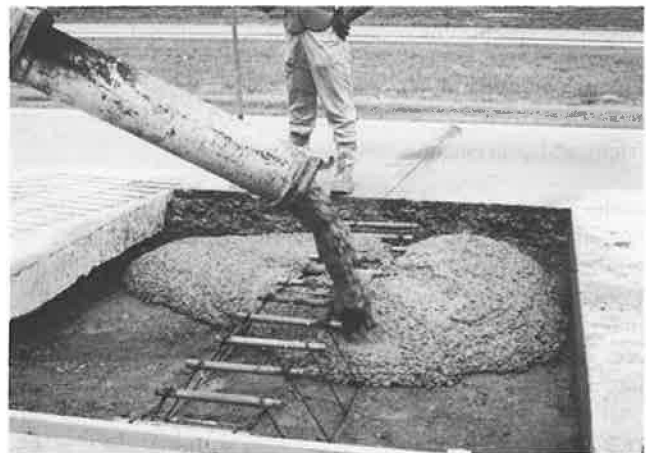
The inverted "T" patch was constructed by cutting up and lifting broken old slab pieces and removing the existing subbase beneath the deteriorated slabs and underneath the edge of the adjacent slabs (Figure 4). No problems were noted during removal of deteriorated sections or pouring of the fresh concrete. The subbase was not removed for the doweled patches (Figure 3). Dowel bars were used to provide load transfer to the adjacent slabs. Inverted "T" patches with dowel basket assemblies in the center were used at replaced joints. Figure 4 illustrates the construction of this type of patch.

1/16-in. faults at the last joints (in traffic direction). This may possibly be caused by incomplete concrete consolidation in the undercut areas of the inverted “T” patches.

FIGURE 4 Construction of inverted T full-depth patches. (top) Excavation for full-depth inverted “T” patch. (bottom) Pouring concrete for inverted “T,” full-depth joint replacement patch.

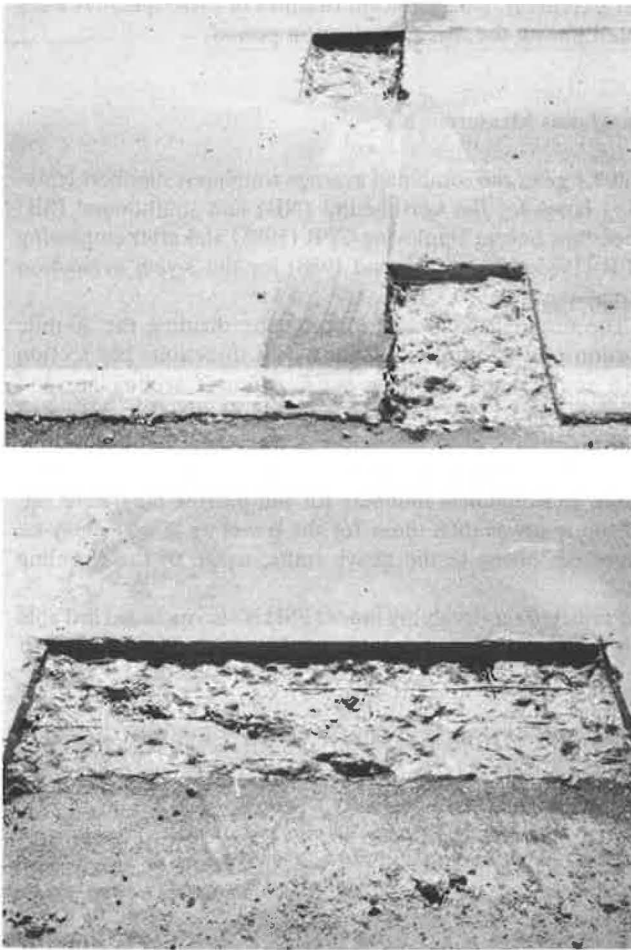
Partial-depth patches (Figure 5) were used to repair minor surface distresses, shallow defects, other surface imperfections, and slab corner breaks (distresses less than $\frac{1}{2}$ ft deep).

FIGURE 5 Construction of partial-depth patch. (top) Prepared partial-depth patches. (bottom) Epoxy coating on slides of a prepared partial-depth patch.

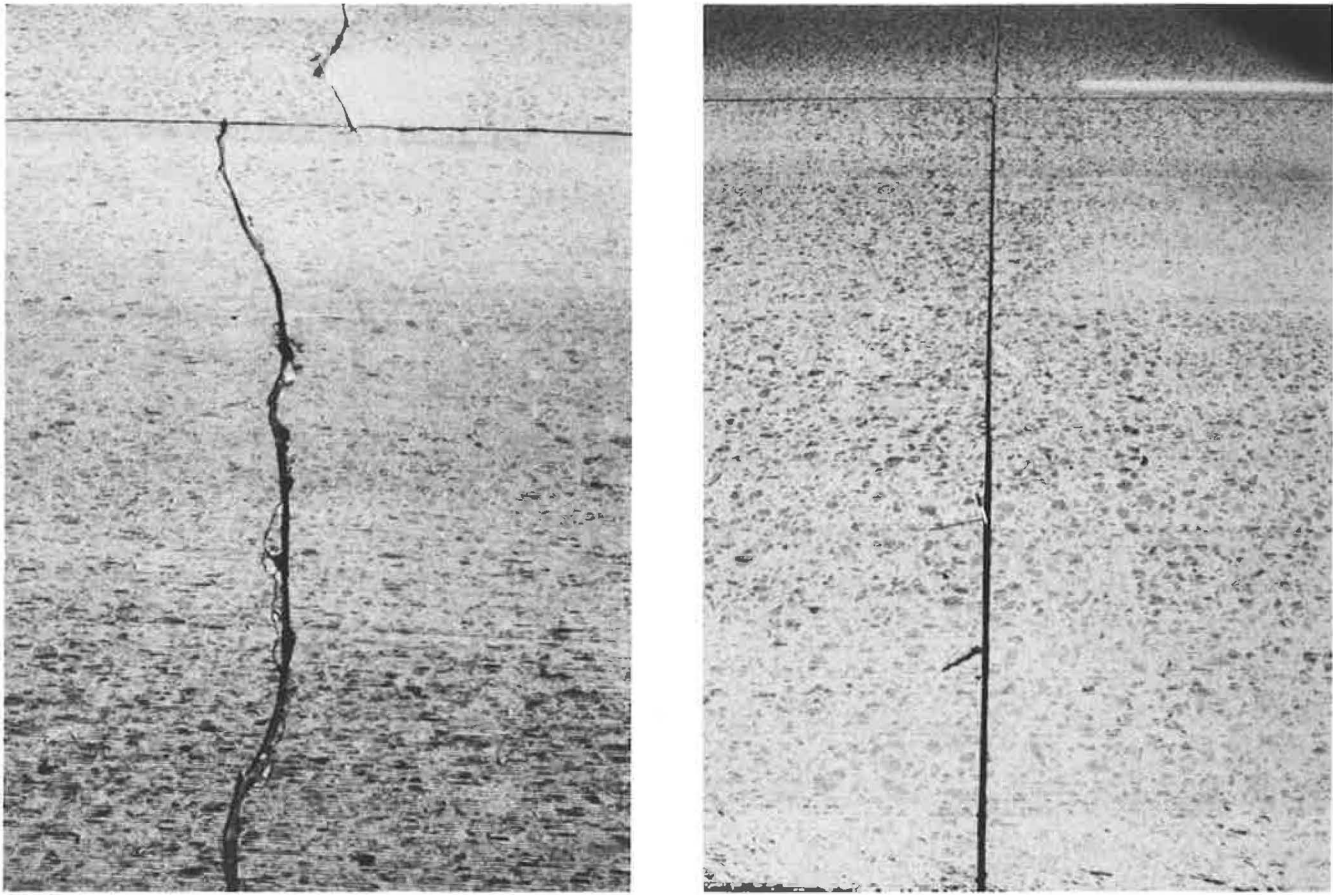
Midslab cracks were routed and resealed (Figure 6). Cracks and joints were resealed to inhibit intrusion of surface water and to avoid possible pumping resulting from water penetration. In addition, an open graded paving layer (#5 base, IDOH Standard Specification) was constructed as an edge drainage treatment between the concrete pavement edge and the existing trench drains in locations needing improved drainage.

Neither faulting nor spalling was observed at the joints. However, many of the routed and resealed cracks faulted about $\frac{1}{16}$ in. down in the direction of traffic (measured using a straight edge). These faulted cracks remained almost the same during the 3-year evaluation period, but smaller hairline cracks have developed around them and eventually spalled out under the effect of heavy traffic on I-65 (Figure 6).

FIGURE 6 Sealing of joints and midslab cracks. (left) Routed and sealed crack. (right) Resealed joint.

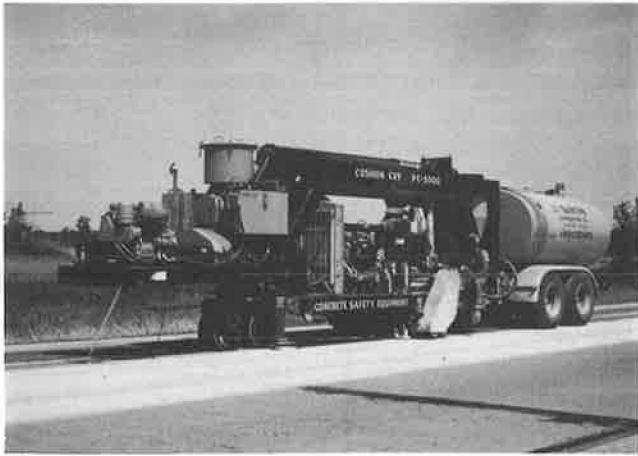
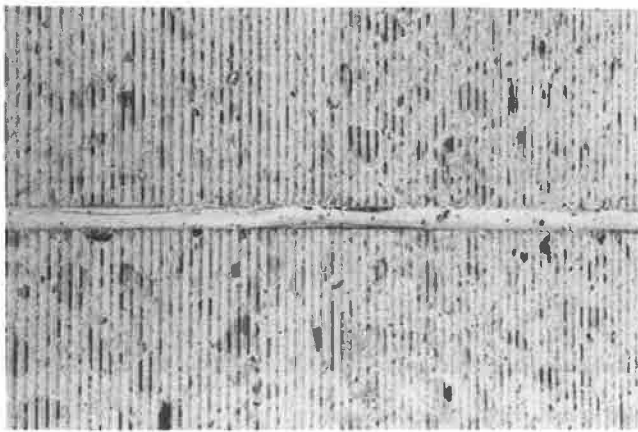
quality, eliminate minor faulting at joints and cracks, and improve skid resistance. Figure 7 shows the concrete pavement surface texture after diamond grinding.

FIGURE 7 Diamond grinding operation. (top) Diamond grinding equipment. (bottom) Concrete surface texture after diamond grinding.

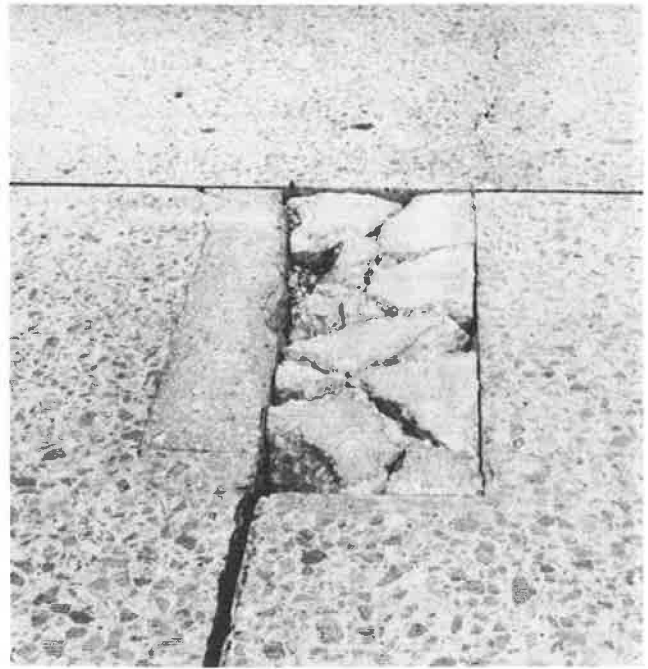
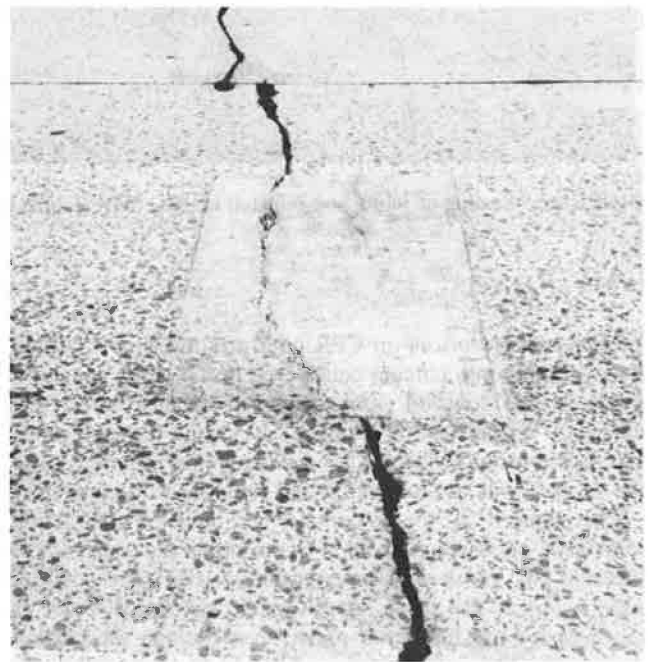
Partial-depth patches placed adjacent to cracks and joints were spalling and broken up. Repairs were required just 1 year after rehabilitation (Figure 8). These distresses were frequently noted throughout the 3-year study period and may have been caused by poor load transfer and differential slab movement across the crack and through the partial-depth patch. In addition, all partial-depth patches that were placed over a crack had cracked (Figure 8). Furthermore, some partial-depth patches were responsible for creating new midslab cracks. This could be attributed to the weakness of the concrete slab due to the reduction of moment of inertia associated with the discontinuity and stress concentration occurring when partial-depth patches are constructed.

FIGURE 8 Performance problems of shallow-depth patches. (top) Cracking and breakup of shallow-depth patch adjacent to crack. (bottom) Cracking through a partial-depth patch.

It is recommended that the use of partial-depth patches be limited as much as possible and that they be replaced with full-depth patches or bituminous patches; alternatively, it should be accepted that they must be rehabilitated annually.

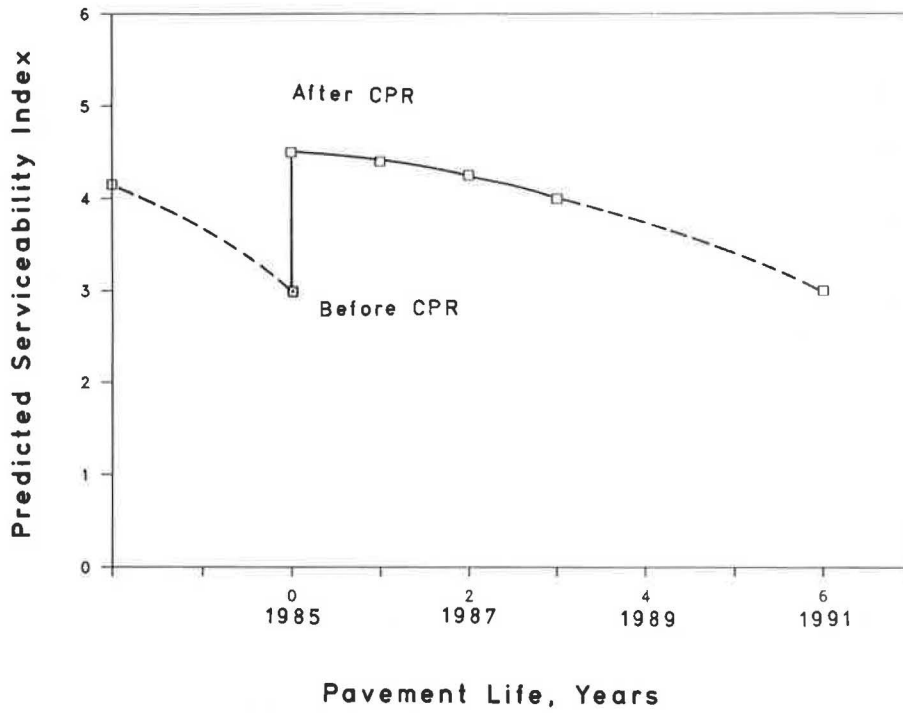
very successful in improving riding comfort and level of service, as indicated by the RN and PSI values. In addition, this improvement was sustained for a period of 3 years and may remain acceptable for a 6-year period (predicted from Figure 9).

FIGURE 9 Effect of CPR techniques and time on pavement condition (present serviceability index).

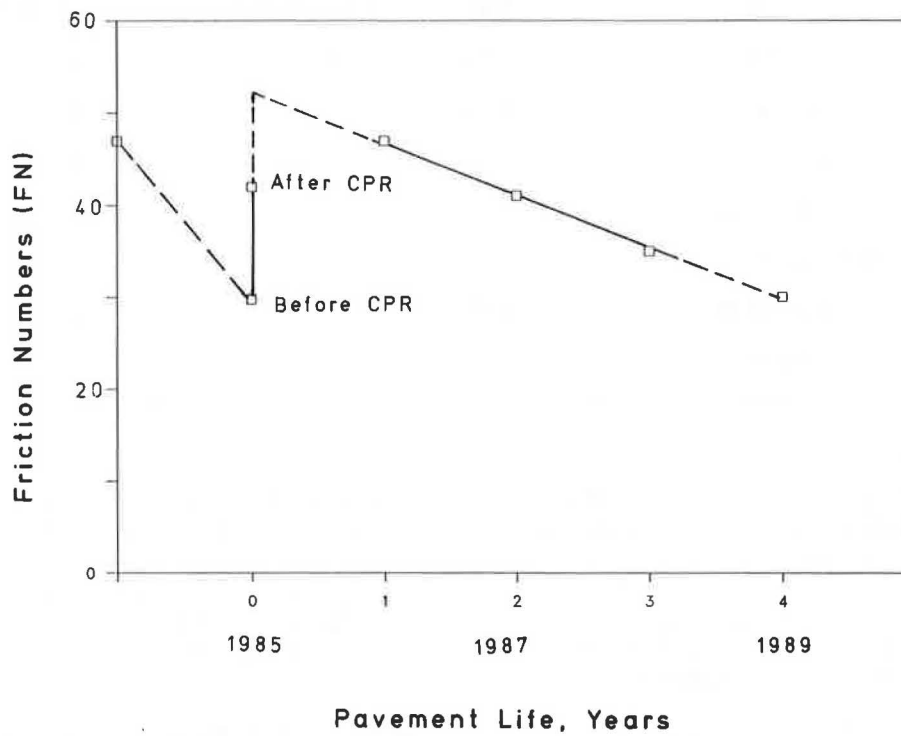
CPR techniques (diamond grinding) have improved the friction numbers significantly (Table 2, Figure 10). The improvement in skid resistance, however, was predicted to remain for only 4 years (Figure 10), and another rehabilitation should be required to improve the pavement condition after those 4 years.

FIGURE 10 Effect of CPR techniques (diamond grinding) and time on pavement condition (skid resistance).

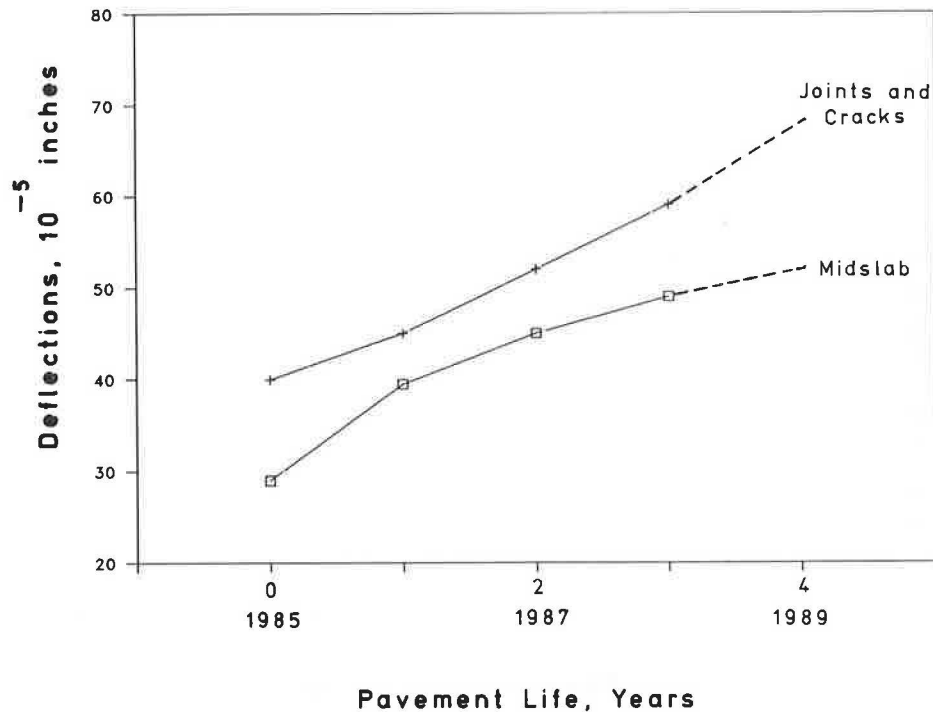
FIGURE 11 Deflection measurements during the 3-year evaluation period.

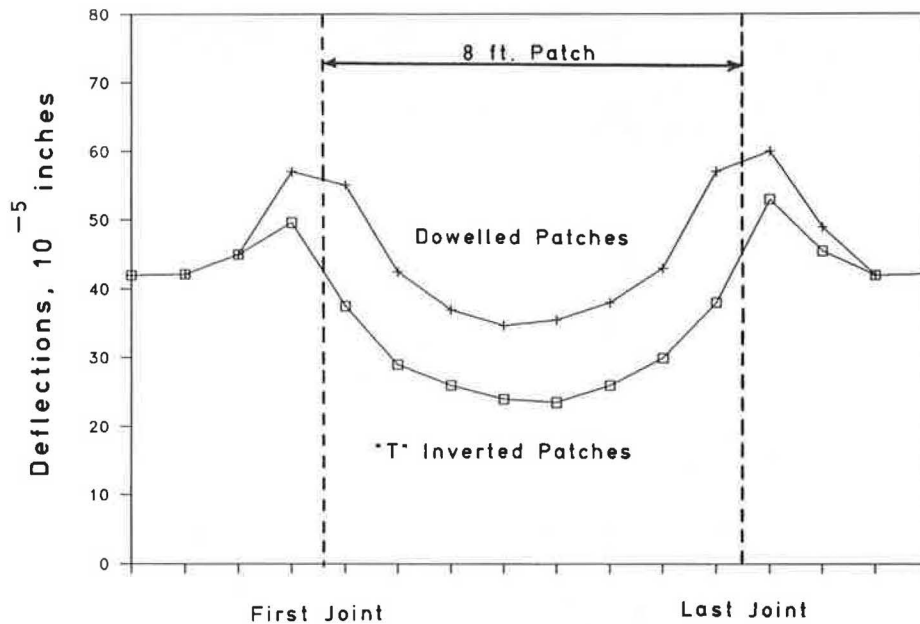
Figure 12 illustrates deflection distribution along the patches (doweled and inverted "T"). Lower deflection values were obtained for inverted "T," full-depth patches, which gained more structural capacity by removal of the subbase and its replacement with concrete. Deflection values along the patch were less than 50×10^{-5} , except at joints where they exceeded this value.

FIGURE 12 Deflection distribution along full-depth patches.
