# Performance of Yielding Seam Structural Plate Pipe Culvert

EARLE W. MAYBERRY AND MARK A. GOODMAN

During project development for construction of Interstate 94, north-east of Miles City, Montana, several alternatives were evaluated regarding perpetuation of two large drainages under extensive fills. The alternative selected consisted of installing two structural steel plate culverts. These culverts used the yielding seam concept to relieve the load on the structure by providing controlled slippage in the longitudinal lapped seams. The subsequent reduction in pipe circumference would allow the soil to carry a portion of the load, therefore allowing a reduction in plate thickness and material savings as compared to a conventionally designed structure. Use of this product, relatively new to highway construction applications in 1983, was approved as an experimental feature. Experimental status required preparation of an acceptable work plan, including monitoring of fill settlements, fill pressures, pipe diameter changes, and strain gauge measurements. The purpose of this experimental feature was twofold. First, a reduction in plate gauge was intended to reduce pipe material costs, ye

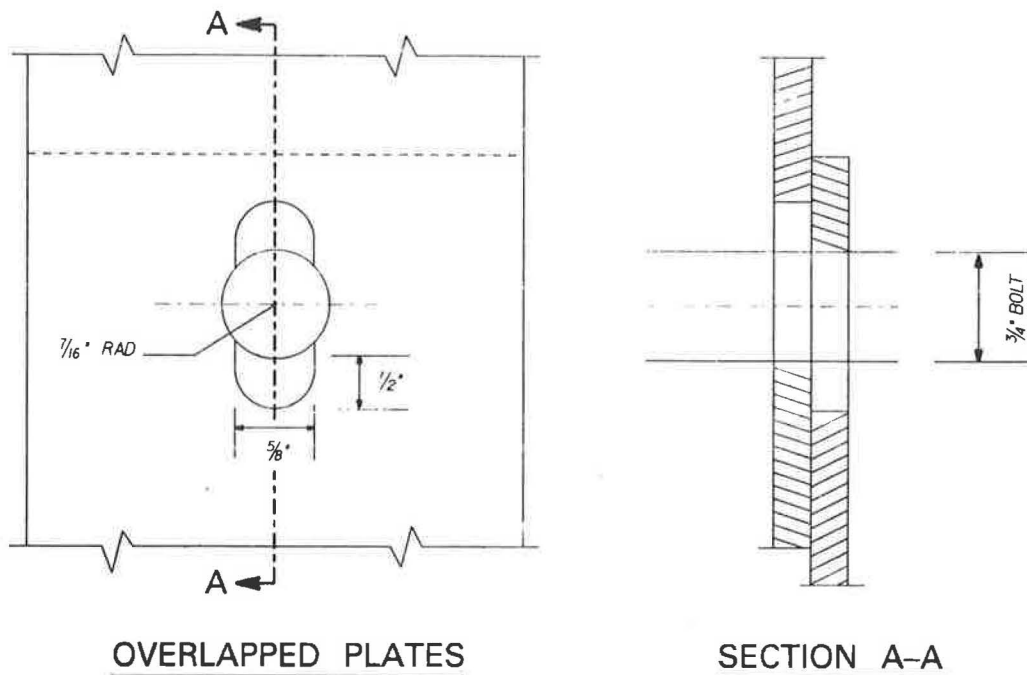
FIGURE 1 Keyhole-Hole slot detail.

Erection of the Key-Hole pipe is the same as for conventional multiplate pipe. Proper positioning of the plates in relation to each other is controlled as the slotted portion is smaller than the bolt and will allow the bolt to enter the slot only under significant load. This is the self-indexing controlled slippage design (Figure 1).

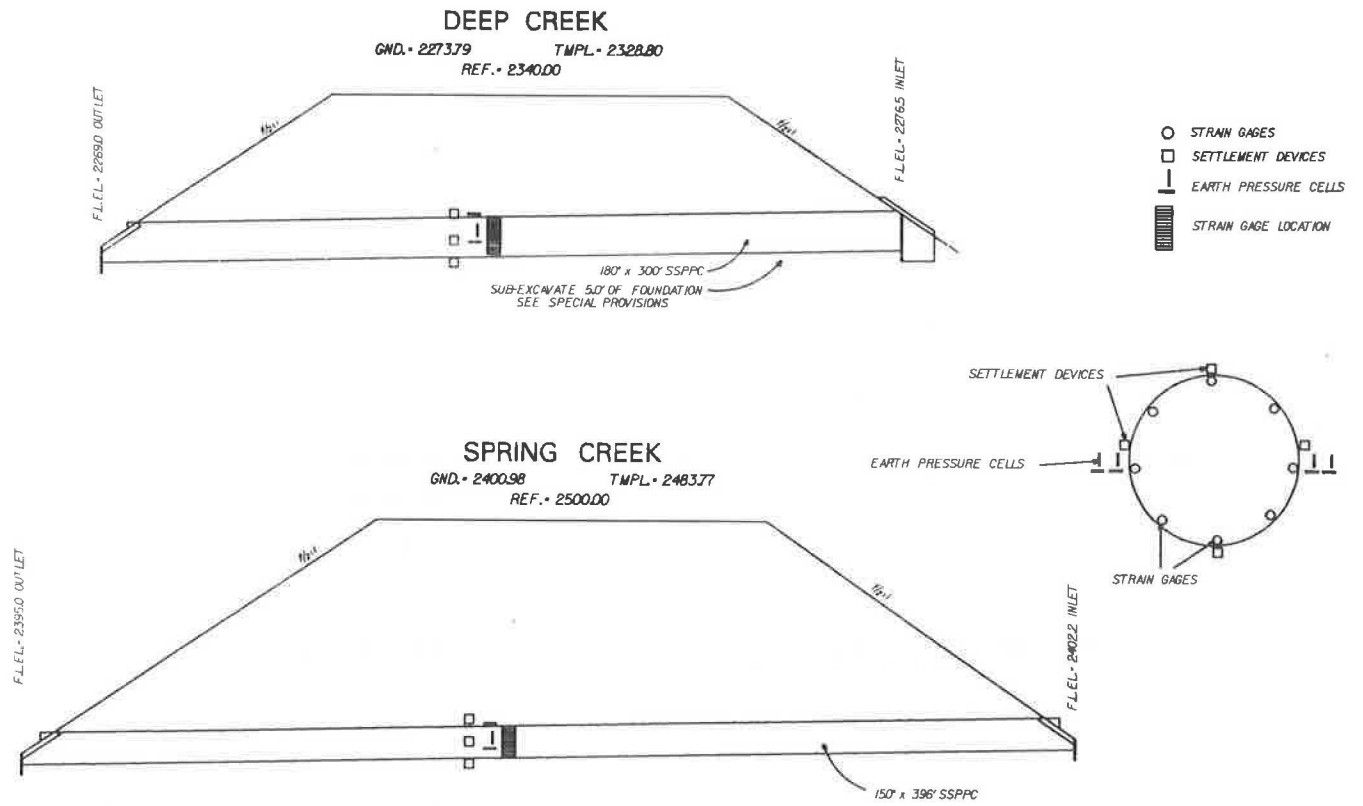
FIGURE 2 Instrumentation layout.

The Key-Hole Slot design allows for stress relieving in the structural members as the embankment is constructed. As stress increases during fill construction, the longitudinal seams slip together, creating a soil arch effect, which acts to support a portion of the weight of the overlying fill. Due to the experimental status of the Key-Hole Slot design, various instruments were installed to monitor interaction of the pipes, foundations, and embankments (2). The instrumentation used and the resulting data observations (Figure 2) are summarized below.

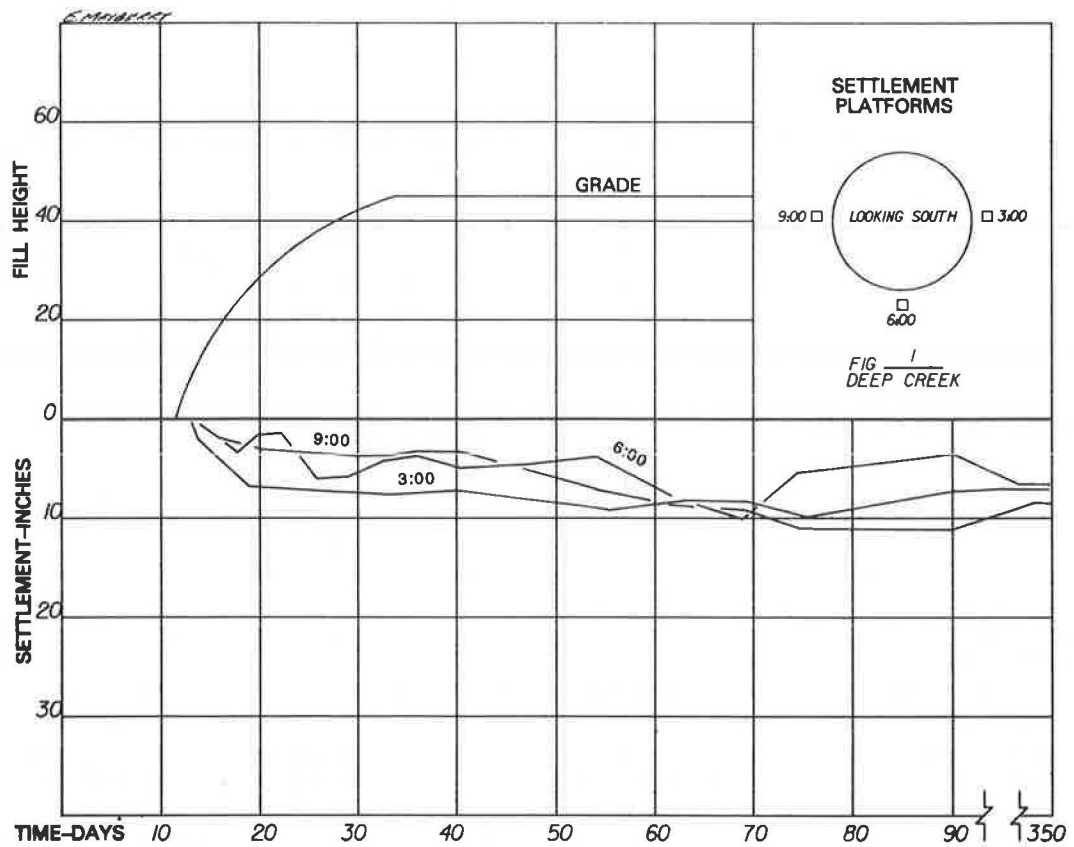
FIGURE 3 Deep Creek foundation and fill settlement.

The settlement platforms (Figure 3) were set 2 ft from the pipe at all locations. The curves show rapid settlement during construction of approximately half the embankment height. Settlement rate then decreased during completion of the fill, after which, periods of rebound occurred, the first coinciding with initial decrease in pressure readings. Early rebound occurred at the 6:00 position on July 18, after 18 ft of fill had been placed, 4 days after the first movements were noted in the longitudinal seams. The seam slippage allows strengthening of the soil arch, which in turn relieves stress around the pipe, possibly accounting for the periods of rebound of the settlement platforms. Less initial settlement took place on the east side of the pipe where transducer pressures were highest.

However, 56 days after fill construction began, all positions neared unity with  $10 \pm$  in. of total settlement. Major rebound then reoccurred, especially at the 6:00 position, after which unity was again attained by October 6. No readings were taken between October 6 and March 1984, as readout terminals had to be moved to allow placement of riprap. Final readings, taken on July 17, 1984, show an average final settlement of  $8 \pm$  in.

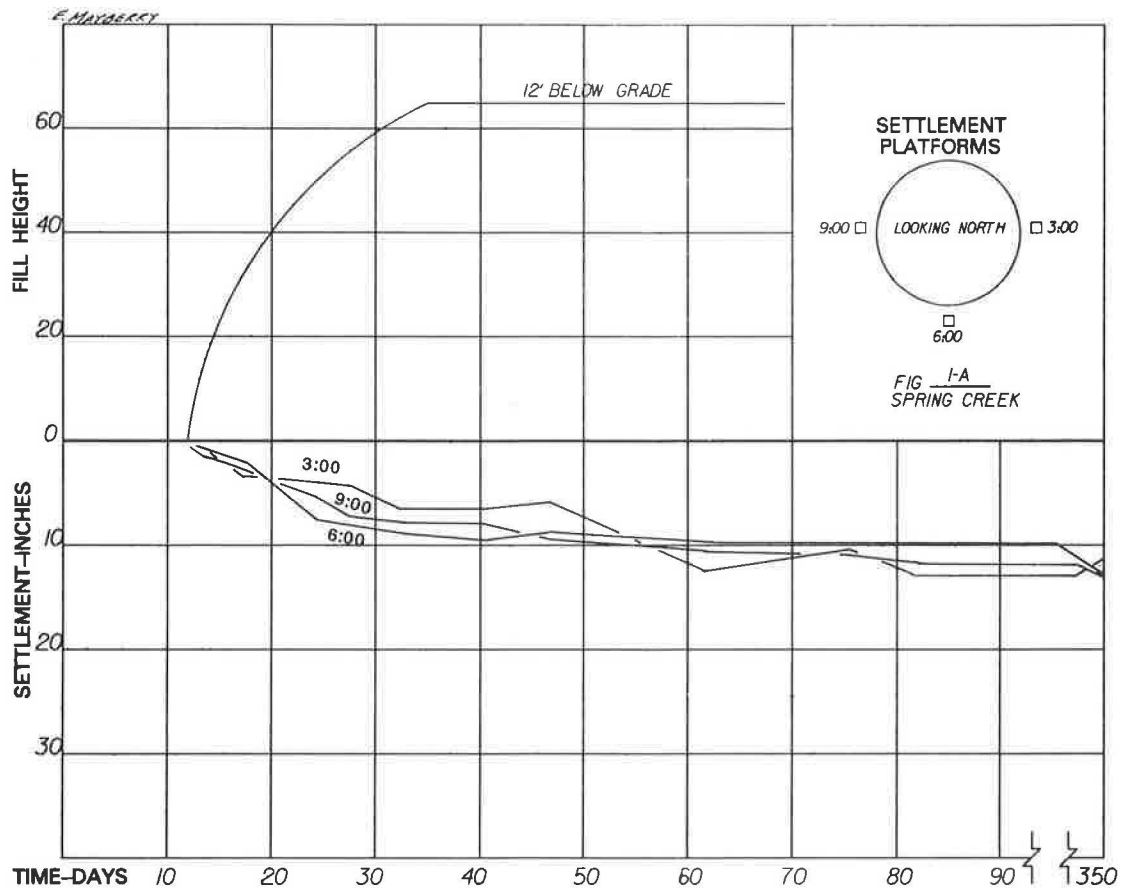
FIGURE 4 Spring Creek foundation and fill settlement.

Initial settlement rate continued high until the fill height reached 55 ft, when the rate decreased (Figure 4); whereas at Deep Creek settlement, the rate decreased after approximately 20 ft of fill were placed. The last readings on July 17, 1984, show an average settlement of  $12 \pm$  in.

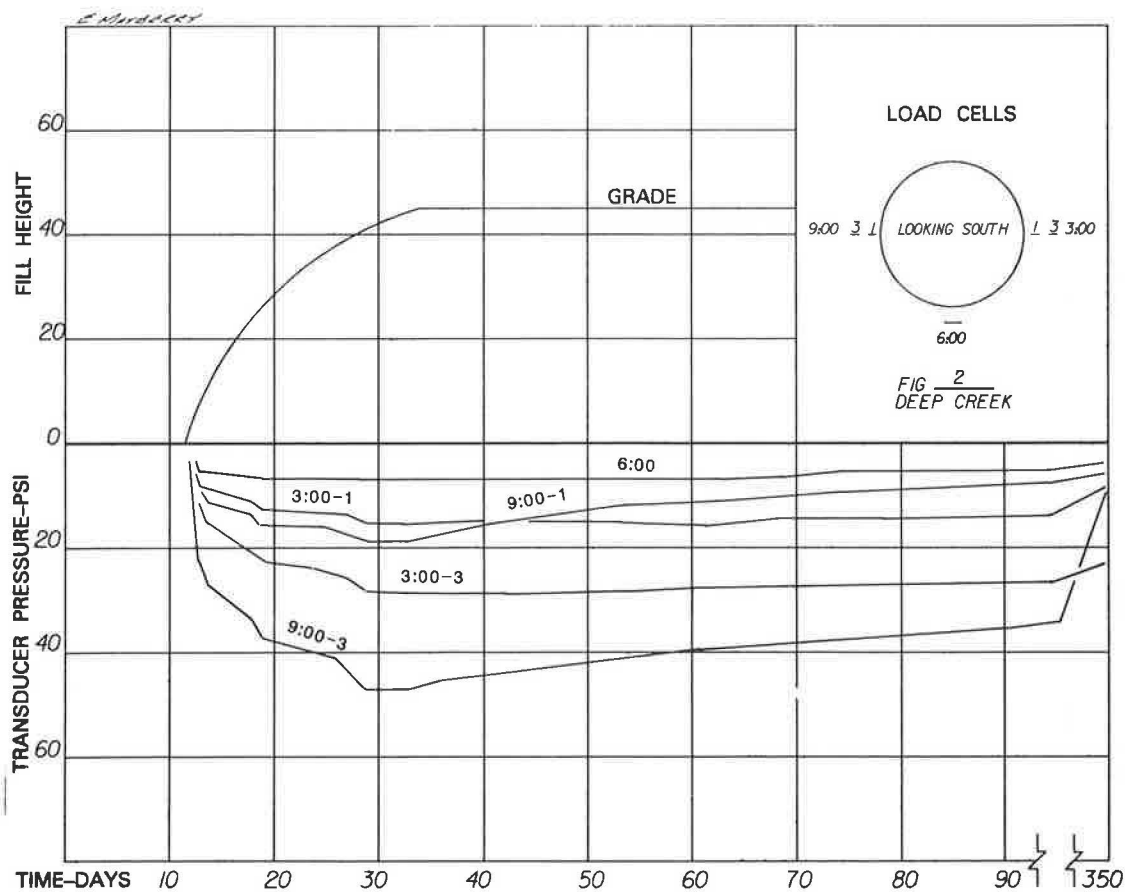
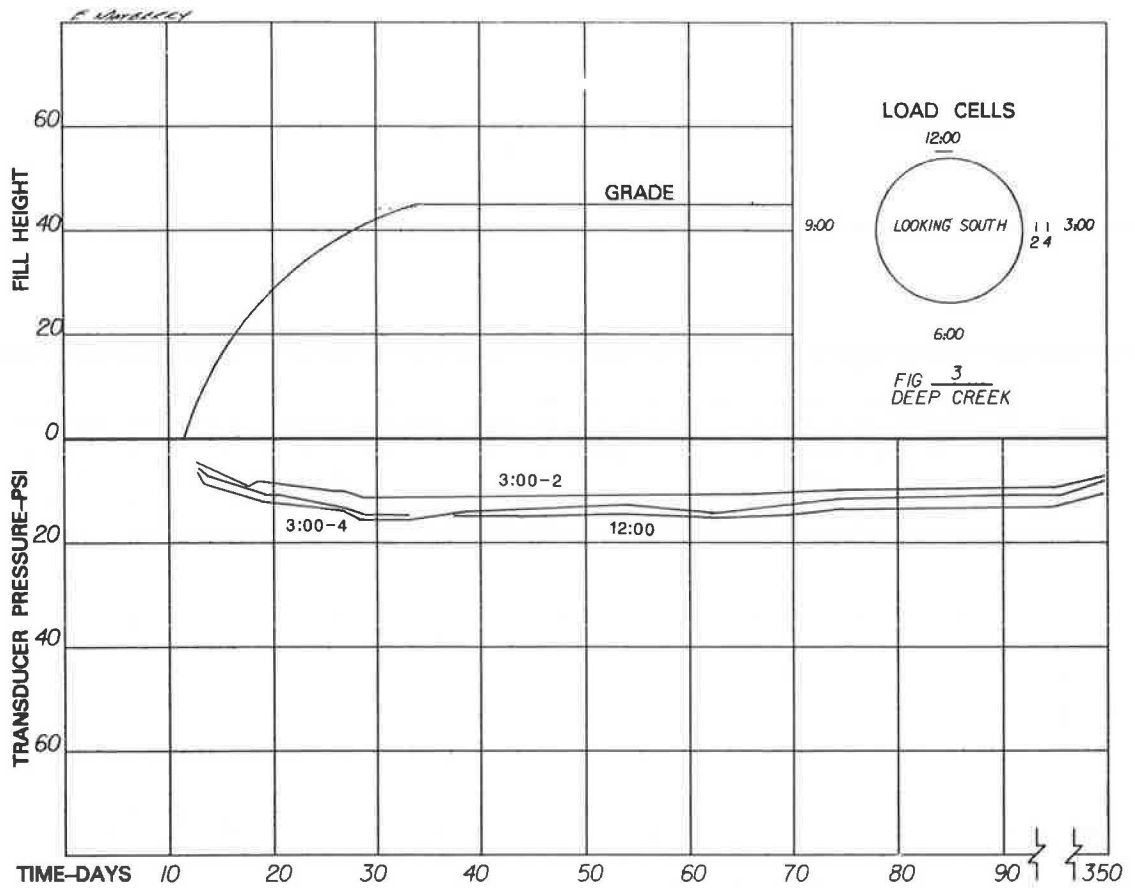
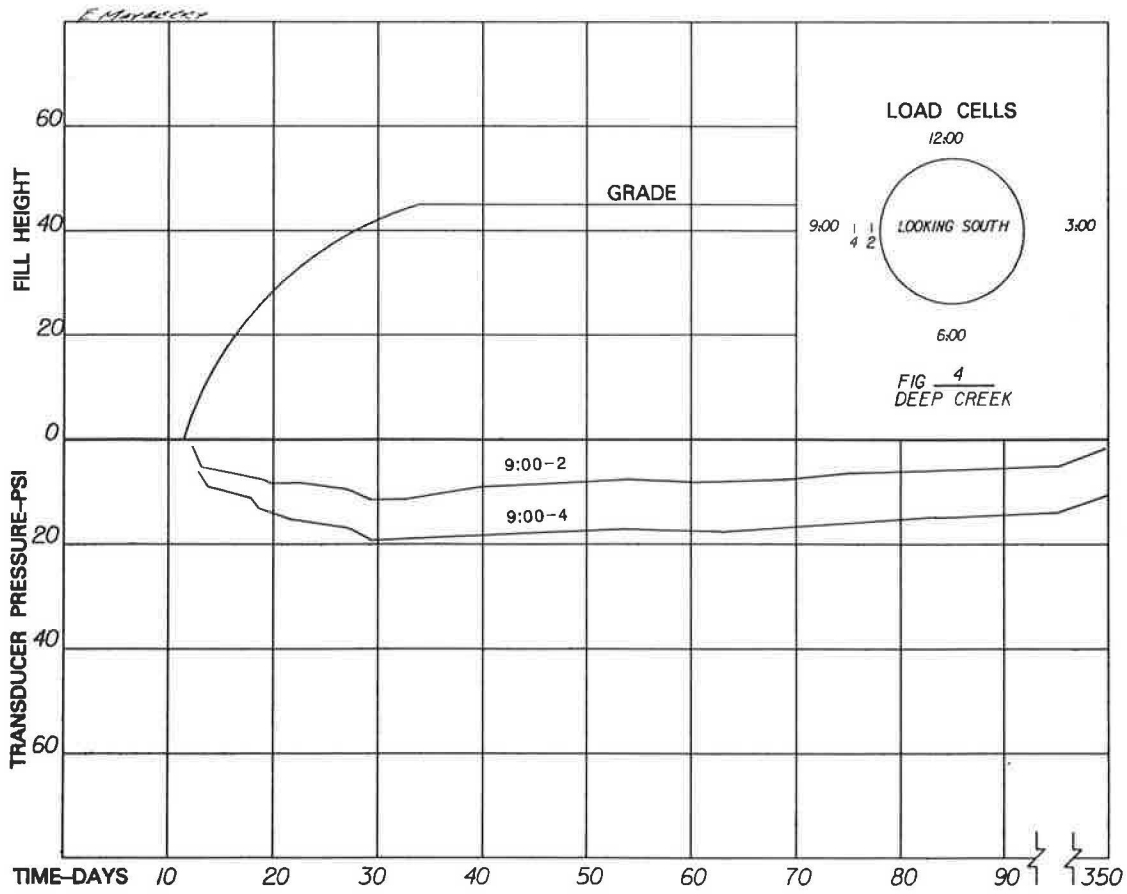
Cells 3:00-1 and -2 and 9:00-1 and -2 are set 1 ft from the pipe. Cells 3:00-3 and -4 and 9:00-3 and -4 are set 3 ft from the pipe. The pressure curves (Figures 5, 7, and 9) show the following:

1. Fill pressures 3 ft from the pipe are normal for the height of fill, although transducer pressures are generally higher on the east side of the pipe (9:00 position). Lower pressures were evident 1 ft from the pipe.
2. Horizontal pressures are lower at all positions than are vertical pressures.
3. Pressures increased proportionately as fill height increased, and response of the pressure cells is almost immediate to changes in time/rate of fill placement.
4. Pressure relief began immediately after completion of the fill and continued through July 17, 1984, when the last readings were taken.

At Deep Creek, the high transducer pressures at the 9:00 position show the greatest total decrease (75-percent average). This was also the area of greatest seam closure and initial strain increase. However, at Spring Creek, instrumentation shows little indication of similar stress relief, although seam slippage has been normal.

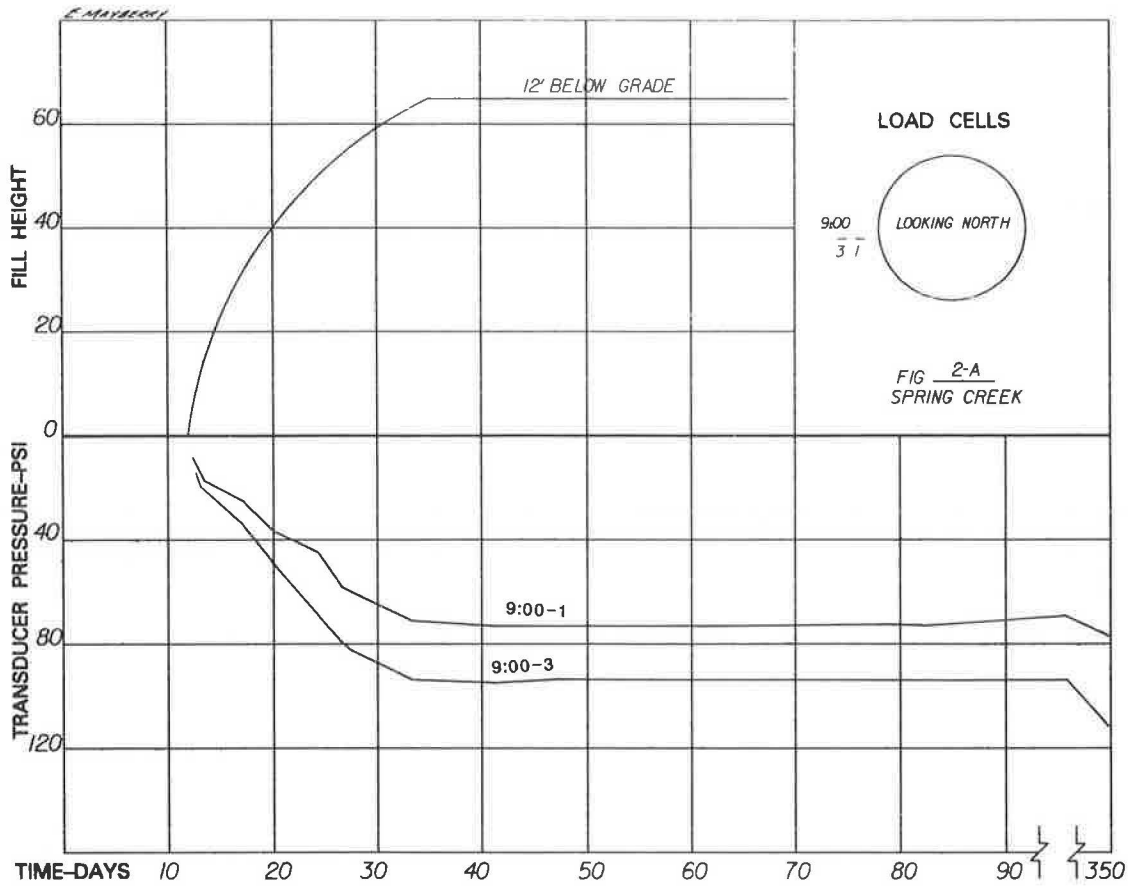
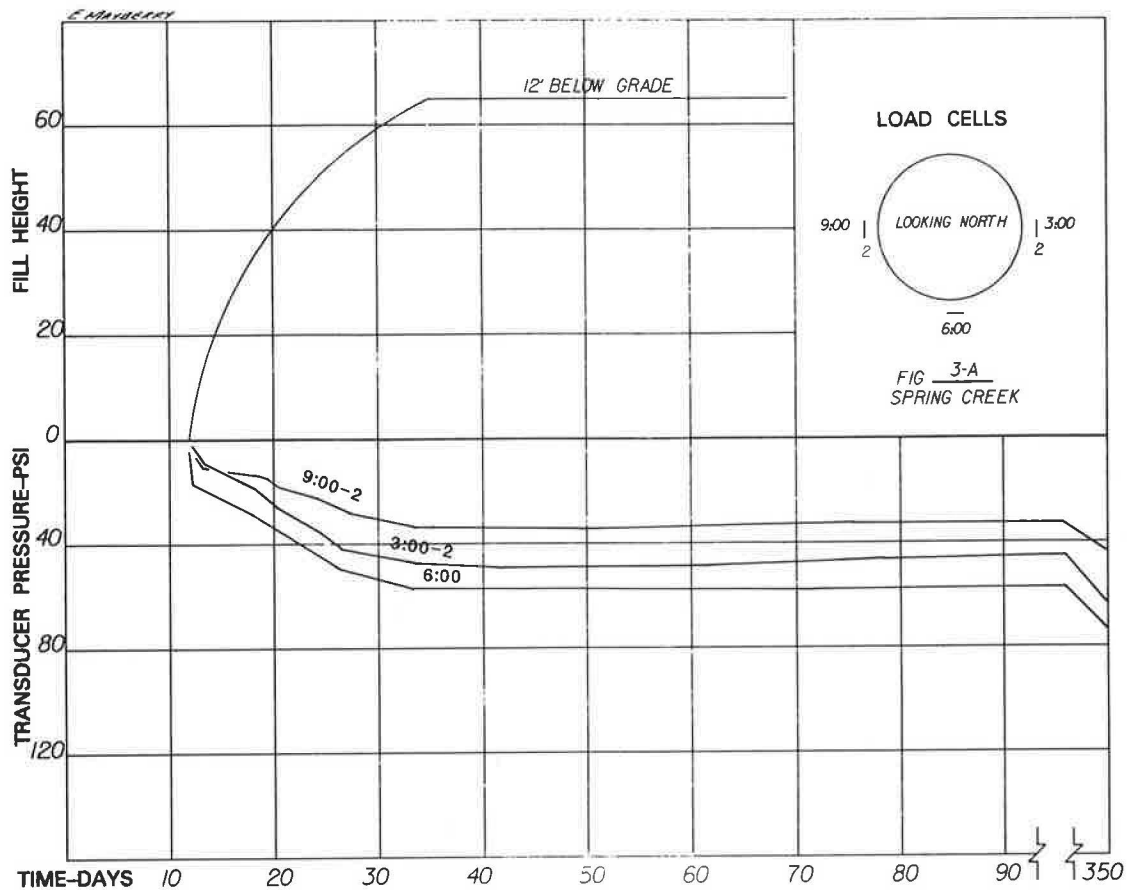
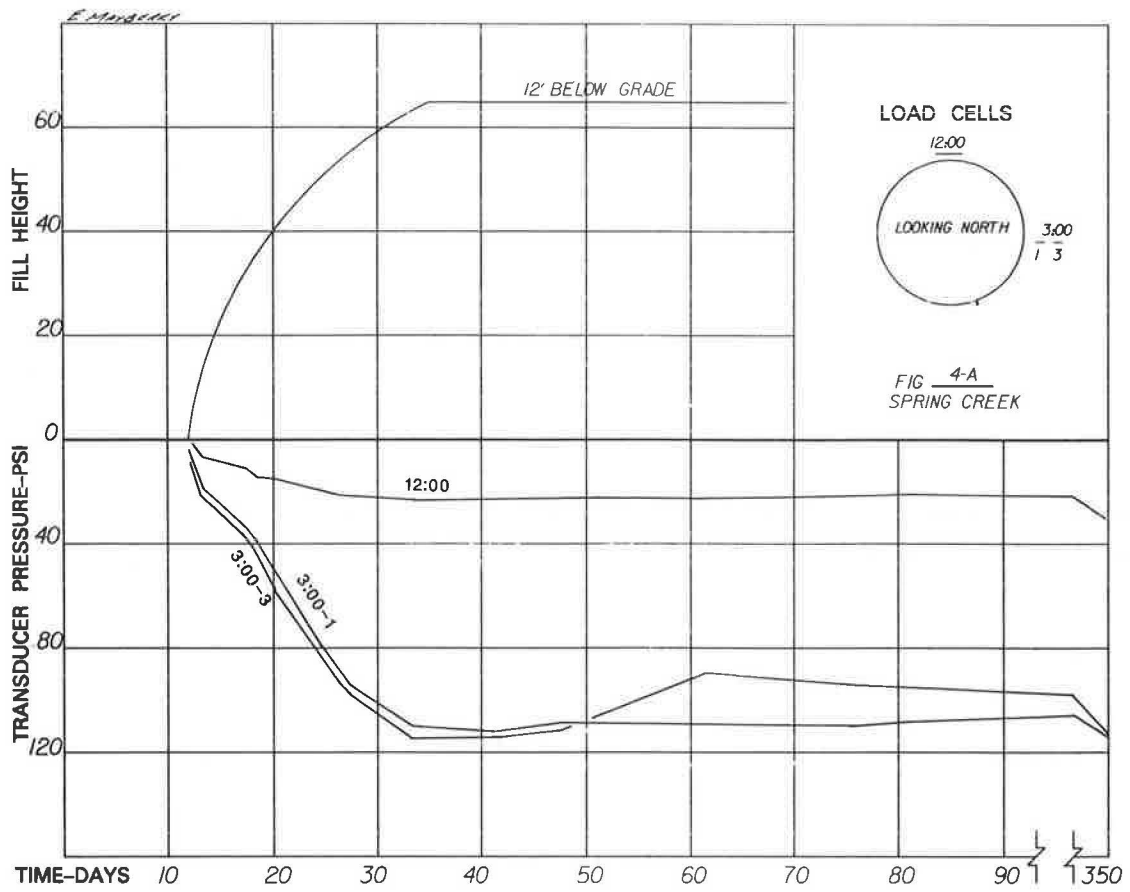
Pressure relationships around the pipe are generally similar to those at Deep Creek except that pressure curves are abnormally high at 3:00–1 and –3 and 9:00–1 and –3 (Figures 6, 8, and 10). In addition, at the 3:00 position, where pressures were highest, the 1 and 3 cells show nearly identical readings, which is not the case at Deep Creek. The high fill pressures at the sides of the pipe could be caused by excessive compaction of the backfill and/or the rate of fill construction. At Deep Creek, 45 ft of fill were placed over a 20-day period. At Spring Creek, 63 ft of fill were placed over a 22-day period, or nearly one-third more fill was placed in the same time span. Little pressure relief took place around the pipe between October 1983 and February 1984 when fill construction began once again. Pressures then increased around the pipe and remained high through July 17, 1984, when final readings were taken.

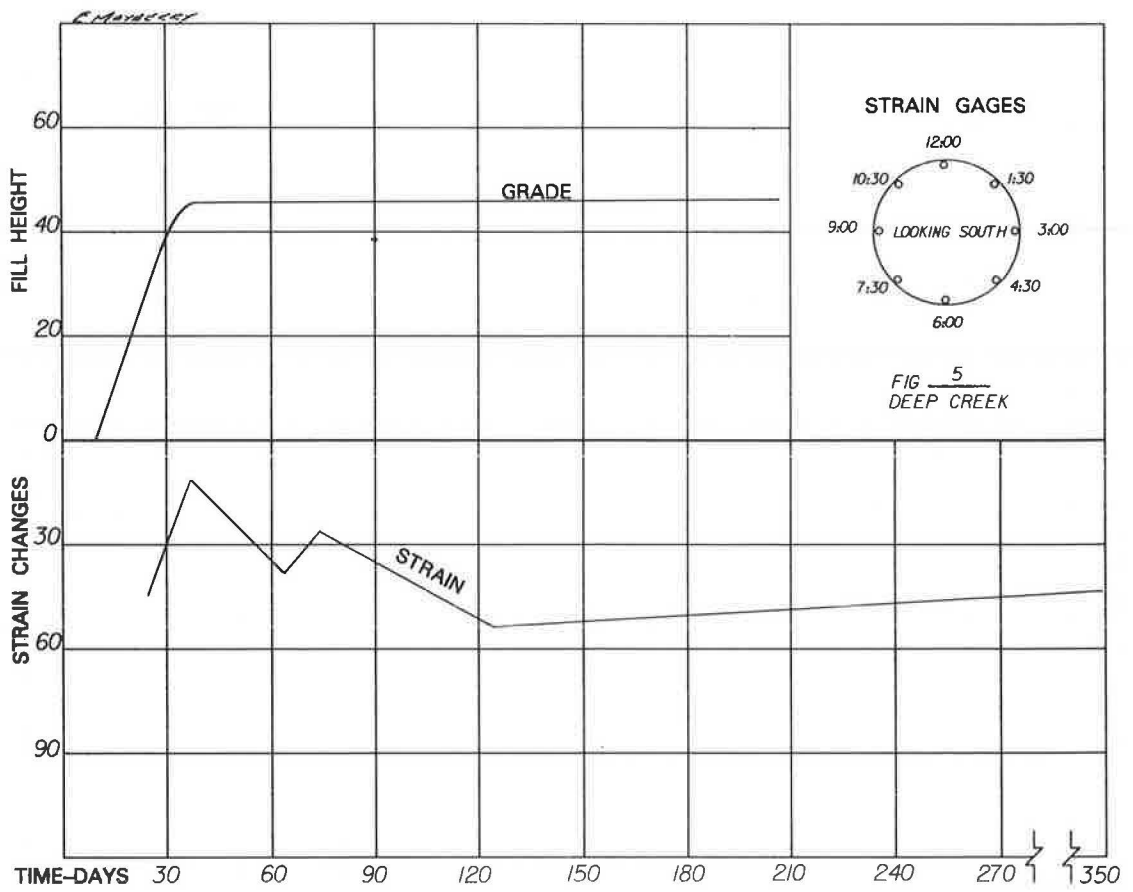
FIGURE 11 Deep Creek strain changes.

Two strain gauges (Figure 11) were installed at each designated clock position, one each in the valley and the crest of the corrugations. Because of late delivery of the indicator, zero readings were not obtained. Readings were begun on July 26, after  $36 \pm$  ft of fill had been placed. This reading was then assigned zero, and the time/strain rate curve shows only the relative strain changes. To best interpret strain, readings for each day were averaged to provide the time/strain curve.

The peak strain coincided with maximum fill pressures at completion of the fill. As transducer pressure began to fall off, strain fell rapidly until August 9, then increased until September 2, after which strain fell off again until mid-September. This period of decrease also coincides with the general change in slope of the pressure curves.

Subsequent readings show another period of strain increase from September 13 through November 2, then a long period of decrease through July 17, 1984, when the last readings were taken.

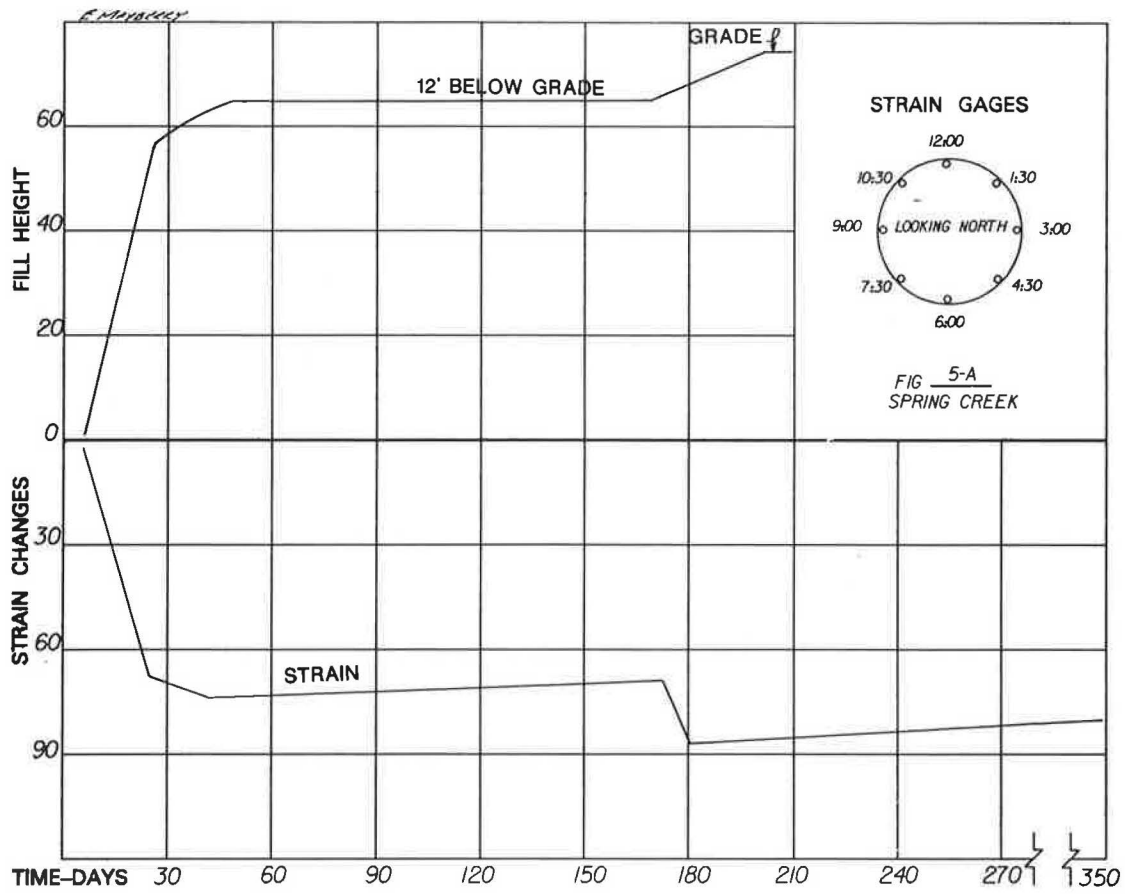
FIGURE 12 Spring Creek strain changes.

The time/strain curve is nearly proportional to the time/fill height curve (Figure 12). However, strain remained constant through February 1984, with only a minor decrease. Strain increased during completion of the fill in 1984, after which some decrease occurred through July 1984.

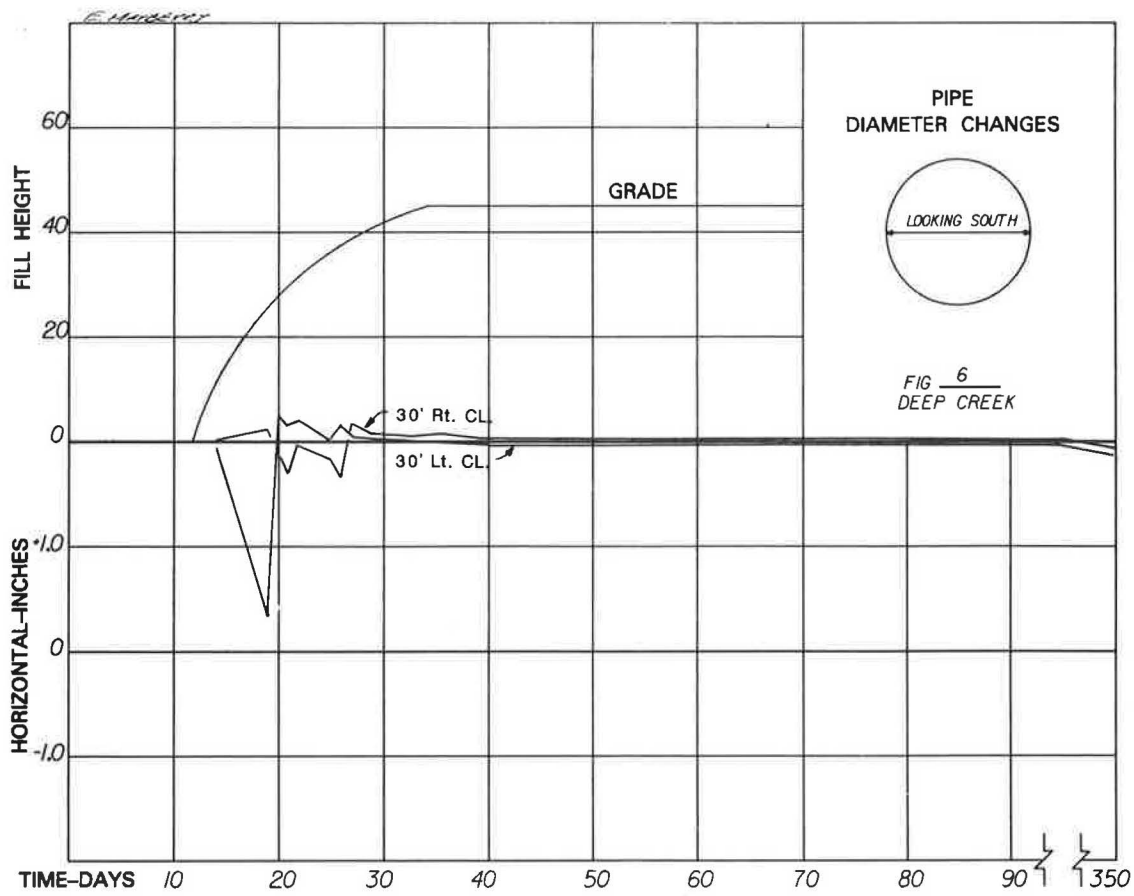
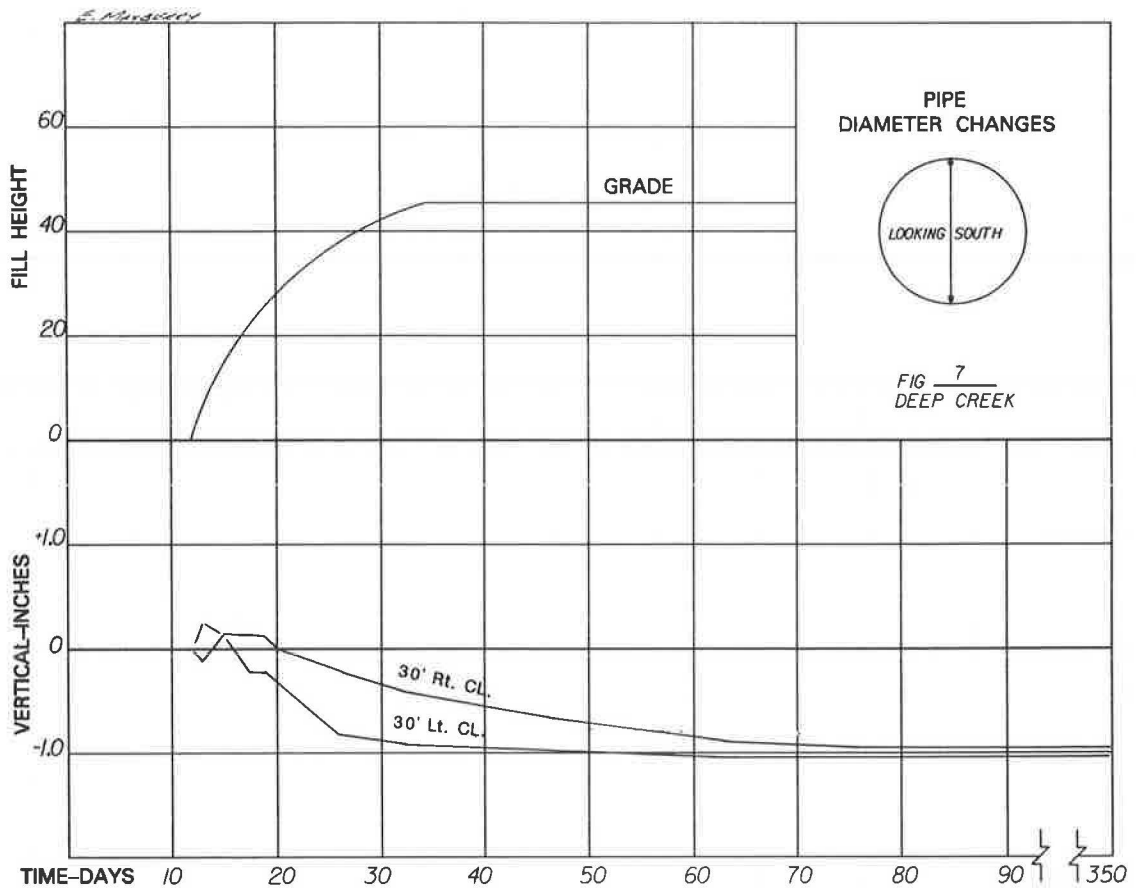
During backfill of the pipe and construction of the fill, several minor adjustments in horizontal and vertical dimensions were noted (Figures 13 and 15). Before completion of the fill, 15 days after backfill began, horizontal dimensions stabilized. Vertical rise increased slightly, then progressively decreased

due to seam slippage, starting 7 days after fill operations began or at 23 ft of fill over the pipe ( $20 \pm$  psi).

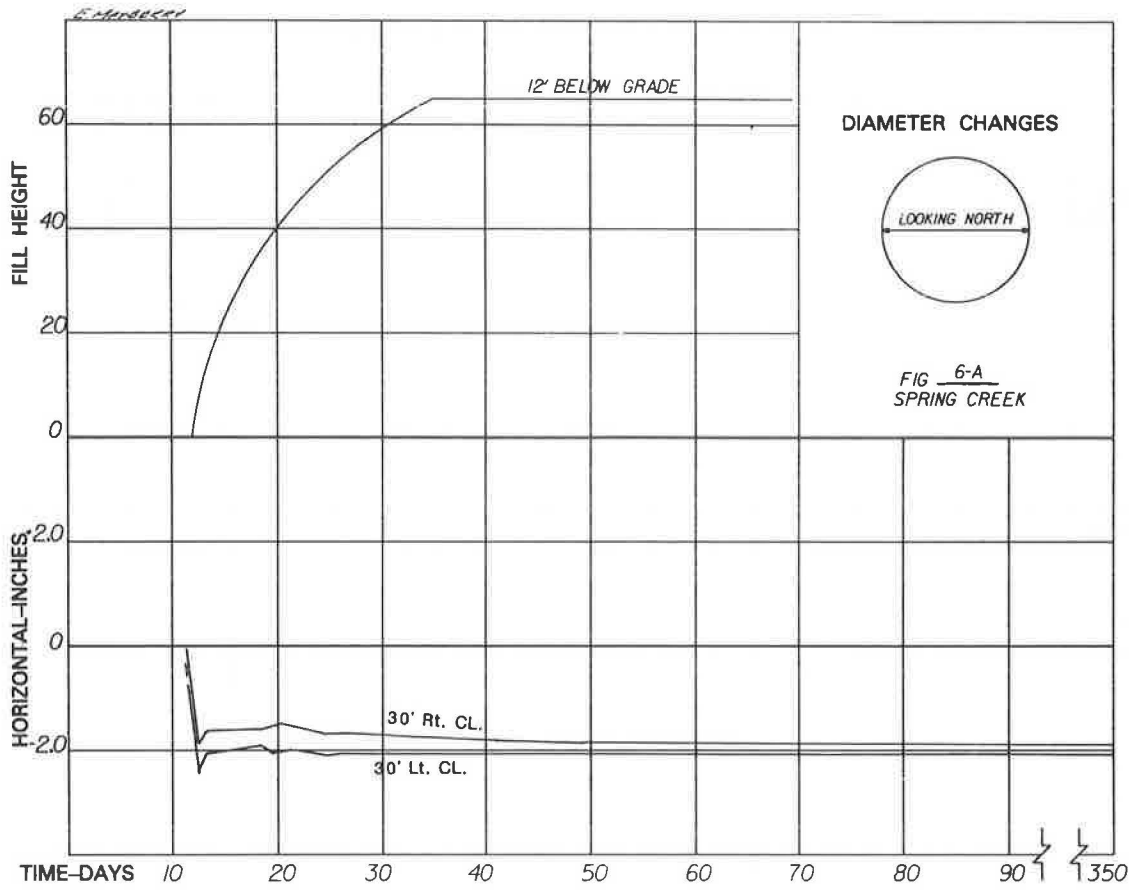
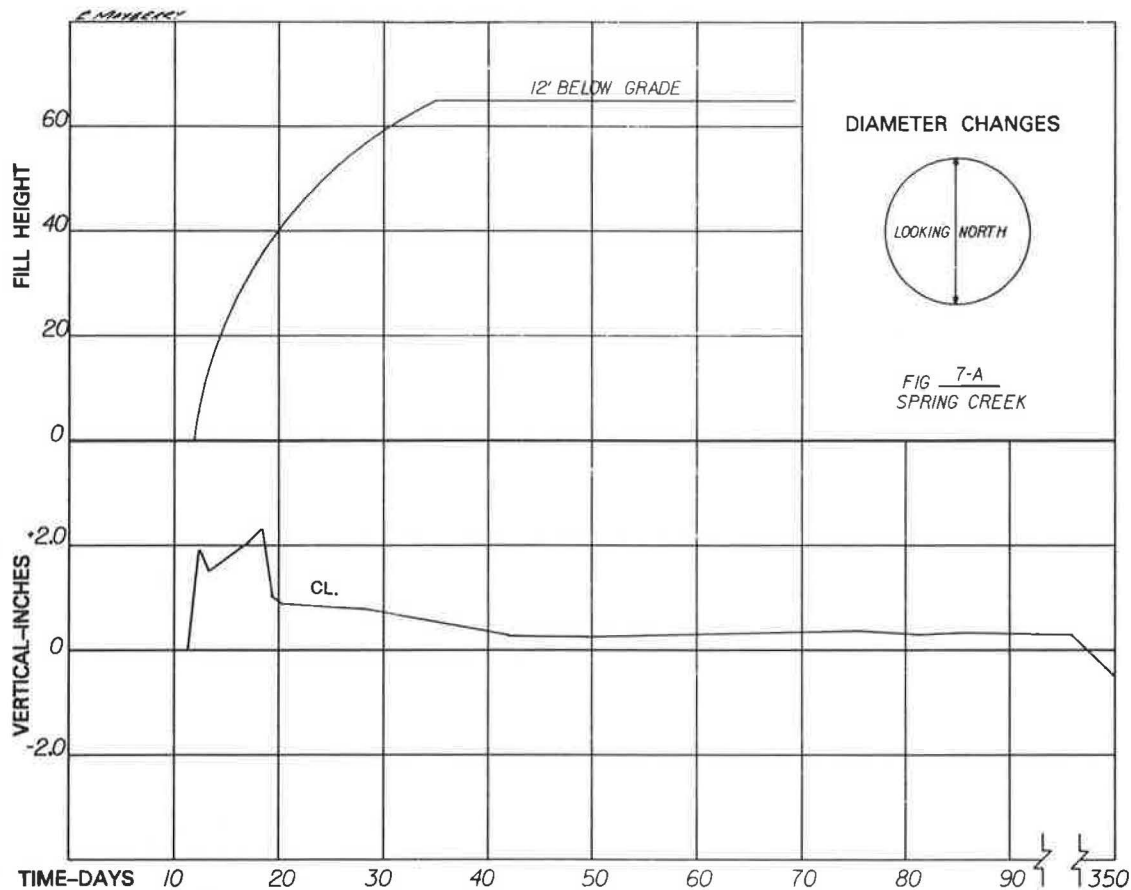
Unlike the pipe at Deep Creek, which, after initial adjustments, returned to the original horizontal diameter 15 days

after backfill began, the Spring Creek pipe (Figures 14 and 16) remains about 2 in. less than the original horizontal diameter. Vertical rise first increased then decreased exactly as the Deep Creek pipe did, after 23 ft of fill were in place over the pipe. However, the rise increase was more than 2 in. as compared with .25 in. at Deep Creek.
