# Durability of a Polypropylene Geotextile in an Unpaved Road Structure

I. D. PEGGS, L. G. TISINGER, AND R. BONAPARTE

This paper addresses select durability characteristics of a continuous-filament, nonwoven geotextile commonly used in transportation-related applications. Two samples of the geotextile were exhumed from the base of an unpaved road structure located at an industrial site in East Texas. The two samples had been in service for 12 and 13 years, respectively. The samples, together with an unused reference sample manufactured at the same time as the exhumed samples, were subjected to a series of destructive mechanical tests, structural analyses, and examinations via scanning electron microscopy. The mechanical tests included measurements of grab-tensile strength and elongation, burst strength, puncture strength, trapezoid-tearing strength, as well as individual fiber strength and elongation. The exhumed samples retained in excess of 70 percent of their initial strength and elongation properties. The microstructural analyses included differential scanning calorimetry and infrared spectroscopy. The results of these tests indicated that some polymer degradation had occurre

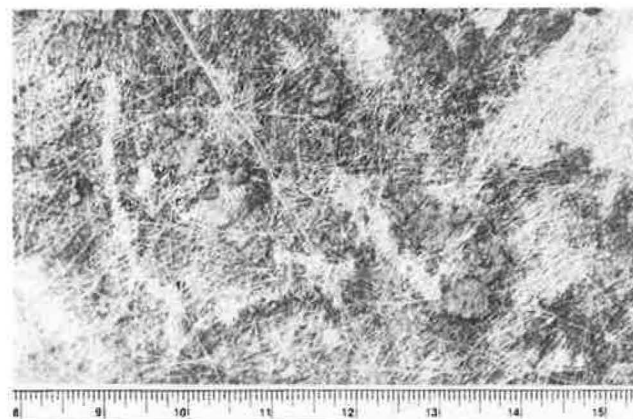
Before any laboratory tests were performed, the as-received samples were examined carefully. Sample 13 contained only one hole, which had been caused by the pickaxe when the soil cover was being removed during field exhumation. The condition of sample 12 appeared to be undamaged. Sample 13 showed no signs of severe distress, although deformations and indentations from the limestone aggregate base that covered the geotextile were evident. A close-up view of a typical area of the sample is shown in Figure 4. The geotextile has retained its original morphology without significant evidence of "fraying" or loosened fibers.

FIGURE 4 Close-up view of the surface of the as-received sample.

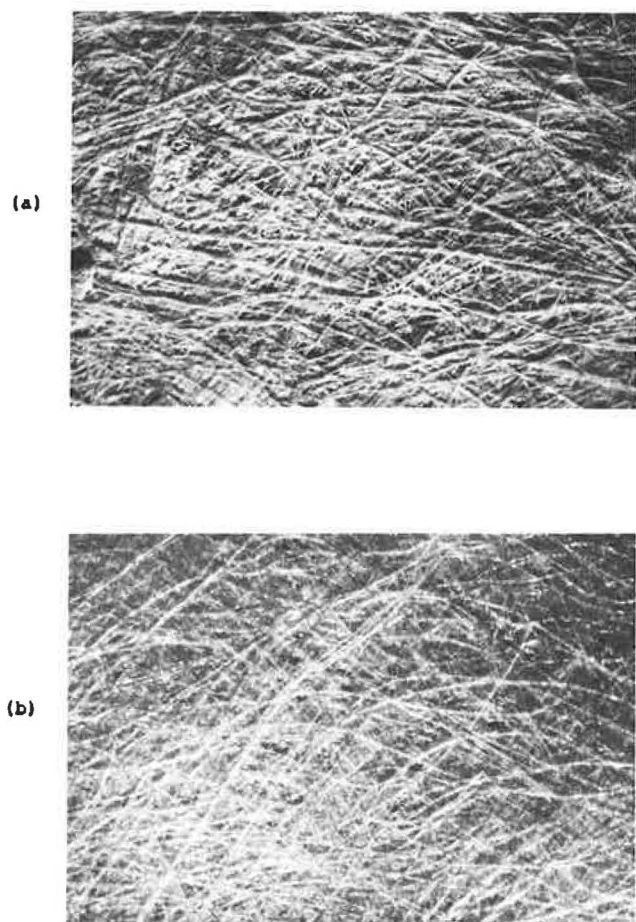
Figure 5 shows a direct comparison of the exhumed sample 13 and the 1975 reference sample. Except for the dirt in the exhumed sample, there is very little difference in the appearance of the two materials.

In general, the exhumed sample 13 does not appear to have suffered significant degradation on a macro scale.

**FIGURE 5** Comparison of the surfaces of (a) sample 13 and (b) the 1975 reference sample ( $\times 3$ ).

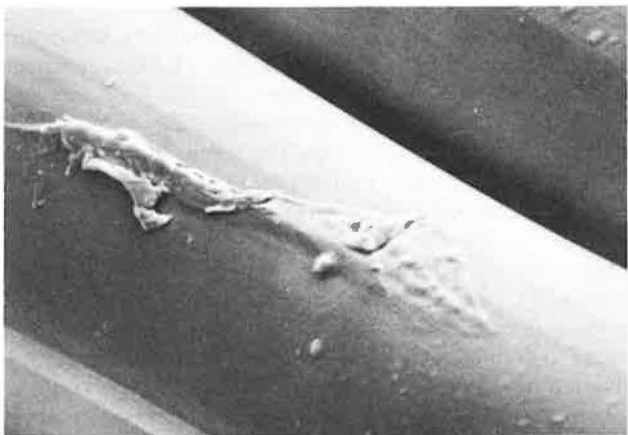
with only occasional surface blemishes (Figure 7). These blemishes, particularly those with the geometrical profile of a notch, were probably responsible for the few low tenacity and rupture strain values obtained in the fiber-testing component of the program.

**FIGURE 7** Blemish on surface of reference geotextile fiber ( $\times 975$ ).

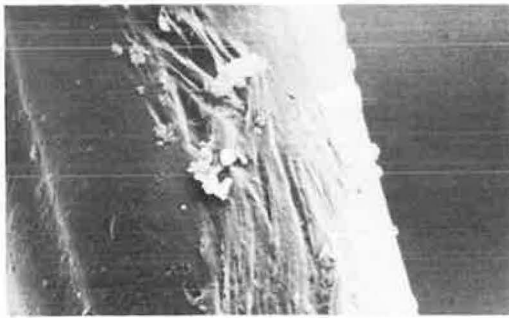
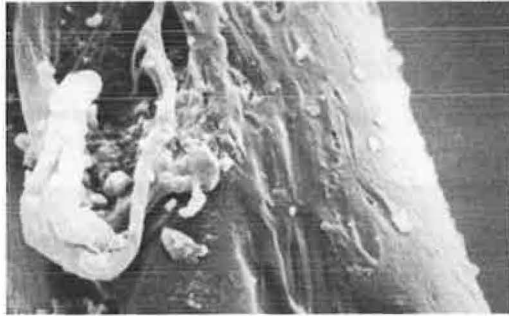
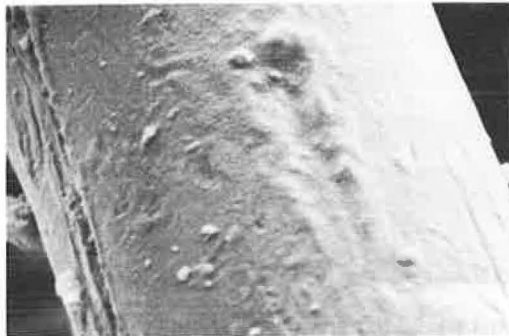
In comparison, Figure 10 shows the surfaces of fibers removed from samples 12 and 13. In general, the fibers from sample 12 are more severely damaged than those from either the sample 13 fibers or the reference sample. The damage appears to be more of a ductile "smearing" than a brittle chipping. In other words, the fiber material is not lost but is just redistributed, probably as a result of spreading of the limestone aggregate over the geotextile during installation.

It appears that the fibers from sample 12 have been damaged more severely than those from sample 13. In fact, the fibers from sample 13 appear to have received very little damage or not to have suffered any damage at all. This may explain the observation that the Mullen burst strength of the geotextile in sample 13 shows no loss when compared with the reference data, whereas the burst strength of sample 12 does.

**FIGURE 10** Surfaces of fibers from (a,b) sample 12 and (c) sample 13 ( $\times 975$ ).

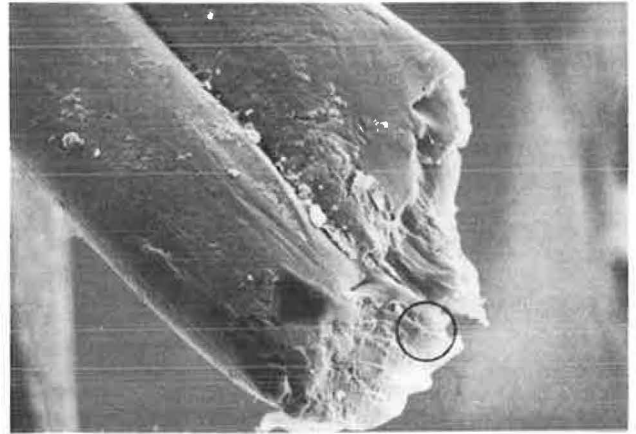
The fracture features of fibers in sample 12 (Figures 11 and 12) show more brittle characteristics in that there is little reduction in the cross section of the fibers. However, the nature of the fracture face itself shows the rounded, coarse surface features of a progressive ductile failure.

**FIGURE 11** Fracture characteristics of fibers in sample 12 ( $\times 423$ ).

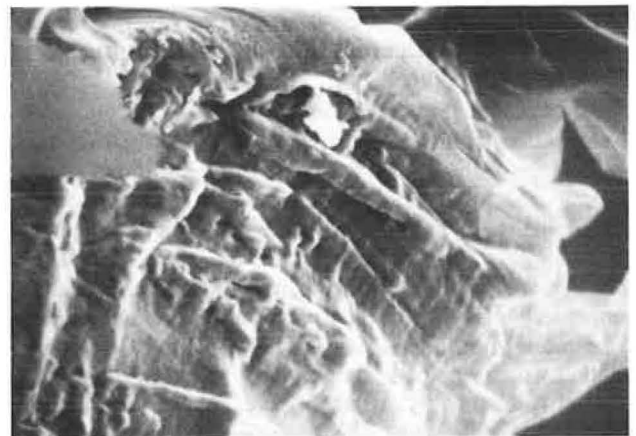
**FIGURE 12** Fracture characteristics of fibers in area circled in Figure 11 ( $\times 1950$ ).

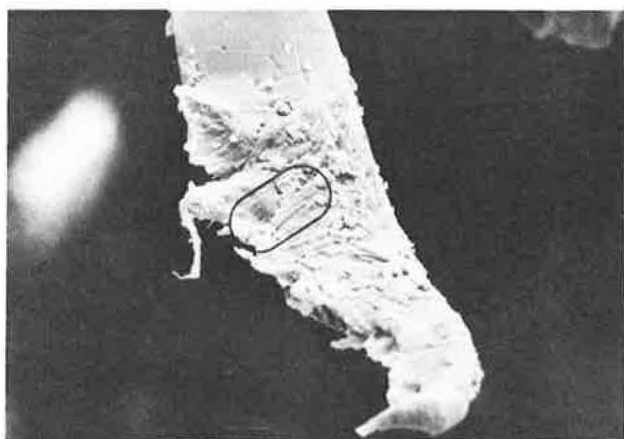
The fiber fracture in sample 13, shown in Figures 13 and 14, is essentially a replicate of the fiber fracture in the ref-

erence material shown in Figures 8 and 9. The only difference is the presence of the soil particles that have contributed to the roughness of the polypropylene surface adjacent to the fracture.

**FIGURE 13** Fracture characteristics of fibers in sample 13 ( $\times 325$ ).

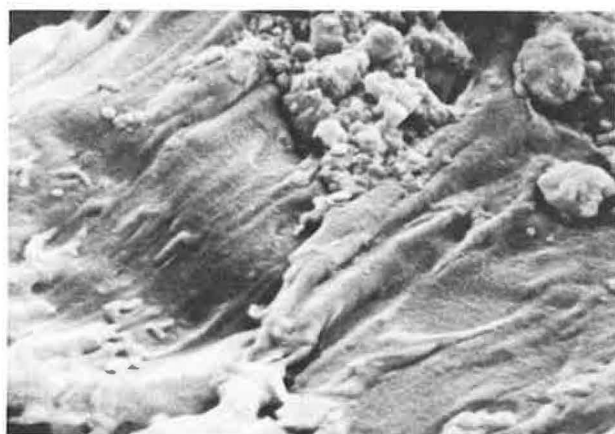
**FIGURE 14** Fracture characteristics of fibers in area circled in Figure 13 ( $\times 1950$ ).

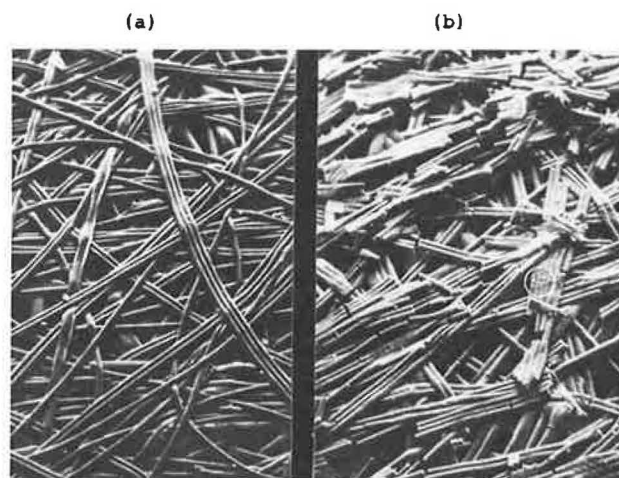
Many fibers were examined in the electron microscope for this project and the project reported earlier (7), but at no time was any evidence of circumferential surface cracking found. Such cracking occurs in highly oriented fibers when they degrade because of oxidation initiated by ultraviolet radiation. An example of degradation after 3 months of exposure to sunlight in a geotextile manufactured from a polypropylene resin similar to the one used in the present study is shown in Figure 15. Quite clearly, the individual fibers of the geotextile break up into short lengths at points where they are stressed.

**FIGURE 15** Comparison of a polypropylene geotextile structure (a) before and (b) after exposure to natural weather conditions for 3 months ( $\times 18$ ).

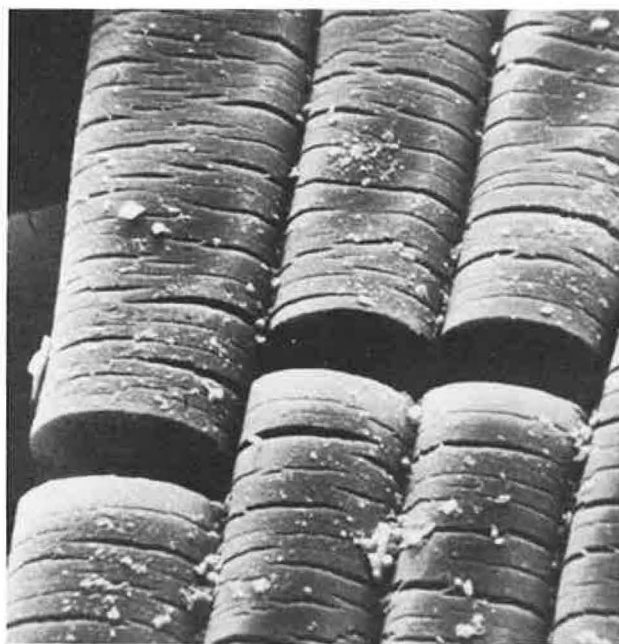
The circumferential nature of the cracking in the oxidized fibers is clearly shown in Figure 16.

**FIGURE 16** Area circled in Figure 15: circumferential cracking after 3 months of exposure to the weather could initiate fiber fracture at any stressed location ( $\times 455$ )

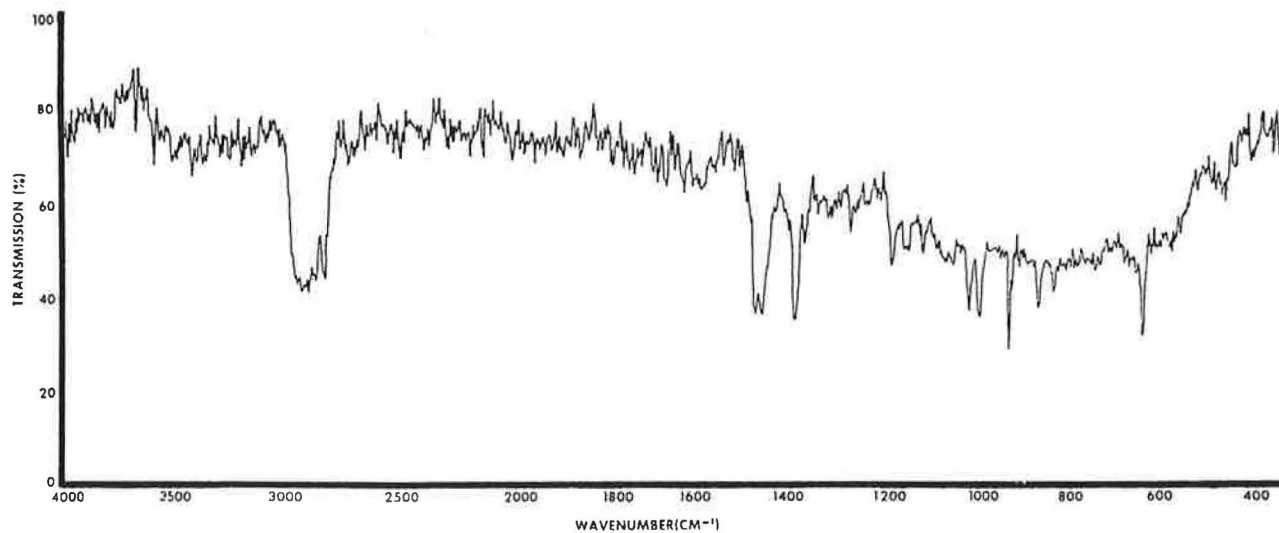
Table 6 lists the characteristic spectral bands of the reference sample and exhumed sample 13 obtained from the IR analysis. Figures 17 and 18 show infrared spectra for the reference and exhumed geotextiles, respectively. Five specimens from each of the reference and exhumed samples were analyzed.

Each spectrum displays bands at  $3000$  to  $2780\text{ cm}^{-1}$  and  $1480$  to  $800\text{ cm}^{-1}$ , which are those bands attributable to polypropylene. The absence of bands in the  $1775$ - to  $1750\text{ cm}^{-1}$  region for the exhumed geotextile sample indicates that oxidative attack on the polymer molecules was minimal. Bands appearing in this region are typically observed when oxidation

FIGURE 18 IR spectrum for the exposed polypropylene geotextile.
