Overlay Construction and Performance Using Geotextiles

JOE W. BUTTON

Geotextiles (engineering fabrics) were installed at four locations in Texas to evaluate their potential as cost-effective measures to reduce or delay reflection cracking in asphalt concrete overlays. Test pavements were 0.25 mi long with the fabric installed edge to edge. Nine different types of commercially available geotextiles made of nonwoven polypropylene or polyester were tested. One woven experimental product composed of polypropylene and polyester was also tested. Resistance to reflective cracking has been evaluated for up to 9 years. Results, based solely on these test pavements, indicate that geotextiles are not cost-effective methods in addressing reflective cracking. However, limited evidence indicates that geotextiles will reduce pumping after cracking occurs. Additional data are presented showing that a fabric can be effective in reducing reflective cracking. Recommendations are made to maximize the probability of success when geotextiles are installed to reduce or delay reflective cracking.

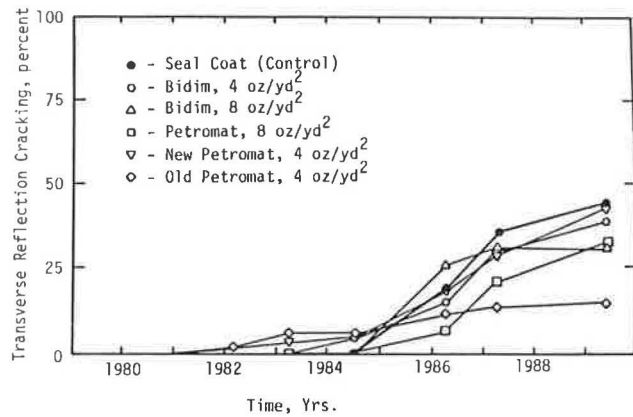
Figures 2 through 4 show transverse, longitudinal and total reflection cracking as a function of time in three representative 100-ft segments of pavement in the WB lanes. In the WB lanes the Petromat products most often exhibited the best resistance to reflective cracking; however, their performance is not a notable improvement over that of the seal-coat interlayer. Figure 5 shows total cracking in the EB test pavements. Although little cracking has occurred to date in the EB lanes, the seal coat is outperforming the fabrics. Observations after rainfall indicate that the fabrics may be reducing pumping well after cracks appear at the pavement surface.

FIGURE 2 Percent transverse reflection cracking as a function of time for westbound test pavements on IH 10 near Ozona, Texas.

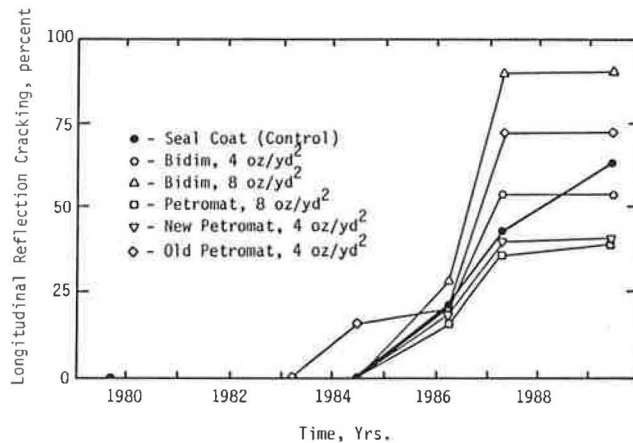
FIGURE 3 Percent longitudinal reflection cracking as a function of time for westbound test pavements on IH 10 near Ozona, Texas.

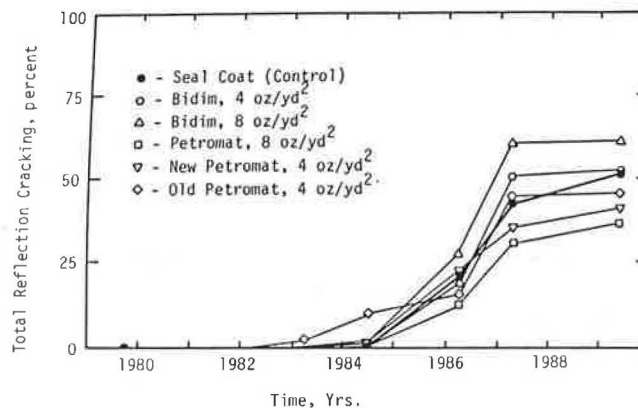
FIGURE 4 Percent total reflection cracking as a function of time for westbound test pavement on IH 10 near Ozona, Texas.

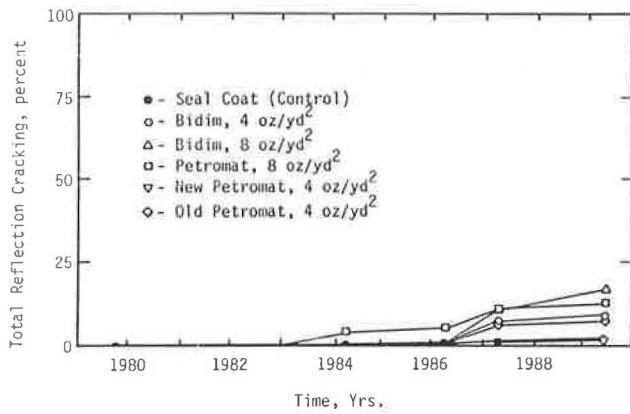
FIGURE 5 Percent total reflection cracking as a function of time for eastbound test pavements on IH 10 near Ozona, Texas.

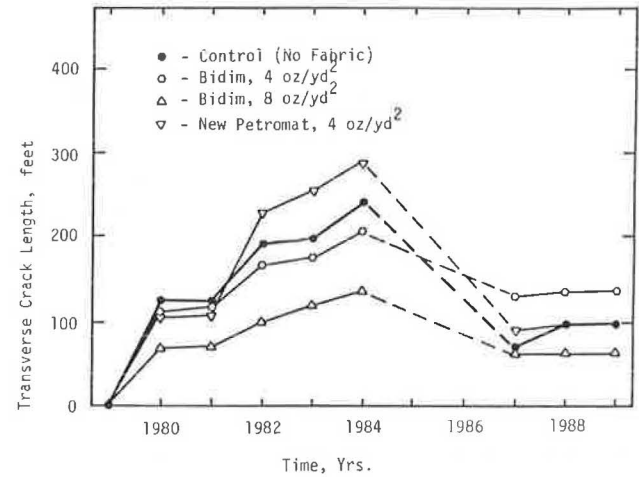
FIGURE 6 Length of transverse cracks in eastbound lanes as a function of time on IH 40 near Amarillo, Texas (600 lane ft).

Three 100-ft segments of pavement in each test section have been monitored periodically to evaluate the ability of the fabrics to reduce cracking. After 7 months in service, following the severe winter of 1979–1980, a visual evaluation revealed a considerable quantity of cracks. Figures 6 through 11 show that the cracks have continued to grow, but at a slower rate. Because the original crack patterns were not recorded, only crack length is shown in the figures and not the percentage of reflection cracking. In 1985 the pavements were heater-scarified to a depth of 0.75 in., an asphalt rubber seal con-

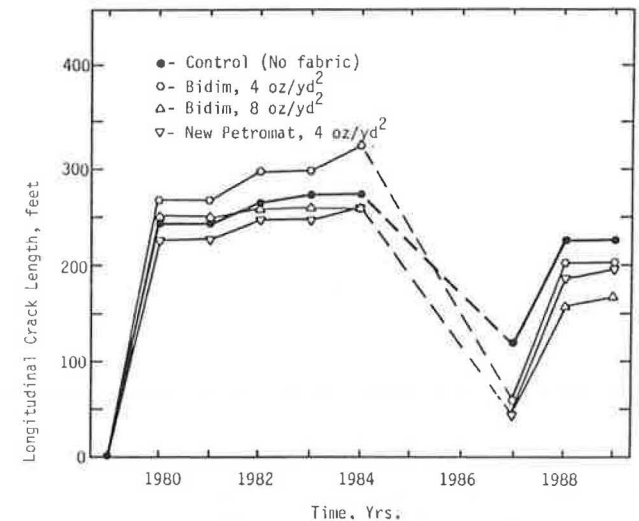
FIGURE 7 Length of longitudinal cracks in eastbound lanes as a function of time on IH 40 near Amarillo, Texas (600 lane ft).

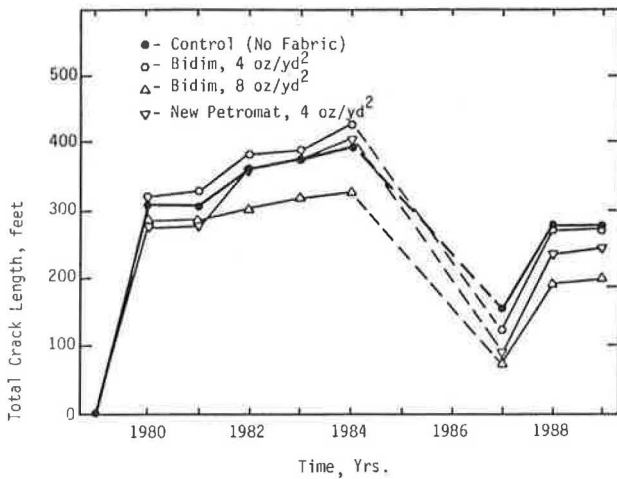
FIGURE 8 Total crack length in eastbound lanes as a function of time on IH 40 near Amarillo, Texas (600 lane ft).

Prior to the maintenance activity in 1985, the control pavements exhibited about the same or less cracking than the sections containing a fabric. After the maintenance activity in 1985, the control pavements, on average, exhibited more cracks in the new surface than the pavement sections containing a fabric. However, in most cases, the differences in crack lengths between the different sections are not considered to be significant. (These data, by their nature, did not lend themselves to a formal statistical analysis.) In these tests, the 8-oz/yd² products exhibited the best resistance to cracking in the overlay applied in 1985 but not in the original overlay. No single type of fabric consistently improved resistance to cracking throughout the 10-year evaluation period.

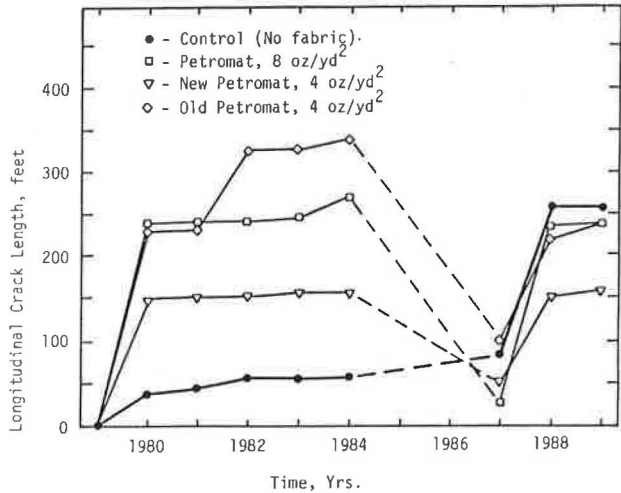
FIGURE 10 Length of longitudinal cracks in westbound lanes as a function of time on IH 40 near Amarillo, Texas (600 lane ft).

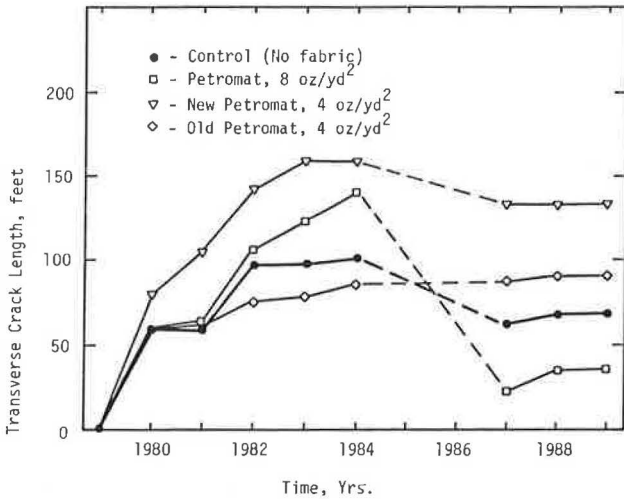
FIGURE 9 Length of transverse cracks in westbound lanes as a function of time on IH 40 near Amarillo, Texas (600 lane ft).

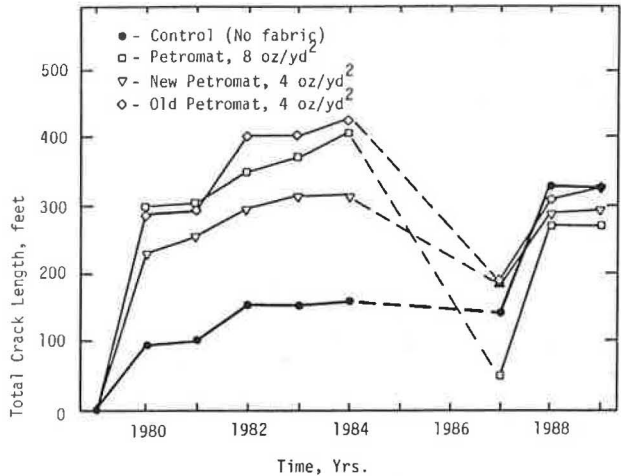
FIGURE 11 Total crack length in westbound lanes as a function of time on IH 40 near Amarillo, Texas (600 lane ft).

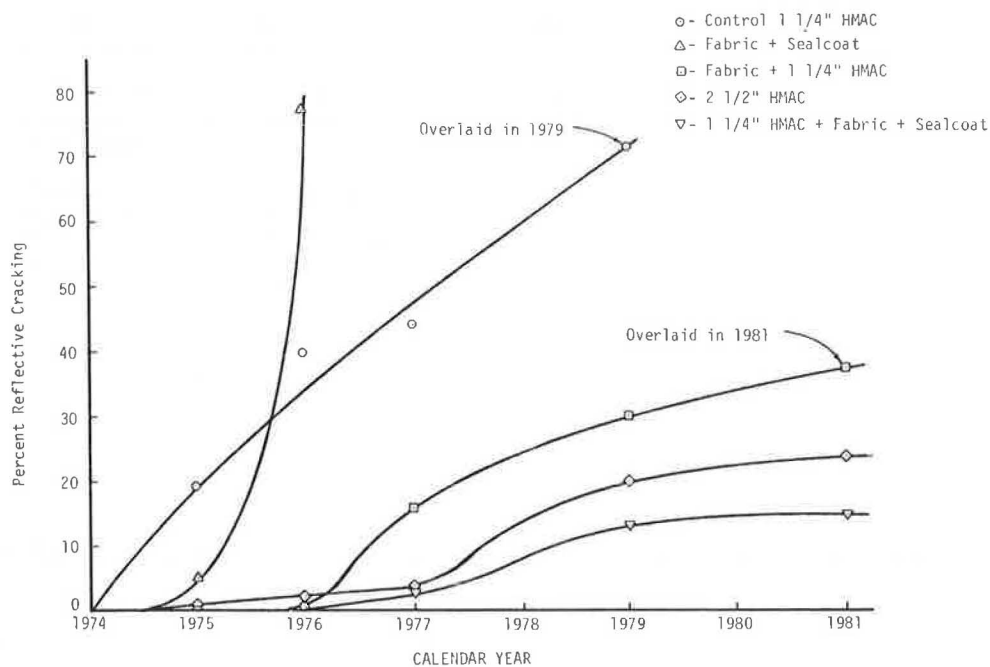
Test sections containing various combinations of fabric, seal coat, and HMAC overlays were installed on IH 20 near Midland, Texas, in 1973 and 1974 (R. S. Neal, unpublished data). Chronological progression of reflection cracking for selected test sections is shown in Figure 12. This plot illustrates the rapid progression of reflection cracks during the first 2 years for the seal coat plus fabric and the conventional thin (1 1/4-in.) overlay. In contrast, the thicker (2 1/2-in.) overlay and those overlays with a fabric or a seal coat, or both, exhibited a delay of 2 to 3 years before significant reflection cracking was visible.

FIGURE 12 Reflection cracking progression for selected rehabilitative treatments (R. S. Neal, unpublished data).
