# Inspection of the Substructure of the Chesapeake Bay Bridge-Tunnel Above and Below the Waterline

DONALD R. GRABER

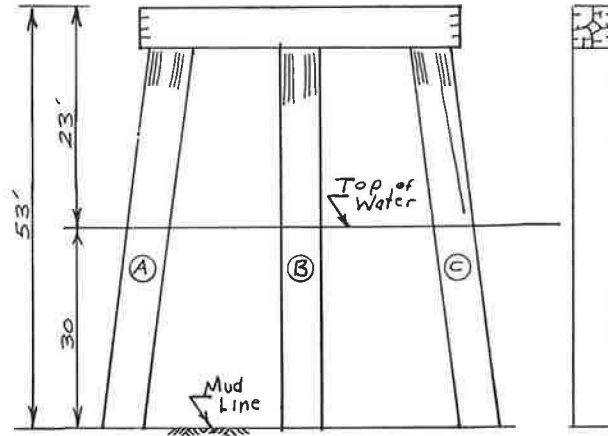
FIGURE 2 Data sheet.

The first of the four tasks was to photograph and sketch both sides of each substructure unit. The sketches included a list of all deficiencies identified and an estimate of the quantities involved. An example of the data collected is shown in Figure 2.

CONDITION	QTY	QUANTITY	REMARKS
CAP MINOR STAINS MODERATE MAP CRACKS	5	2-3'x3'	ON ENDS
PILE A MODERATE CRACKS	5	6-6'	
PILE B MODERATE CRACKS	5	6-6'	
PILE C MODERATE CRACKS ADVANCED CRACK	5	5-6'	
	4	1-15'

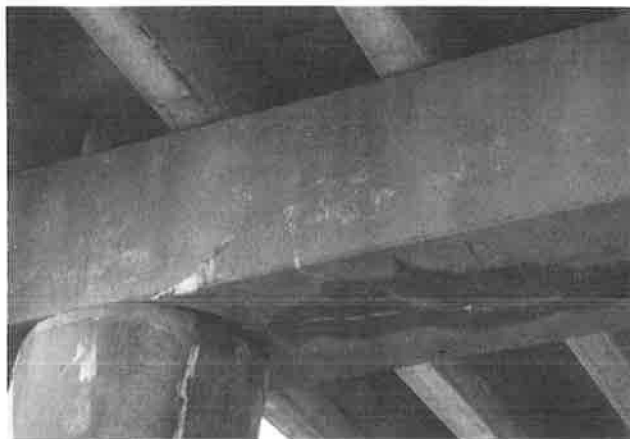
The caps were found to be in good condition. As shown in Figure 3, open deck expansion joints wet the surfaces of the caps resulting in minor discoloration caused by moss, lichen, road oil, and light efflorescence. Many cap ends exhibited minor map cracks. Figure 3 also shows a cap with extensive map cracks.

FIGURE 3 Cap with map cracking.

The bent caps are wetted by rainwater because of the open deck slab expansion joints, which have been left open to help drainage. This wetting has resulted in moderate staining of the pier caps and in light efflorescence of the concrete surface by allowing aggressive agents to enter through the top of the cap, percolate through the concrete matrix, and leave through the bottom and side faces of the cap. This process weakens the concrete paste by removing soluble compounds. Future bridge projects should not allow open joints to continually wet the pier cap with salt-laden spray, contaminated rainwater, and road oils.

Although the joints on this type of superstructure are left open to increase drainage and neoprene bearing pads are provided, it is recommended that open bridge deck expansion joints not be used on a bridge subjected to large amounts of salt spray. Once the joints are sealed, a maintenance program should be established to ensure that the joints remain watertight.

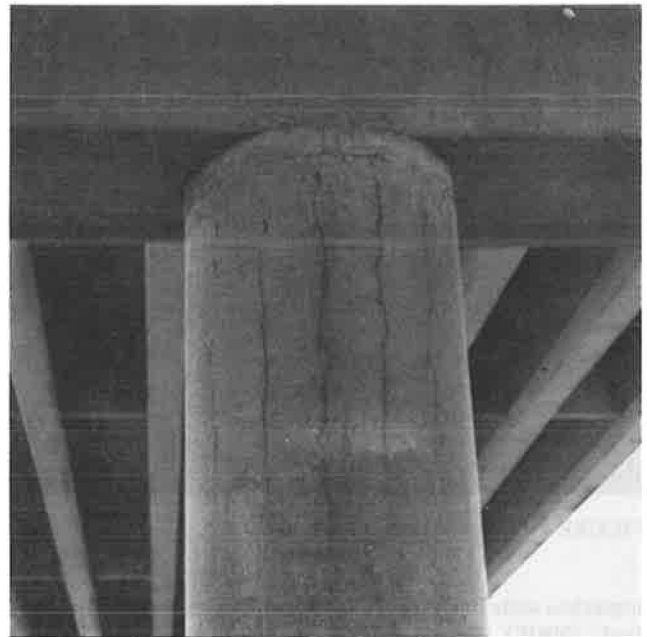
The piles were in generally fair condition, typically having minor and moderate cracks over the prestressing strands around the uppermost 4 to 6 ft of each pile. Figure 4 shows this condition. Some piles had open cracks and some had minor scaling of the concrete surface, which would be expected of 25-year-old concrete.

FIGURE 4 Pile with typical cracks.

Minor and moderate cracks require no remedial action at this time, because active corrosion is not the cause of cracking. However, it is recommended that these cracks be monitored during future inspection for any signs of progressive deterioration.

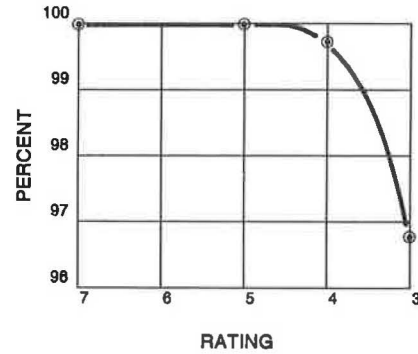
By grouping the test scores according to crack severity (crack rating), averages can be generated for each rating category. The result is that prestressing strands with no associated cracks, moderate cracks, advanced cracks, and severe cracks (rated 7, 5, 4, and 3, respectively), have an average percent remaining steel area of 100, 100, 99.7, and 85 percent, respectively. If the 50 percent datum value is discarded, the average value for severe cracks changes from 85 to 96.7 percent. A graph of these averages is shown in Figure 7. The plot is exponential, as might be expected.

FIGURE 7 Remaining steel area.

corrosion initiates halfway between a rating of 4 and 5 and progresses at a rate of 1.4 percent per rating-decrease squared.

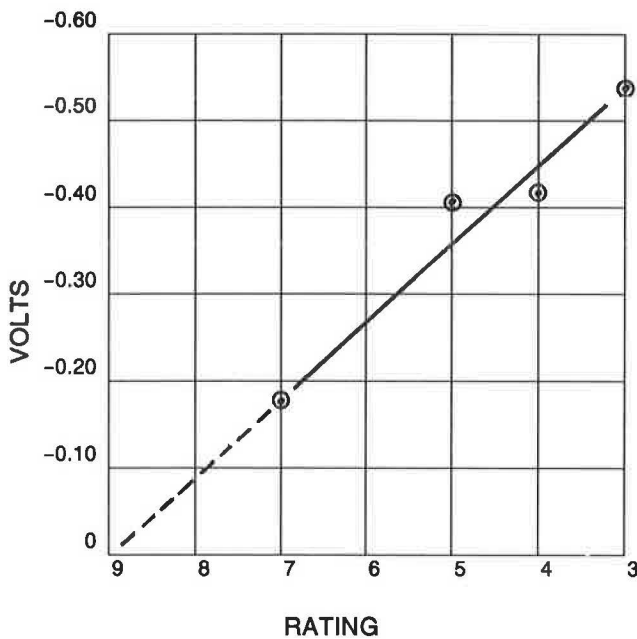
FIGURE 9 Corrosion potential.

reveals that the potential for corrosion increases at a rate of  $-0.09$  volt per rating decrease.

Half-cell corrosion potential readings correlated with the rating of the crack tested. The prestressing strand with no associated crack had a low potential for corrosion, the moderate and advanced cracks tested had a moderate potential, and the severe cracks had a high potential for corrosion. The categories for corrosion potential are based on FHWA guidelines for bridge decks, which use the values of  $-0.35$  and  $-0.50$  volt as breakpoints to separate low, moderate, and high potential readings.

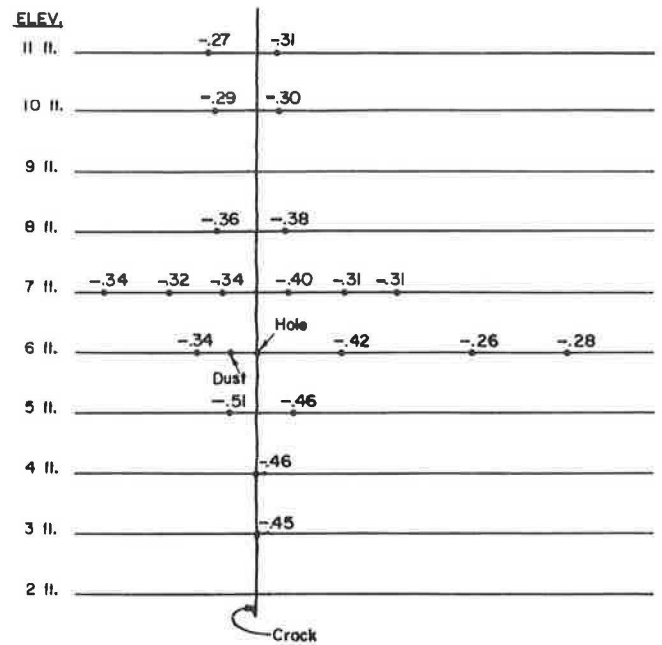
The additional potential readings have been mapped. A typical map is shown in Figure 10. The information reveals that (a) potential readings are greatest in the vicinity of the test site, (b) potential reading values decrease with distance above and below the test site, and (c) no trend exists to predict reading horizontally around the pile, as might be expected, because strands are electrically insulated.

FIGURE 10 Potential readings.

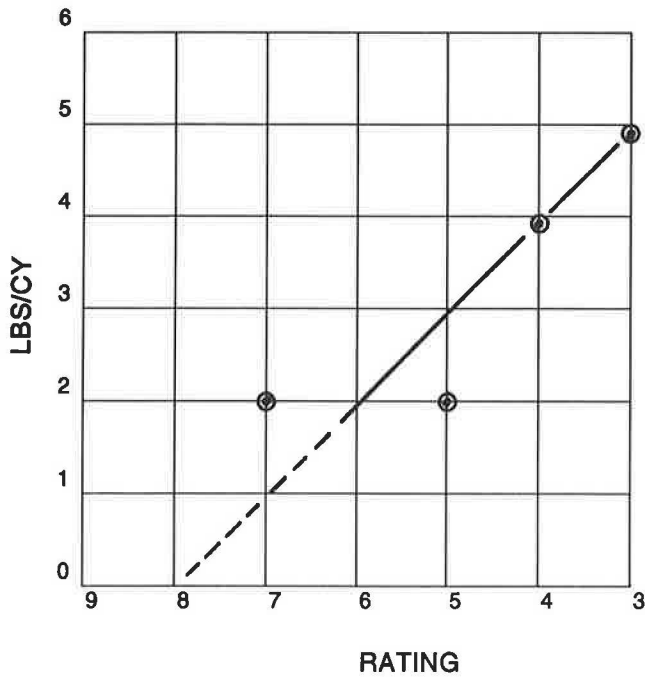
Figure 11 shows the data that resulted from the chemical analysis of dust samples, which shows a fair amount of scatter. Averages have been plotted in Figure 12. A correlation exists, however, between the crack severity and level of associated chloride ion content. After extensive data manipulation, the plot shown in the graph was developed. This plot passes to the right of the origin of the graph indicating that, near a

Equation 4 indicates that the concentration of chloride ions increases at a rate of  $0.9$  lb/yd<sup>3</sup> per rating decrease.

The chloride ion content measured near the concrete surface was in the contaminated range for cracks rated 6 or less on the basis of the FHWA breakpoint of  $2$  lb/yd<sup>3</sup> for plain reinforced concrete bridge decks. It has been previously recommended that for prestressed-concrete beams, "... permissible water soluble chloride ion content ... not exceed 0.10 percent by weight of portland cement" (1). This amount translates into a value of approximately  $4$  lb/yd<sup>3</sup>.

FIGURE 12 Chloride content near surface.

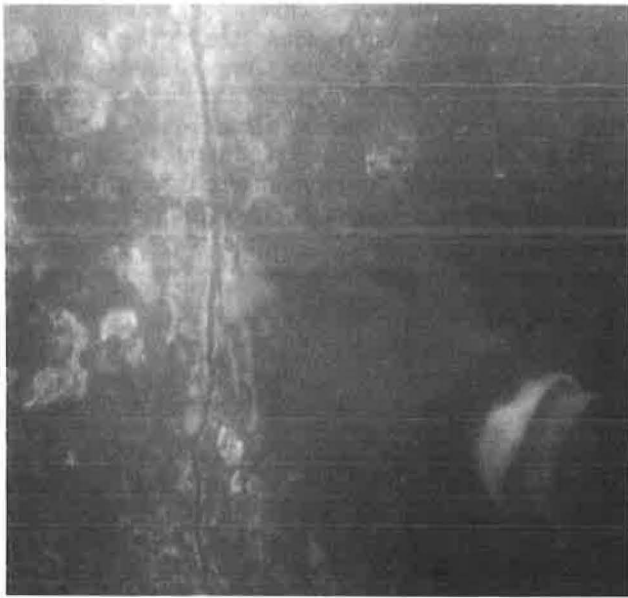
Almost all of the pilings were in good condition below the waterline with only occasional minor and moderate cracking,

FIGURE 16 Two views of underwater cracks.

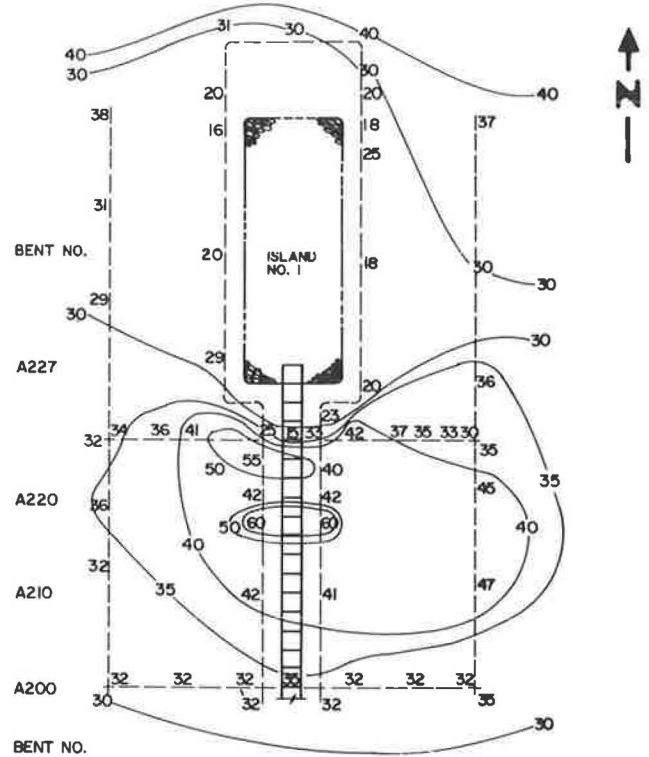
A hydrographic survey was run parallel and perpendicular to the facility and showed the formation of a scour pocket beneath the approach trestle near one of the man-made islands. As shown in Figure 17, the scour pocket approaches 30 ft in depth and has compromised the structural integrity of the piling. This compromise occurs when scour lowers the bay bottom locally either to an elevation below the point of fixity

FIGURE 17 Contour map of first island vicinity (not to scale).

assumed in the design or to an elevation near the pile tip elevation.

The scour pocket, which exists near one of the four man-made islands, is the result of tidal currents that must now flow around the islands. This pocket has formed on the trestle side of each island because the piles create a restriction that increases the flow velocity. In addition, this side of the island is not extensively overlaid with riprap for the tunnel tube cover. This scour pocket has compromised the structural integrity of the piles in the vicinity by increasing the unsupported length. It has either attained depths below the point of fixity assumed in the design of the pile or attained depths near the pile tip elevation. Future bridge projects under similar conditions should try to minimize any obstacles to tidal flow.

Finally, it is recommended that the scour pocket that has formed near the man-made island be filled with riprap. This riprap should take the shape of a cone centered around the piles and slope away from each bent. This remedial work is now in progress.
