Experimental Rehabilitation of Jointed Portland Cement Concrete Pavement

ASHWANI K. SHARMA

A study was initiated in 1981 by the Wisconsin Department of Transportation to demonstrate and evaluate the performance of some innovative rehabilitation techniques on a section of I-90 between STH 30 and USH 18. The existing pavement was a 20-year-old, four-lane, 9-in. reinforced concrete pavement with dowelled contraction joints spaced at 80 ft. The average daily traffic in 1981 on this segment of highway was 36,000, with 30 percent trucks. Eight different full-depth, full-lane-width, portland cement concrete (PCC) patching techniques were tried. Patch lengths were 4, 5, and 6 ft. Eleven percent of the total surface area of the existing PCC pavement was patched. After patching, the eastbound lanes were intermittently ground and westbound lanes were continuously ground. All transverse cracks and joints were filled with a silicone joint sealant. The longitudinal joints were filled with a rubberized asphalt sealant. Five years after the rehabilitation was completed, the condition of the various sections had deteriorated considerably. Pavement serviceability index values for the driving lane

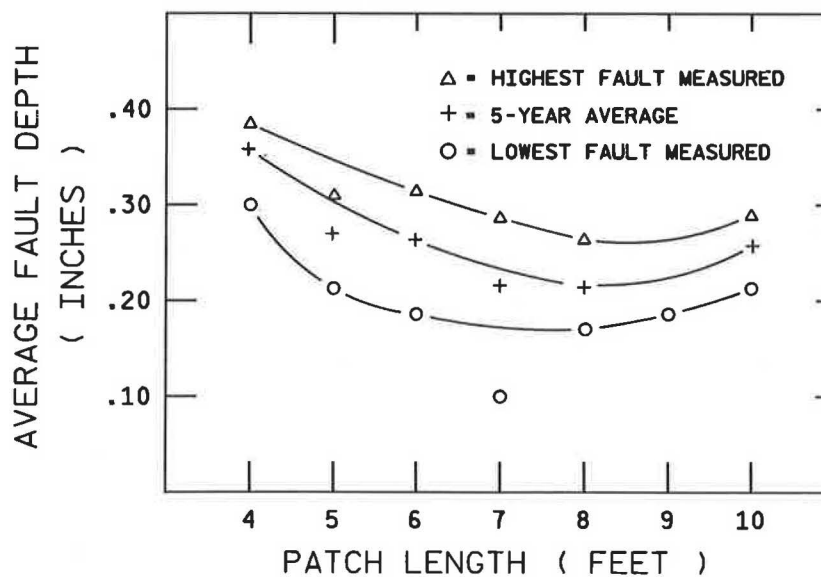
Average fault depth (average of approach and leave sides) was plotted against patch length (Figure 1). The results show that there is a decrease in faulting with an increase in patch size up to 7 or 8 ft. The shorter the size of patch, the more faulting (all other factors being equal). Thus, of all the designated patch types, the 4-ft cast-in-place patches had faulted the most. It appears that placing patches at a skew to the centerline did, in fact, serve to keep the faulting approximately 38 percent less than that which had occurred for the patches placed perpendicular to the centerline (averaged from 1982 to 1986). There was no significant difference in faulting between right-hand-forward (RHF) and the left-hand-forward (LHF) skewing for the same patch size. The 6-ft precast patches faulted more than the 5-ft transverse cast-in-place patches, but less than the 4-ft cast-in-place patches. Some of the faulting in the precast patches was due to difficulty in getting the patches placed at the proper elevation during construction.

FIGURE 1 Faulting in the driving lane for transverse cast-in-place patches (approach- and leave-side faulting averaged).

6. The shorter the patches (4, 5, and 6 ft CIP transverse), the more faulting. At 7 or 8 ft the faulting remains the lowest and then increases slowly by an increase in size.

1. Patches should be full lane width, full depth, and skewed.
2. A minimum patch length of 6 ft and maximum of 8 ft should be used.
3. All patches should be dowelled or undercut to achieve load transfer.
4. Partial-lane-width patches should not be used.
5. Continuous diamond grinding should be used rather than intermittent diamond grinding.
6. PCC rehabilitation cost analysis should be performed to justify patching. This is an appropriate problem for computer modeling. Therefore, such a model can and should be developed to address the cost-effectiveness of patching versus complete reconstruction or other options for distressed PCC pavement.

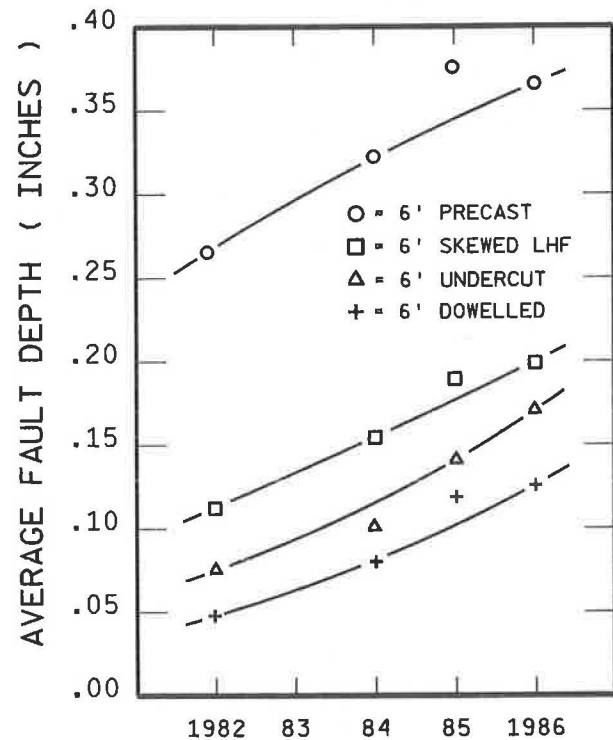
The average fault depth (average of the approach and the leave sides from 1982 to 1986) was plotted against them (Figure 2) for various types of 6-ft-long patches. The results indicate that over a period of 5 years the 6-ft precast patches had faulted the most and the 6-ft cast-in-place patches with the load transfer devices had faulted the least.

FIGURE 2 Relationship between average fault depth and various rehabilitation techniques over a period of 5 years.

7. The load-transfer and the undercut patches had faulted the least and the 4-ft cast-in-place and 6-ft precast had faulted the most in 5 years.

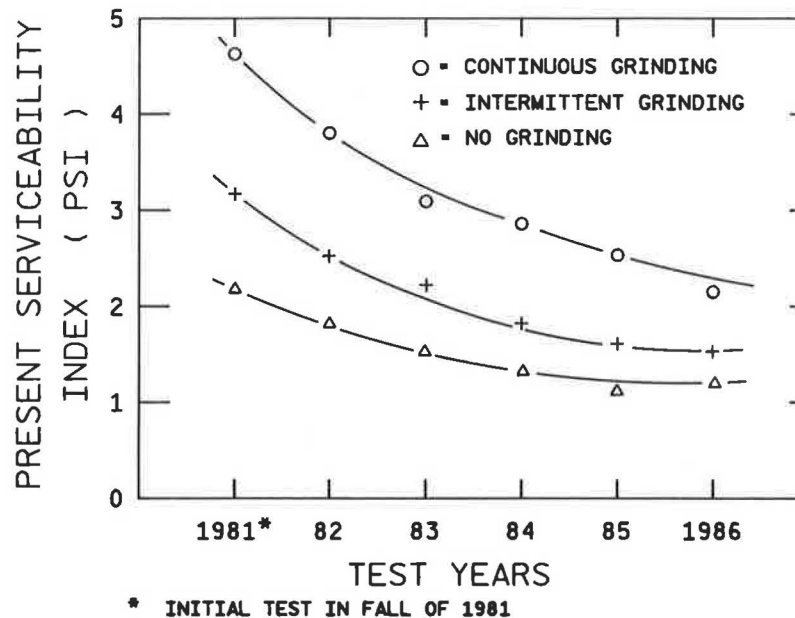
Initially, the intermittent grinding raised the PSI above that measured for the previous patched condition by 1.2 (DL and PL combined), whereas an increase of 2.6 points resulted from

the continuous grinding process. Unfortunately, this improvement in ride quality did not last very long. During the period between 1981 and 1986 there had been a continuing decline in the ride quality (Figure 3). The PSI value for the intermittent ground section in 1981 was 3.1 compared with 1.6 by 1986, approximately a 48 percent decrease. In 1981 the average PSI value for the continuously ground section was 4.7, but by 1986 this value had dropped to 2.2, a 53 percent decrease. Thus, within the 5-year period (1981 to 1986) the average PSI value for each of the special sections had dropped below 2.5, the level at which rehabilitation should be considered.

2. Continuous grinding improved the ride quality much more than intermittent grinding, but in 5 years ride quality had fallen to undesirable levels for both types of grinding techniques.

FIGURE 3 Relationship between PSI and various types of grinding techniques.
