Crack Detection at Cover Plate Ends and Welded Splices Using Ultrasound Technology

PATRICK D. ZURASKI

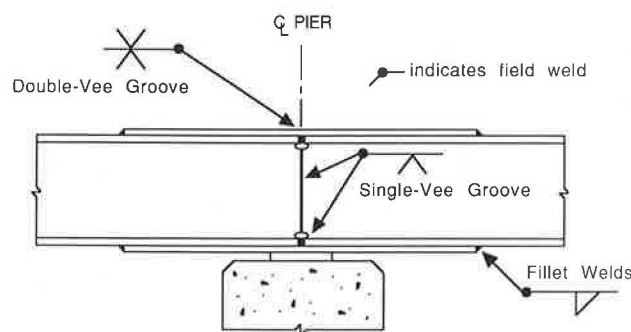
The welded connection shown in Figure 1 was a standard splice detail in Ohio's expressway construction from the late 1950s to the mid-1960s, some of which detail was eventually incorporated into the Interstate system. Frequently, the stress range at the end of the top flange cover plate, calculated using the standard HS-20 design vehicle, is much higher than that allowed by the AASHTO specifications (1). Considering that the majority of cover plate terminations within this study are AASHTO Category E' details and that one-way traffic volumes exceed 4,000 trucks per day, it is quite difficult to find any acceptable location within a tension zone for terminating the cover plates.

FIGURE 1 Welded splice and cover plate detail.

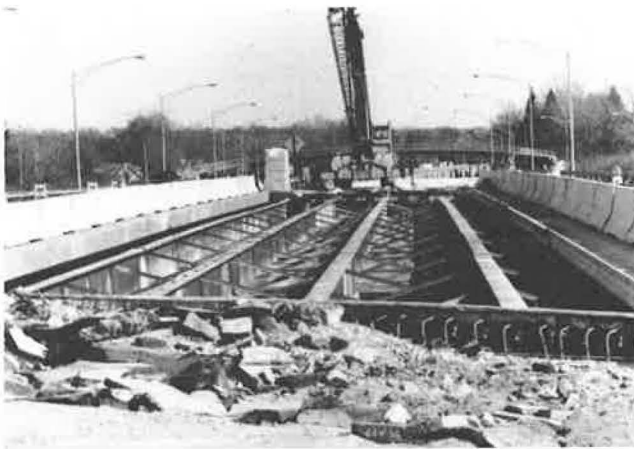
FIGURE 8 Beam lines with deck removed.

Four beam lines within one of the bridges, exposed after deck removal, are shown in Figure 8, which also shows the angle-type cross bracing frames between the girders. The termination of a typical top flange cover plate is shown in Figure 9. Falsework was installed between bottom flanges of the girders to protect the roadway below during deck removal. It also provided convenient access to the cover plates for ultrasound examination.

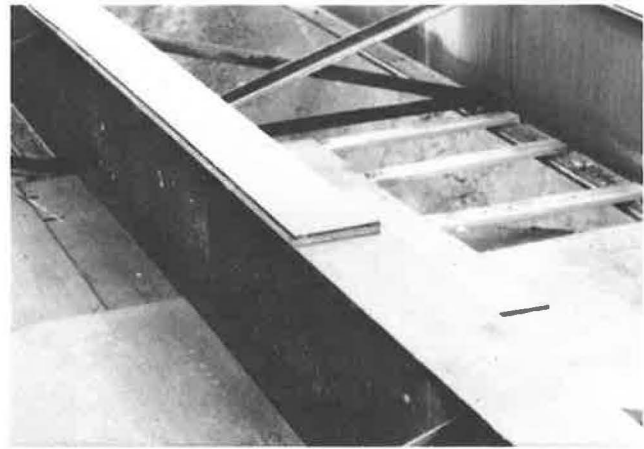
FIGURE 9 Termination of top flange cover plate.

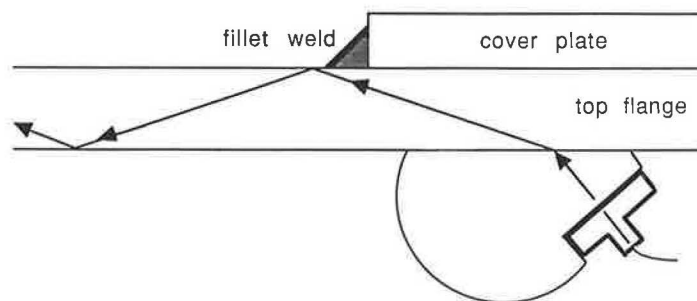
Paint should be removed from the surface over which the transducer is moved for a distance of approximately 5 in. on each side of the transverse weld toe. Separate techniques with small power tools, wire wheels, and disks covered with coarse aluminum oxide grit were employed for the removal. The last method provided the best results. Paint removal is not necessary for obtaining a trace on the oscilloscope screen, but it greatly enhances the quality of the signal. Figure 10 shows the transducer positioned on the bottom surface of a cover-plated flange, and Figure 11 shows actual usage of the instrumentation.

FIGURE 10 Inspection at end of welded cover plate: scan of cover plate end.

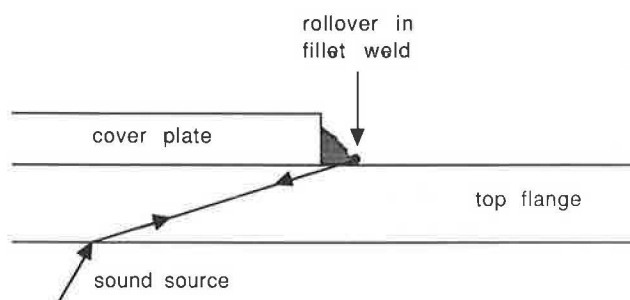
photograph in Figure 13, provide false indications. The sound incident to the concave surface in Figure 12 is focused by the corner-like trap back toward the transducer, and an indication appears on the screen.

FIGURE 12 Sound reflection from irregularity in weld surface: rollover in fillet weld.

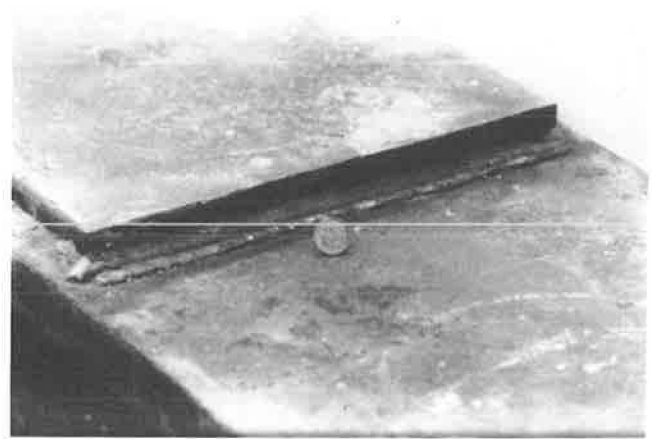
Even though no cracks were detected at the ends of the cover plates, indications (spikes) did appear on the oscilloscope screen during the examination. It was discovered that certain undulations in the surface of the weld (sometimes referred to as "rollovers"), shown schematically in Figure 12 and in a

FIGURE 13 Irregularity in weld surface at end of cover plate.

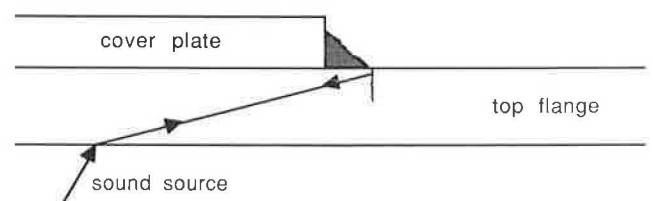
The indication caused by a rollover does not differ from that caused by a real crack, such as the one shown in Figure 14. The corner created by the intersection of the crack and surface of the top flange focuses the sound back toward the transducer in a manner similar to the rollover. It is possible, however, to distinguish between a real crack and a false indication by conducting the ultrasound scan from both sides of the weld. The crack shown in Figure 14, representative of a fatigue crack at the end of a cover plate, causes an indication to appear for scans conducted from both the left and right sides of the weld. When a scan is conducted from the right side of the weld in Figure 12, there is no indication because the sound is no longer incident on a trapping surface feature.

FIGURE 14 Sound reflection from fatigue crack at weld toe.

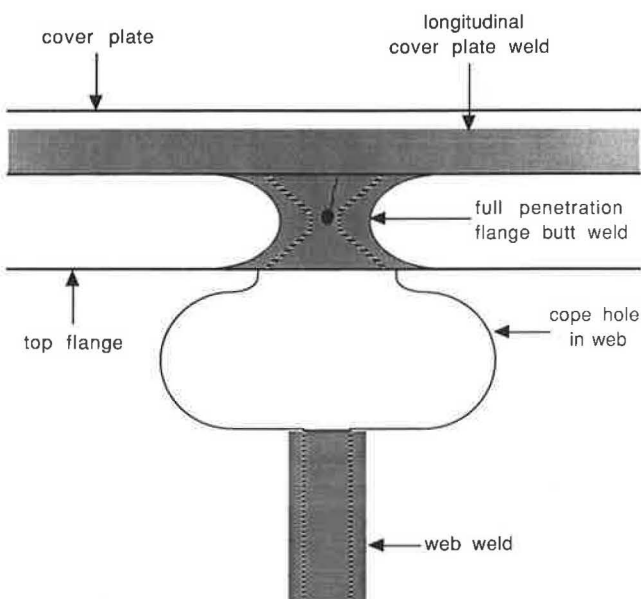
At three locations, however, indications were detected that revealed a through-thickness dimension extending from the center of the flange to near its top surface. It becomes difficult to assess the full extent of the flaw as it nears the surface because of interference from the metal-air interface at the top of flange and irregularities in the flange surface. In one instance, there was evidence from the ultrasound that a defect had travelled to within $1/64$ in. of the surface of the top flange. The evidence indicated the type of crack shown in Figure 15. There was no way to confirm this finding by visual methods, because the cover plate and side fillet welds obscured the top flange surface from view.

FIGURE 15 Crack propagation from flaw within root of flange splice butt weld.

To ensure safety and preserve the overall integrity of the negative moment connection, a bolted flange splice was installed at the location where ultrasonic examination revealed that the defect had nearly reached the surface. Other locations with flaws of significant depth will be closely monitored.
