# Field Test of a Geotextile-Reinforced Levee

REDA M. BAKEER, TARIK A. HADJ-HAMOU, FRANK M. DUARTE, AND GERARD S. SATTERLEE

The field performance of a full-scale test section of a geotextile-reinforced embankment founded on a soil deposit of mostly soft clays is discussed. The test section was constructed in 1986 under the supervision of the U.S. Army Corps of Engineers as an enlargement prototype of an existing hurricane protection levee. The section was built to test the performance of the proposed design prior to commencing work on the entire 13-mi (20.8-km) span. The soil investigation conducted by the Corps included undisturbed and disturbed borings, soil sampling, and laboratory testing. The test section was fully instrumented with inclinometers, settlement plates, and piezometers. Displacement transducers were used to measure the deformations in the fabric. Field measurements consisted of horizontal movements, vertical settlements, pore pressures, and strains in the fabric. Measurements were taken during construction and continued for 2 years.

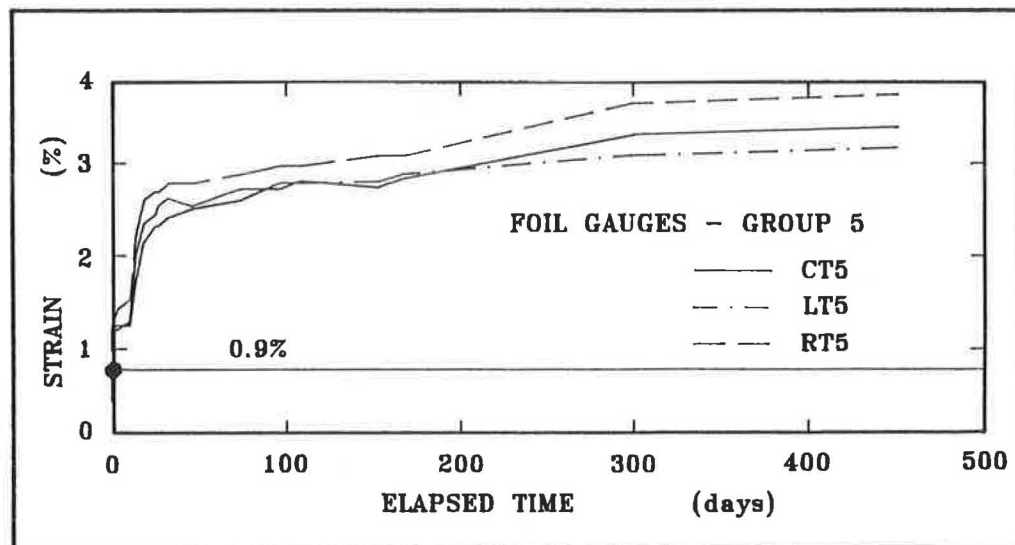
FIGURE 8 Strains in the fabric.

Typical lateral strains measured in the fabric by the foil gauges during the first 300 days are shown on Figure 8 for Group 5 (CT-5, LT-5, and RT-5). The readings of other groups of gauges followed similar patterns. The lowest strain of 0.8 percent was measured by gauges LT-1 and LT-2, and the maximum lateral strain was 2.6 percent at gauge RT-5. On average, a maximum strain of 2.3 percent was measured by Group 5 of lateral gauges, located near the fold on the Gulf side, and a minimum strain of 0.97 percent at Group 4. A gradual decrease in strain was observed toward the slope on the canal side, except for an inconsistent reading of Group 4. The 300 days readings of RT-4 and CT-4 were small (0.3 and 1.0 percent) in comparison with the reading of 1.6 percent at LT-4 (maximum difference of 1.5 percent) and the average readings of Groups 3 and 5 of 1.4 and 2.3 percent, respec-

tively. In addition, lower strains were observed at Group 2 of gauges, located at the toe of the existing embankment (bend in the fabric), than in Groups 1 and 3, located before and after the toe.

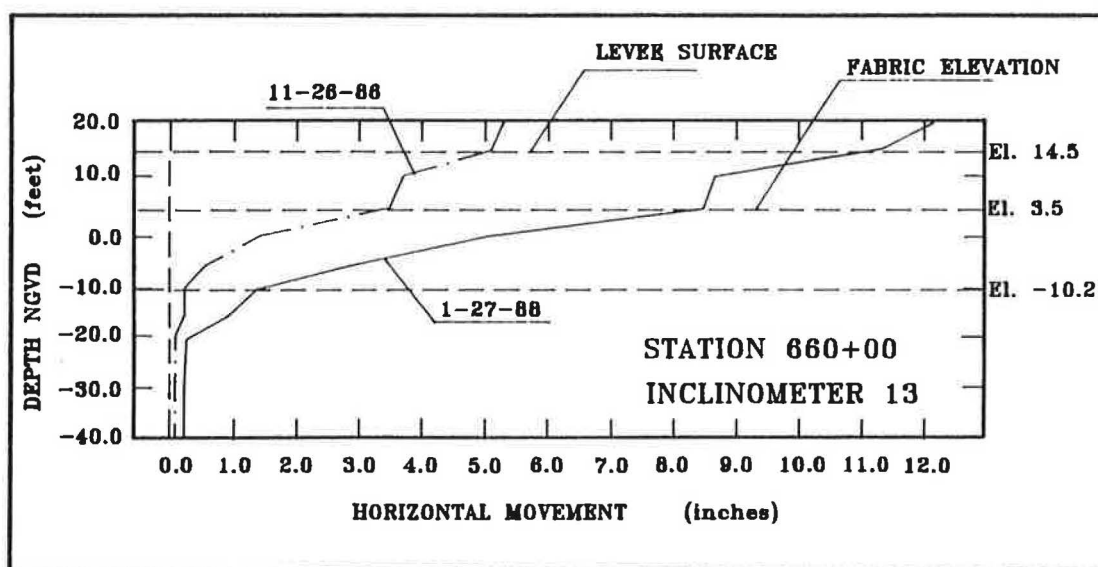
FIGURE 9 Horizontal movements below crown.

in all inclinometers with time, as shown in Figures 9 and 10. The horizontal movement measured by the inclinometers after 400 days is also shown in Table 5 at four selected elevations. Inclinometers 13 and 14, near the center of the embankment, experienced a horizontal movement toward the Gulf of 13 and 8.5 in. (330 and 216 mm), respectively. The average movement of 10.75 in. (273 mm) detected by these inclinometers is equivalent to 12.8 percent of the 7 ft (2.13 m) wide crown. The horizontal movement at the surface of the slope on the Gulf side was measured by inclinometers 15 and 16 as 14.3 and 10.5 in. (363 and 267 mm) toward the Gulf, respectively, for an average value of 12.4 in. (315 mm). This average reading represents 1.35 percent of the levee width of 76.4 ft (23.3 m) at that elevation (8.9 ft, 2.72 m). The horizontal movement at the fabric level was also toward the Gulf

and ranged from 6.8 in. (173 mm) at inclinometer 14 to 14.4 in. (366 mm) at inclinometer 15. The average horizontal movement of 10.6 in. (0.27 m) corresponds to a 1.26 percent lateral strain in the 70 ft (24.4 m) long fabric. This value is consistent with the average reading of all foil gauges of 1.4 percent.

A plane of relatively large horizontal movement and potential failure surface was detected along the interface between the top CH clay layer and the first ML silt layer at approximately elevation -11 ft (-3.4 m). No appreciable horizontal movement, more than 0.5 in. (12 mm), was measured in the subsoils below elevation -30 ft (-9.1 m) by inclinometers 13 and 14, or below elevation -60 ft (-18.2 m) by inclinometers 15 and 16. All inclinometers showed movements in the subsoils toward the Gulf except for inclinometer 14, which

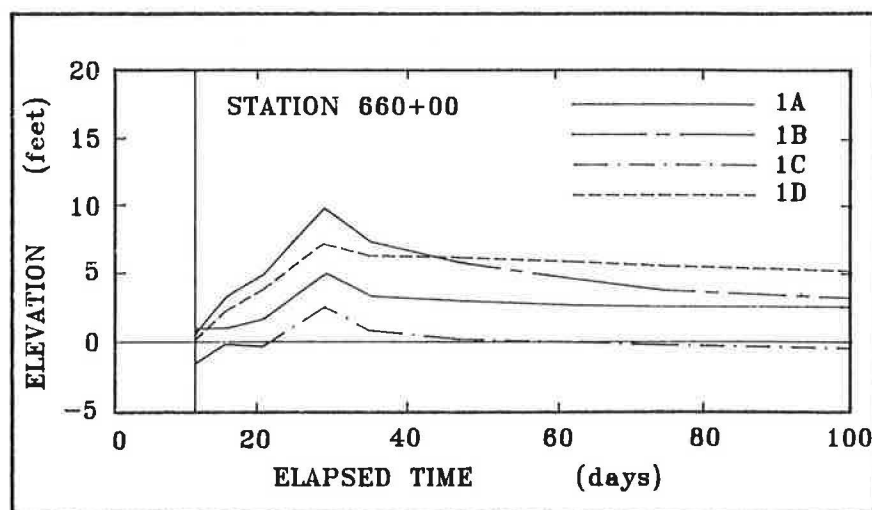
FIGURE 11 Pore pressures in subsoils.

The maximum average increases in the pore pressure at piezometers A, B, C, and D were 4.1, 9.03, 3.68, and 7.1 ft

(1.25, 2.75, 1.12, and 2.17 m), respectively. A reduction in the pore pressure of 28 percent occurred in the four days after reaching the design grade of the levee. This rapid reduction is indicative of the quick process of consolidation in these clays. The maximum average increase in pore pressure of 9.03 ft (2.77 m) is equivalent to about 64 percent of the added fill of 8.5 ft (2.9 m) between elevations 5 and 13.5 ft (1.53 to 4.11 m) when the last reading was taken during construction. It should be noted that removal of the top soil of the existing levee may have resulted in negative initial pressures, and no readings were taken just after completion, which allowed pore pressures to dissipate somewhat. The highest residual pressure of 5 ft (1.53 m) was measured by the deepest piezometers, D, located in the bottom thick clay layer of very low permeability and poor drainage conditions. On the other hand, the quick dissipation of the pressure in piezometers B and C is due to their location between relatively highly permeable lay-

ers of sand or silt. Piezometers A, by contrast, are located in the middle of the top CH layer, just below the clay levee, and accordingly measured much slower decays.

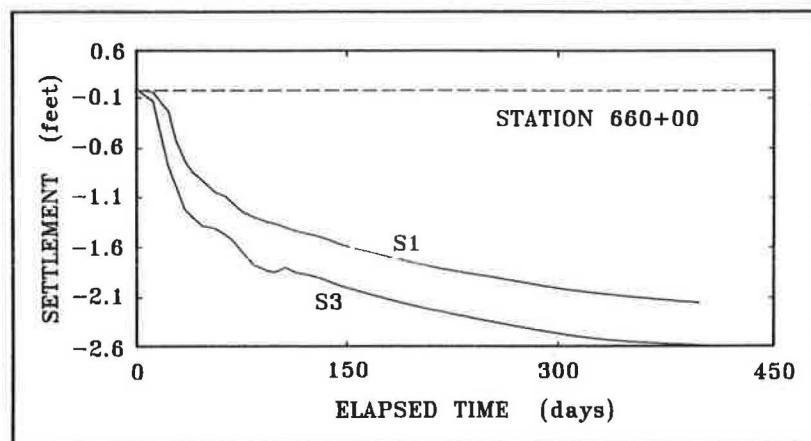
FIGURE 12 Measured settlement in the test section.

As expected, the pattern of settlement at the fabric level followed that of the pore pressures, with measurable increase in settlement recorded during the construction phase of lifts 2 through 8 (refer to Figures 2, 11, and 12). The rate of settlement decreased considerably after 150 days, and no measurable increase in the settlement was recorded after 300 days. The two settlement plates on the side slope, S-3 and S-4, showed identical readings, but an average difference of

about 2 in. (50 mm) was observed between the readings of plates S-1 and S-2, located below the crown. The difference may be attributed to the variation in the thickness of the clay layers at the two stations or their drainage conditions. The maximum average settlement was 2.56 ft (0.78 m) under the slope on the Gulf side and 2.04 ft (0.62 m) below the crown. The settlement at the crown and the slope of the levee is equivalent to a loss of 18 and 38 percent of the added height of fill above each settlement plate, respectively. The net loss due to settlement at the crown as a ratio of the total height of the levee is 14 percent.
