Fatigue Cracking in Welded Steel Bridges

JOHN W. FISHER AND CRAIG C. MENZEMER

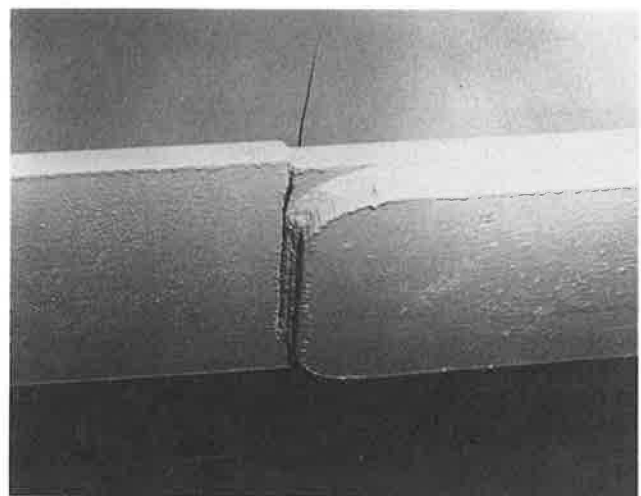
FIGURE 1 Fatigue crack at end of coverplate on Yellow Mill Pond bridge.

developed numerous fatigue cracks at the ends of cover plates (1). These cracks resulted from the high volume of truck traffic and the unanticipated low fatigue resistance of the large cover-plated beams (5).

Low-fatigue-strength details, such as cover-plated beams and welded web and flange gusset plates, should be avoided on new structures that will experience large numbers of stress cycles during their design life.

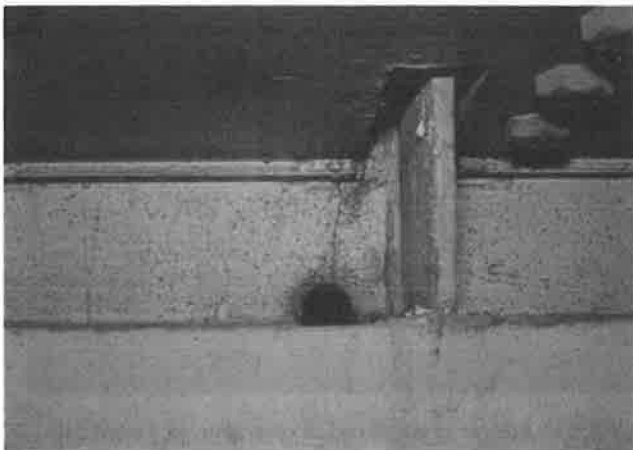
Another low-fatigue-strength detail is the welded web gusset plate shown in Figure 2. These plates are particularly susceptible to crack growth when adjacent, but not attached, to transverse stiffeners and connection plates. A detrimental combination of cyclic stresses results from the expected in-plane deformation of the main girder and from unexpected out-of-plane web gap stress. This latter stress develops from the lateral forces that cause the gusset plate to twist and deform the unstiffened segment of the web between the gusset and transverse stiffener or connection plate.

FIGURE 2 Fatigue crack at web gusset weld termination.

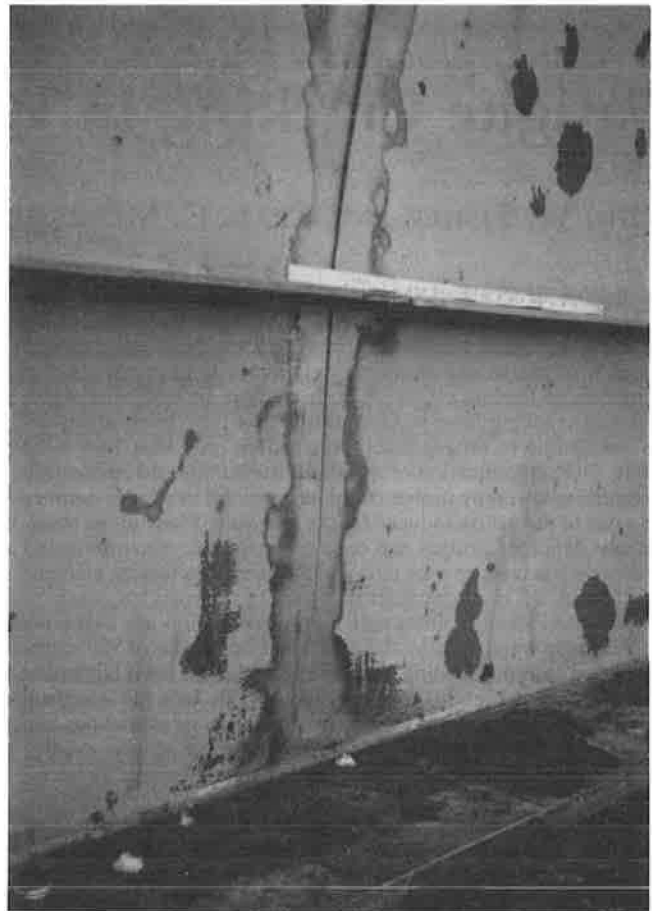
In November 1973, an inspection revealed a large crack in the south fascia girder of the suspended span of the I-91 bridge over the Quinnipiac River (6). The bridge was approximately 9 years old when the crack was discovered. Figure 3 shows that the crack had propagated to the middepth of the web and had extended into the bottom flange at the time it was discovered. Detailed examinations of the fracture surface conducted during the course of the investigation revealed that the fracture began at the unfused butt weld in the longitudinal stiffener splice.

FIGURE 3 Crack originating from groove weld in longitudinal stiffener.

a lateral gusset plate. Lack of fusion usually exists adjacent to the girder web in the transverse groove welds. When the detail is such that the transverse welds intersect the longitudinal welds, a continuous path is created for the crack to enter the girder web. Longitudinal stiffeners on beams or girders of new structures should be fabricated with fully fused welds whose quality is verified by nondestructive examination.

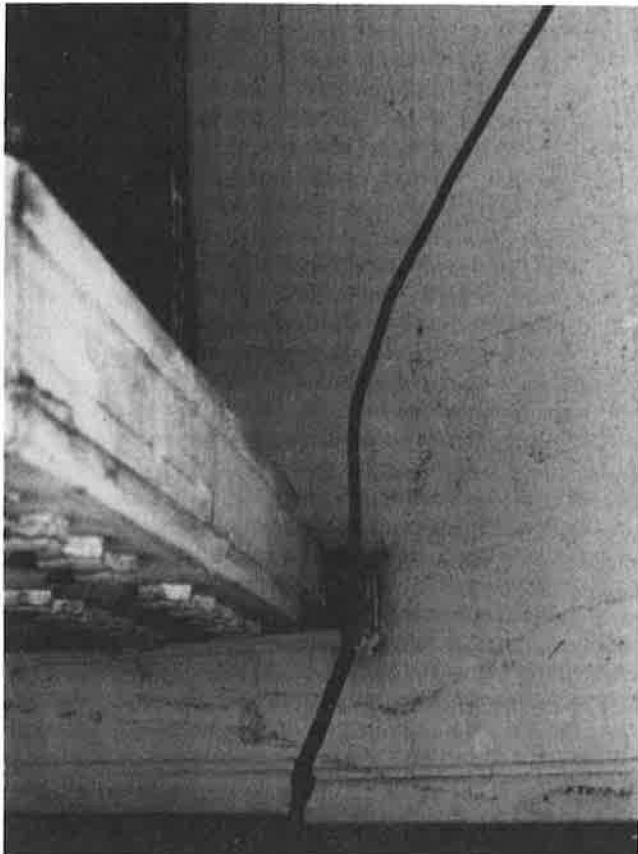
Intersecting welds should be retrofitted and the local area carefully inspected for cracks. A related lack-of-fusion type defect and cracking, which has been among the most severe encountered, occurred at details where a plate component was inserted through an opening cut into a girder web. The resulting detail was usually welded into place with either fillet or groove welds. In either case, large cracks in the girder web resulted at the edge of the flange plate where short vertical weld lengths contained large unfused areas. This feature was illustrated by a large crack in one of the steel box bents supporting the elevated track of Chicago's mass transit Dan Ryan line. Discovered in January 1978, subsequent inspection showed that box adjacent bents were also cracked (8). Initial field examination of the fractures indicated that all of the cracks started at the junction of the plate girder flange tip to the box side plate, as shown in Figure 4. All three cracks completely severed the bottom flange of the box girders and the webs.

FIGURE 4 Crack in box girder web at intersecting flange tip.

Extreme care must be exercised when flange, web, or diaphragm plates pass through the web of an intersecting member. Because it is nearly impossible to provide full fusion welds at the penetrating flange tips, installation of open holes are desirable at the ends of the slots to ensure adequate fatigue resistance. Figure 5 shows a retrofitted detail.

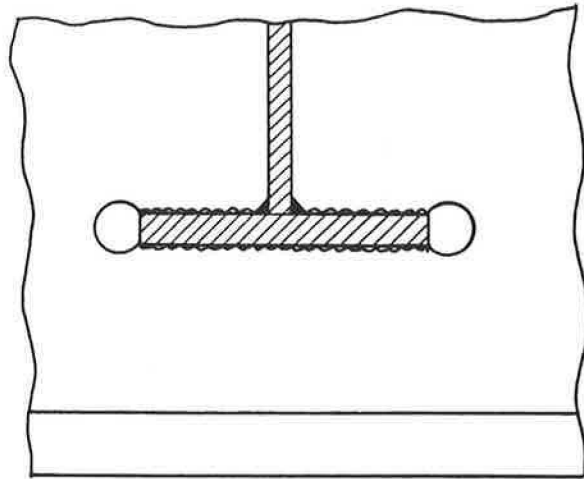
FIGURE 5 Flange plate passing through intersecting web with holes at flange tip.

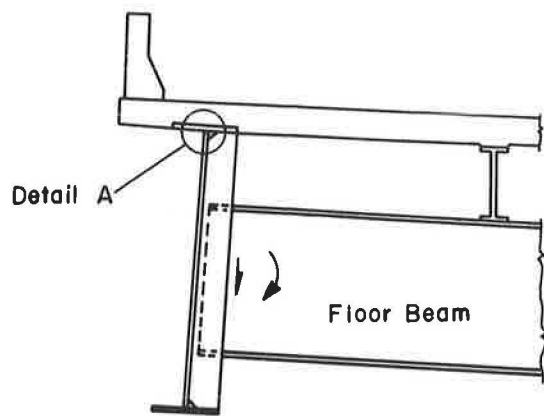
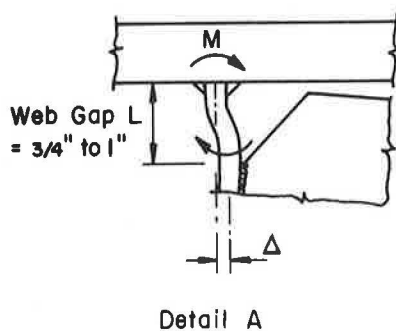
Conditions that favor the formation of web gap cracks have most often developed because of the desire to avoid welding transverse connection plates to the tension flange. Figure 6 shows a typical condition that exists in floor beam girder bridges. As the floor beam rotates under traffic loading, the segment of girder web is pulled out-of-plane, producing a large stress gradient in the web gap. Such large cyclic stresses will result in fatigue cracking in a relatively small number of load cycles.

FIGURE 6 Schematic of distortion in web gap at end of transverse connection plate.

Current AASHTO specifications require new designs to provide a positive attachment between transverse connection plates for diaphragms and X frames and both girder flanges (9). This attachment decreases the web gap distortion to acceptable levels, providing web gaps at the copes are at least 2 in. or four times the web plate thickness, whichever is larger. Structures without positive attachment will eventually have to be retrofitted by providing this corrective measure.

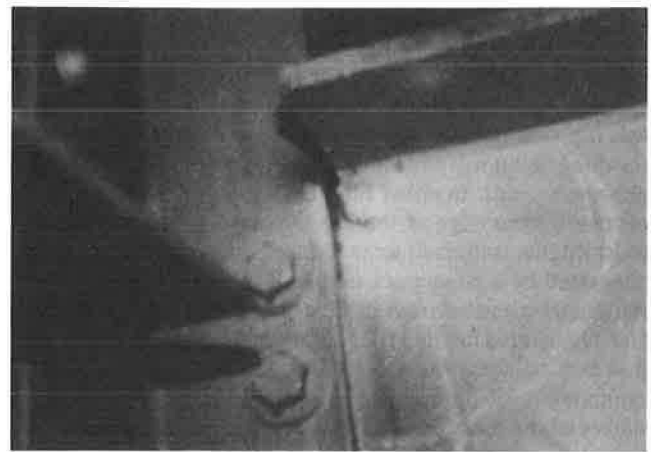
A similar condition results when the flanges of welded beams are terminated short of their end connections. This practice is typical in many floor beam girder bridges. Figure 7 shows a crack that developed at the end of a floor beam flange of the Woodrow Wilson bridge over the Potomac River. The fatigue crack at the cope of the floor beam resulted from a reduction of in-plane bending resistance, low-fatigue-strength detail created by termination of the flange plate welded to the web, and end restraint of the shear connection. Cracks can form at the top and bottom flanges because of the residual stresses at the flange-to-web weld termination and because of construction-induced stresses.

FIGURE 7 Fatigue crack in floorbeam web at end of welded flange.

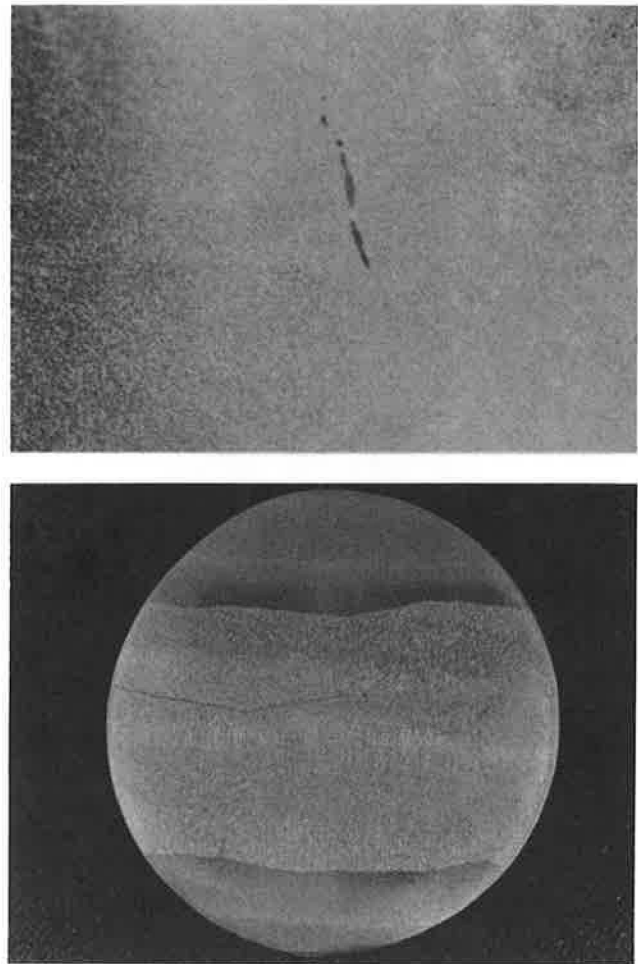
In a number of cases, much smaller cracks exist and removal of large pieces is not necessary. Core samples can be used to remove all or a major part of the crack. Figure 8 shows the polished surface of a core sample removed from a groove weld. The core was positioned near the end of the crack to see if fatigue crack growth had occurred. Figure 9 shows a core removed from a cover-plate termination where a partly through crack was found at a weld toe.

FIGURE 8 Crack in groove weld (*top*) and core sample removed from groove weld (*bottom*).

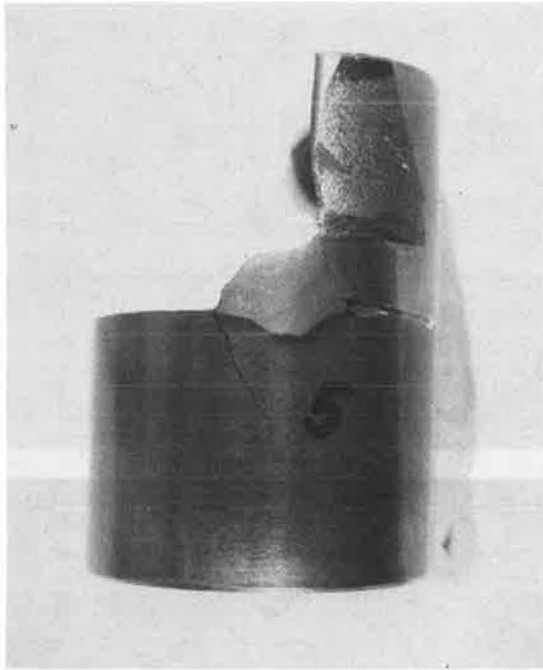
FIGURE 9 Core sample from end of coverplate showing crack at fillet weld toe.

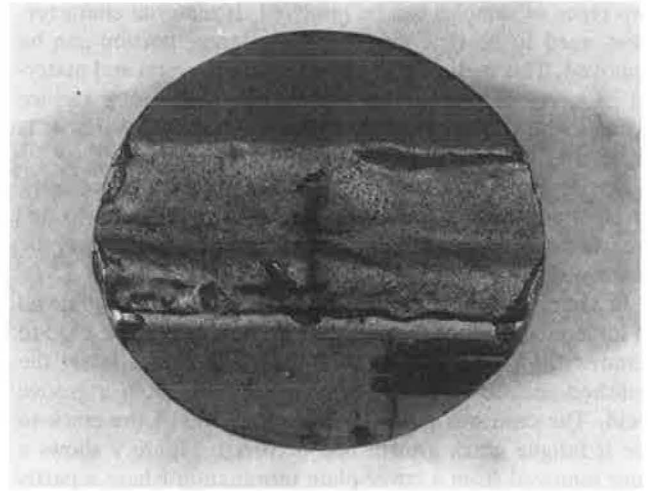
Careful attention to the saw cut surfaces, which can be polished and etched, can also reveal weld repair passes, method of fabrication, and other characteristics that may be important in assessing the fracture. Figure 10 shows a crack in a longitudinal box corner weld that has been removed with a hole saw. When the crack surface was exposed, the crack shown in Figure 11 was revealed.

FIGURE 10 Core containing crack from box corner weld.

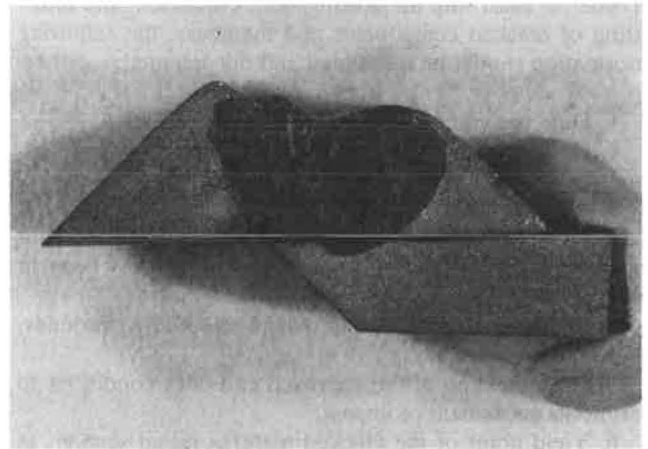
FIGURE 11 Exposed crack surface from box corner weld.

Where possible, a direct visual examination of the fracture surface is often beneficial in defining the cause of cracking. However, severe corrosion can destroy fatigue and fracture surface markings, as shown in Figure 11. Adequate photographic documentation should be obtained before cutting the surface into segments or cleaning off corrosion.

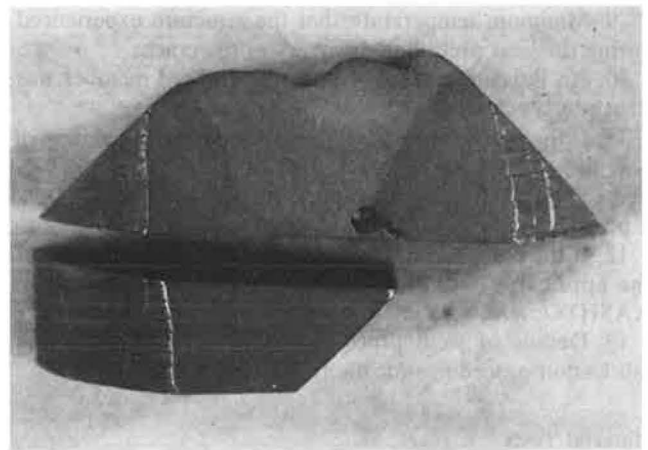
When crack surfaces are exposed, polishing and etching a saw-cut plane parallel to the crack surface will generally be desirable. This plane should be relatively close to the crack surface, normally within $\frac{1}{2}$ to 1 in. Weld repairs, secondary cracking, and other features may be observed. Figure 12 shows the polished and etched surface of a plane parallel to the crack surface shown in Figure 11.

FIGURE 12 Polished and etched plate behind crack surface.
