Effectiveness of Various Schemes in Controlling the Behavior of Continuous Welded Rail

MAX A. FERGUSON

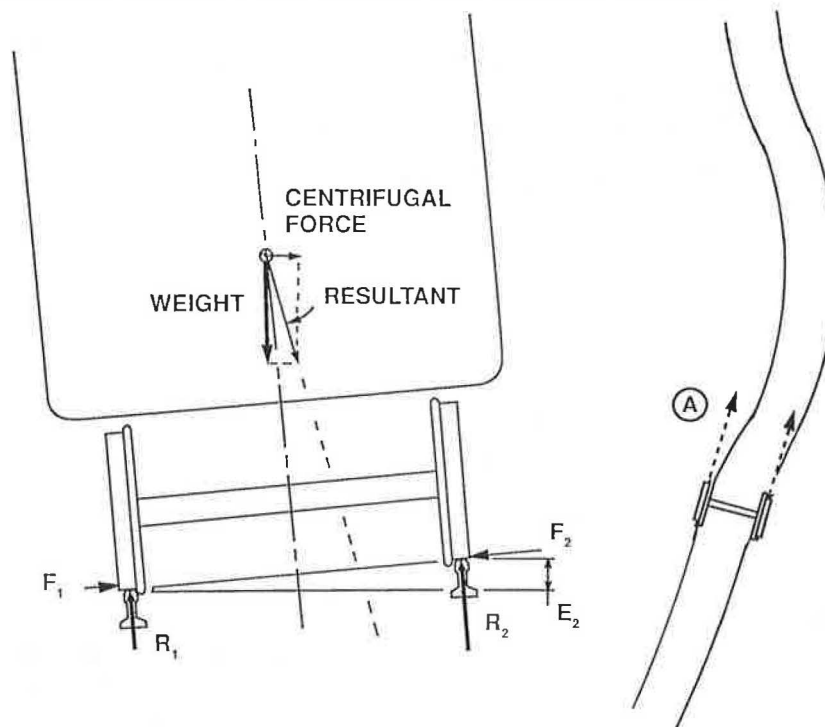
FIGURE 1 Rail vehicle negotiating a buckling in an unstable equilibrium.

For example, one pattern noted in several derailments on curves, in which other evidence substantiated buckled track, was that loaded cars traveling in an unstable equilibrium on strong CWR track derailed to the low side, or where the wheel or wheels cross over the inner rail of a curve. Often one car derails, one or more negotiate the buckling, another derails, and so forth. In a curve the track buckles to the outside of the curve, but in the example just given the wheels derail in the short reverse curve preceding and made by the buckled-out portion of track (see Point A, Figure 1). The inside rail of the original curve becomes the outside rail of that small reverse curve. With a loaded car in an unstable equilibrium, the weight on the wheels on the inner rail of the curve is significantly lower than that on the outside rail (see Figure 1). About the only other situation causing a car to derail to the inside of a curve involves a train experiencing excessive draft forces resulting in a stringlining effect. Empty cars may derail because their wheels cross over either rail. On track with a weak tie condition, the wheels of loaded cars may turn either rail outward far enough to cause the cars to drop inside the track gage, or they may spread the track and all following cars will probably derail.

Condition: CURVING AT UNBALANCED (CANT DEFICIENT) SPEED

Response: VEHICLE LEANS TO RIGHT AND TENDS TO UNLOAD INNER RAIL
