# Corrosion and Its Influence on Strength of Steel Bridge Members

JOHN W. FISHER, BEN T. YEN, AND DAYI WANG

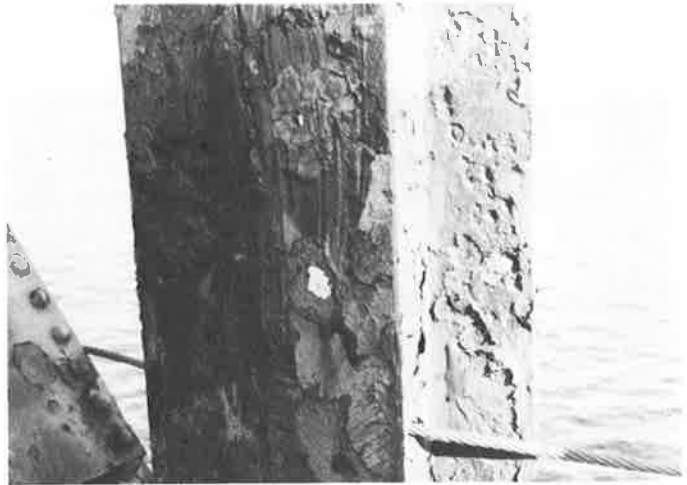
Extensive corrosion damage is often observed in girders, floor beams, and stringers of steel girder bridges and in the truss members and their floor system of truss bridges. The loss of material often results in complete corrosive penetration of the plates or rolled components. Figures 1 to 3 show examples of complete penetration of a built-up hanger, batten plate on a chord and the web of a girder. Significant reductions in cross-section areas are possible as a result of active corrosion cell activity<sup>(1)</sup>.

Figure 1 Corrosion Penetration of Riveted Hanger Components

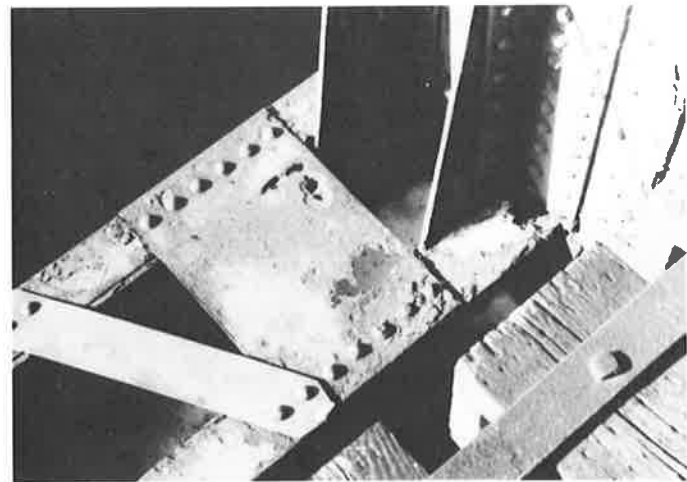
Figure 2 Local Corrosion Penetration of Batten Plate and Chord Components

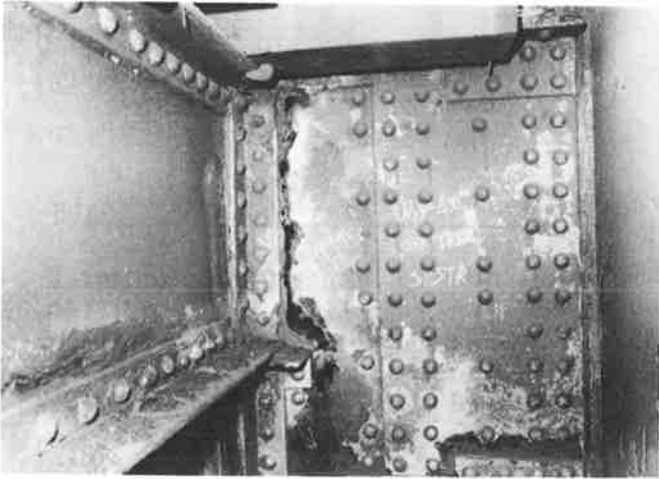
Crevice or pockets exist at the edge of the angles used to connect end connections and flange angles to the girder web. Crevices have a tendency to corrode at a far faster rate than the adjacent flat metal areas. Figure 7 shows a schematic of the corrosion battery that tends to develop at the crevice between the angle and web interface. The essential elements of the corrosion process of oxygen, water and ions must be present. Crevices generally trap dirt, salt and rust, and with water, promote galvanic corrosion with the anode provided by the web at the crevice and with the cathode of the steel adjacent to the crevice. The steel in the crevice is an oxygen starved area, acts as the anode, and becomes corroded. Both the web plate adjacent to the connection and crevices in the connection are anodes. However, the corrosive attack is greatest where the anodic and cathodic regions meet as

shown in Figure 3. When the angles are more flexible, the corrosion cell can extend into the joint.

Figure 3 Corroded Web Penetration Along Vertical Angle Legs of Stringer End Connection to Floor Beam

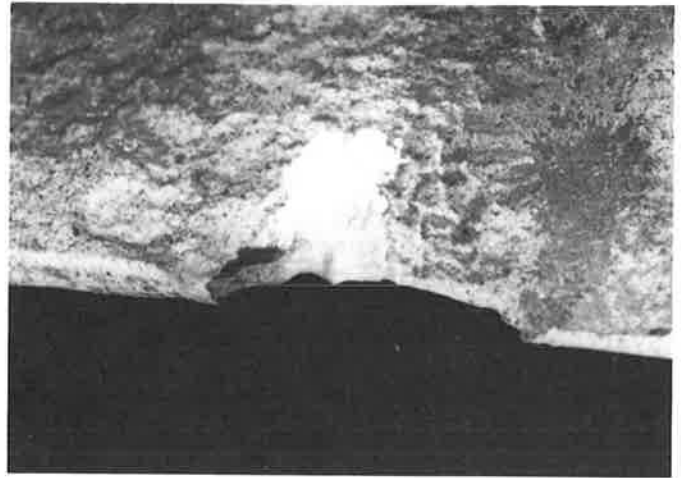
Severe notches in the flanges can develop, particularly where dirt and debris accumulate and create an active corrosion cell. This type notching will occur in all steel materials. Figures 4 and 5 show corrosion notched flange angles of riveted girder members. In Figure 4, dirt and debris accumulated under a diaphragm, and this provided an active corrosion cell site.

The most severely corroded angle evaluated in Reference 4 is shown in Figure 5. The angle leg was about 40% corroded away. After cracking developed at the corroded section, this detail was retrofitted by drilling a hole at the crack tip and splicing the section. The crack had propagated to near the mid-depth of the web at the time of retrofit, as can be seen in Figure 11.

Figure 5 Severe Corrosion Notching of Flange Tip

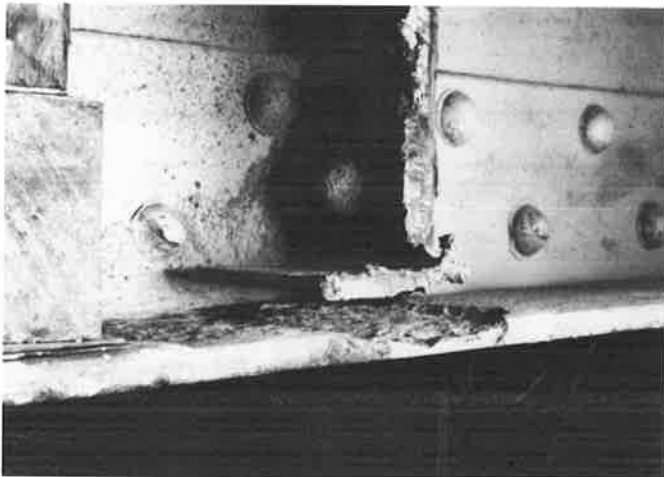
Figure 4 Corrosion Notched Flange Angle Below Diaphragm Where Dirt and Debris Accumulates

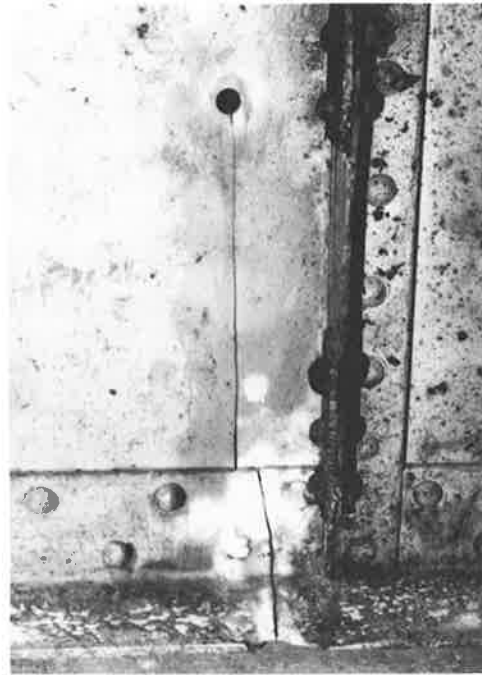
Figure 11 shows the cracks that developed in the heavily corroded flange angle and web plate of the built-up section from a bridge member. It can be seen that the flange angle crack was not influenced by the rivet holes.

Figure 11 Cracked Components in Corrosion Notched Member

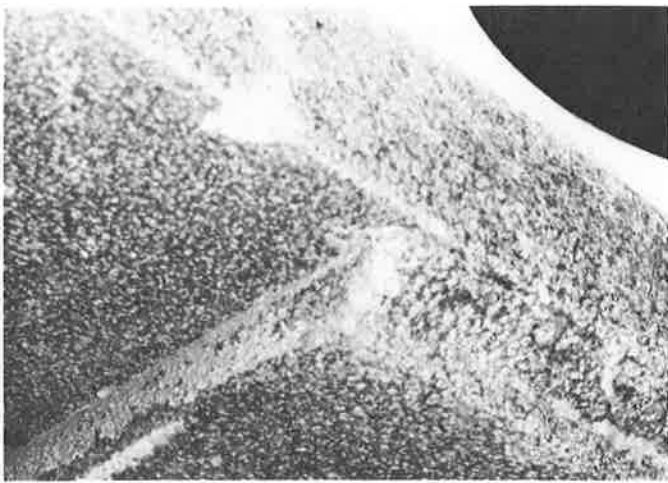
Pitting corrosion results in an extremely localized electrochemical process that produces local holes. It occurs when a small area of the metal surface becomes anodic to the rest of the surface. An anode will often form at a point where oxide film or paint coating breaks occur, so that the external electrolyte comes in contact with a small area relative to the larger surrounding cathodic area. Mill-scale is a form of iron oxide created during the steel rolling process. It is a hard brittle film that adheres to the steel surface, is fragile, and is subject to cracking and spalling. Mill-scale is also cathodic with respect to the steel surface and can accelerate galvanic corrosion. The failure resulting from painting over mill-scale is shown schematically in Figure 8. When the coating is applied over mill-scale, small bare steel areas may exist. After cracking of the coating occurs, a corrosion battery will be set up and the small bare areas will be subject to attack from the large cathodic areas. As the pitting and rust and dirt build up, it will result in peeling, blistering and rupturing, as was illustrated in Figures 1 and 3. The oxygen concentration cell under the surface deposit and coating creates an accelerated galvanic corrosion reaction. When dirt and debris are not present, pitting can develop at the surface, as illustrated in Figure 9.

Figure 9 Corrosion Pitting of Beam Flange and Welded Coverplate

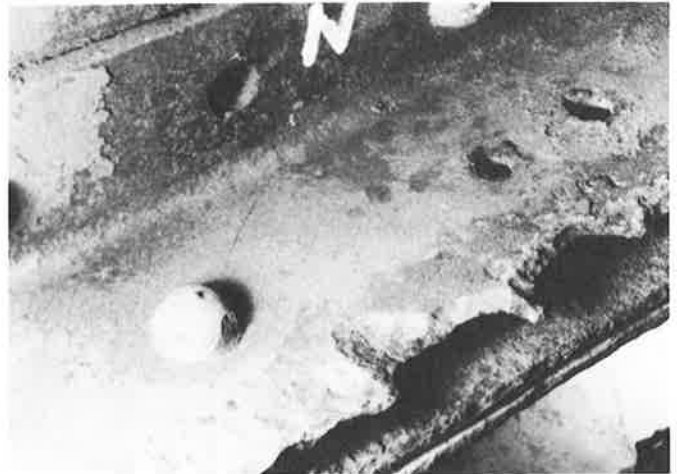
The corrosion notches shown in Figures 4, 5 and 12, resulted in fatigue cracking, as illustrated in Figures 11 and 13. The fatigue resistance of corrosion notched riveted sections has been examined with full scale tests on riveted members with regions of corrosion reduced flange angle thickness, as was illustrated in Figures 4, 5 and 12<sup>(4,5)</sup>. In Reference 4, five members with corroded sections failed at a corrosion-reduced section. In Reference 5, three members with corroded sections resulted in fatigue cracking. These test results are summarized in Figure 14. All of the cracks initiated in corrosion notched flange angles of the eight test girders. The degrees of reduction in the flange angle cross-section, however, were quite different and varied from 5 to 40% of the angle leg area. The angle leg thickness reduction was the principal influence on the fatigue strength of the detail. In three cases there was also a reduced width. These effects resulted in significant stress concentration at the corroded section. The stress elevations resulted from the notches on the rough irregular surface. No convenient measure of quantifying this was found. Figure 4 shows the reduced section of beam 1 which lost about 60% of its thickness. Cracking was observed to initiate at multiple sites in the region near the edge of the angle, where the thickness was minimal. No cracking was observed in the corroded region of members when the maximum thick-

Figure 12 Extensive Corrosion Loss of Tension Flange

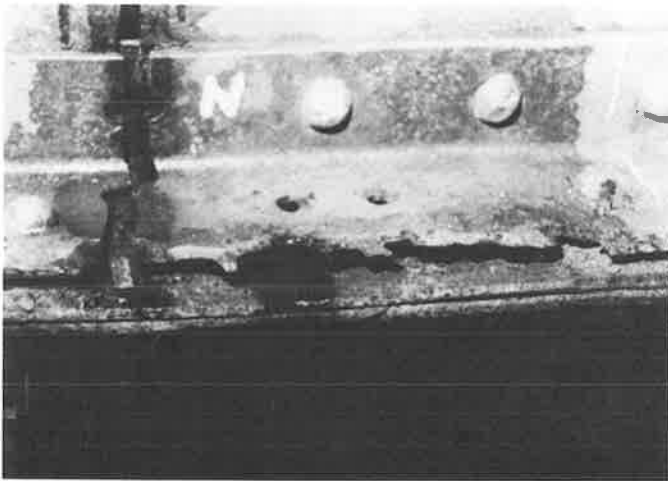
The mechanism of crack formation in the corroded area proceeded as follows. First, several small cracks formed in the rough surface at the deeper notches close to the flange tip. These cracks coalesced and formed a long, shallow surface crack. This surface crack then propagated through the flange thickness at the tip and became an edge crack. Small cracks continued to form in the corroded surface and coalesced with the edge crack. The crack length measured at the bottom surface of the angle leg always lagged behind the length at the corroded top surface.

Figure 13 Fatigue Crack Initiated From Corroded Flange Angle

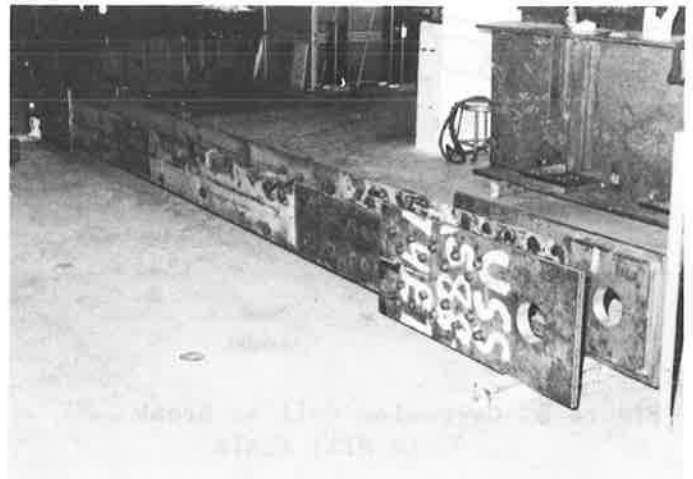
The test specimens were 20 ft. (6.10 m) long, cut from the lower end of the 30 ft. - 8 in. (9.35 m) long hangers. End plates were bolted to the flanges for anchorage and load application. Figure 16 is a photograph of the pin-connections at the ends of the hanger. Thus, the hangers were subjected to axial loads only, without end moments.

Figure 16 Corroded Hanger Specimen with Bolted End Fixtures

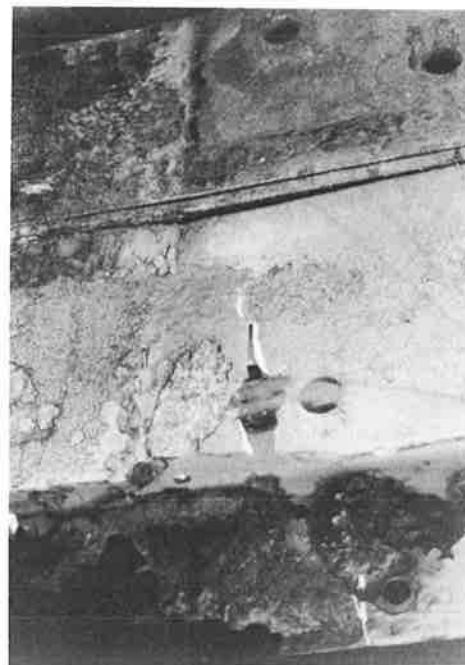
Six strain gages were mounted on each specimen near midheight: one gage on each of the angles and two on the web. Also attached to each specimen were four LVDT's for the measurement of overall elongation and elongation of the corroded portion. Both specimens failed by excessive elongation and local cracking of the angles at the corroded region. Figure 17 shows the load-elongation plots from the LVDT data. The overall elongation at maximum load was about 1.75 in. (44.5 mm). At termination of the test, the deformation was about 2 in. (50.8 mm) for the 16 ft. (4.9 m) measurement length of the specimens. Figures 18 and 19 are examples of the cracked flange angles of specimens No. 1 and 2. Testing was continued until the applied load dropped substantially below the maximum load. The maximum applied loads,  $P_{max}$ , are listed in Table 1, together with the computed reference forces and the section properties.

Figure 18 Crack in Flange of Hanger No. 1

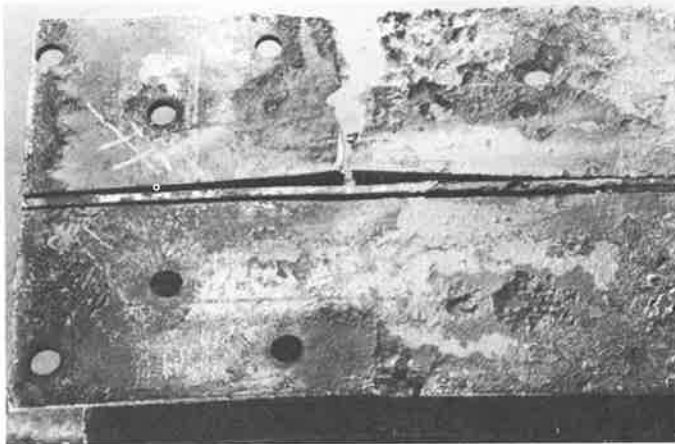
Figure 19 Crack in Flange of Hanger No. 2
