Field Observation of Steel Pier Caps

DALE E. POORMAN

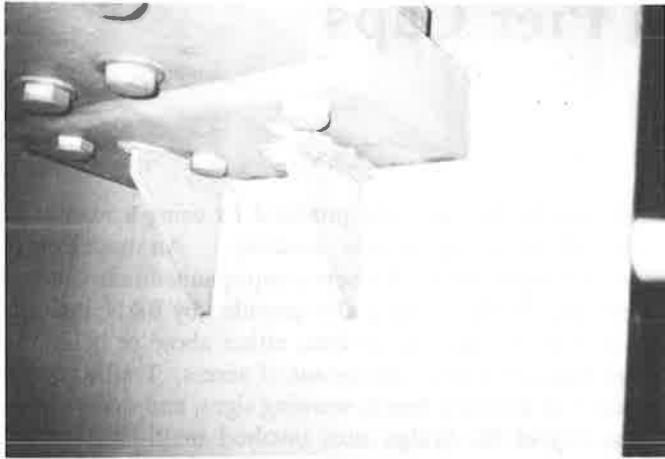
Figure 2. Cap Web Seal Weld Around Girder Lower Flange.

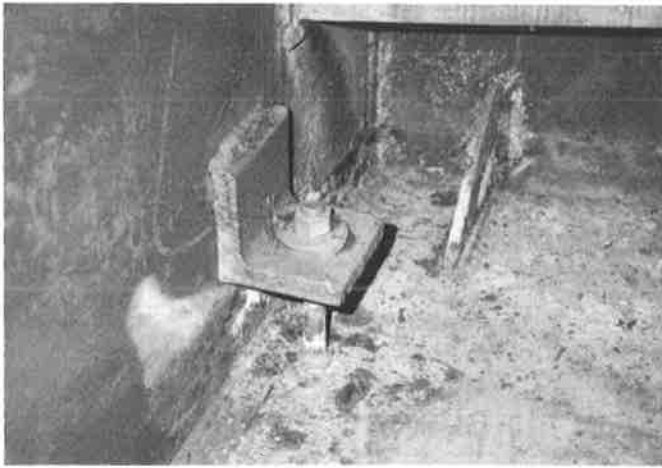
Figure 8. Angle and Bolt Welded to Inside of Box Cap Member

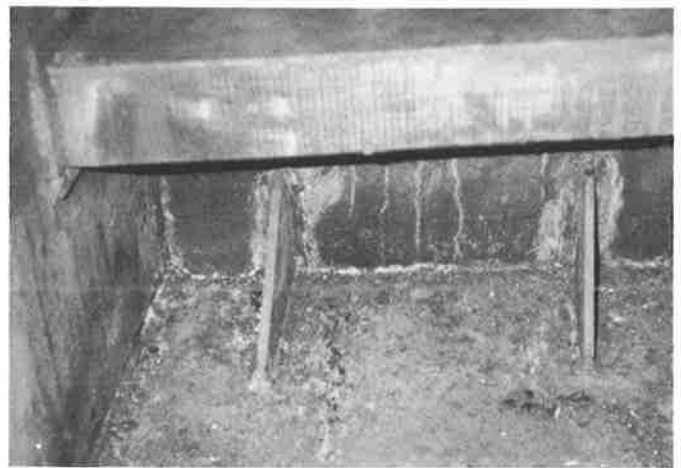
Figure 9. Diaphragm Stiffener Inside Box Cap Member is Welded to the Cap Lower Flange

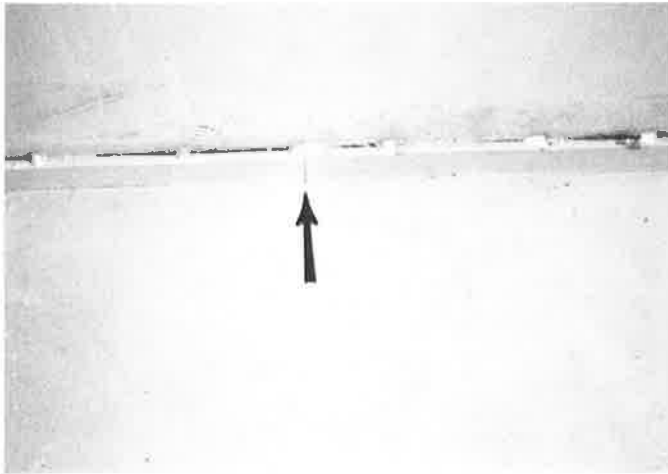
Figure 10. Backing Bars Inside Box Cap Member is Tack Welded to Cap Web and not Welded Together at Splice

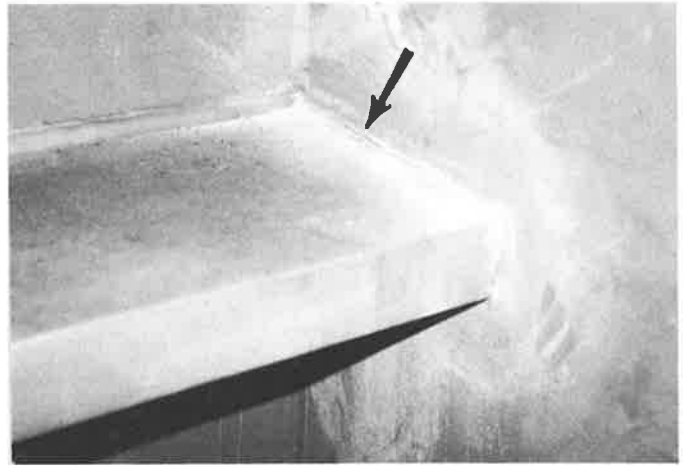
Figure 12. Crack in Seal Weld on Inside Face of Web of Box Cap Member

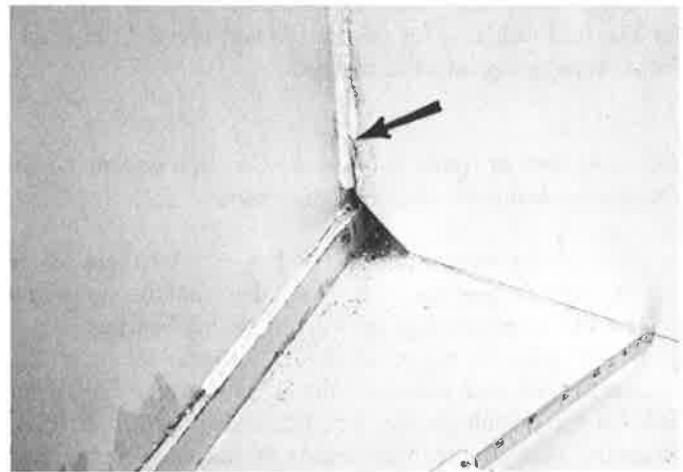
Figure 13. Crack in Vertical Weld Between Cap Web and Diaphragm Inside Box Cap Member

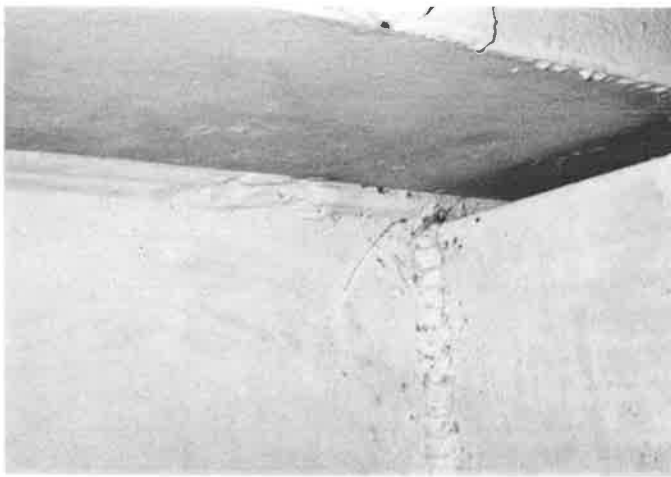
Figure 14. Crack Through Web of Girder "T" Type Pier Web Connection of the Center Beam.

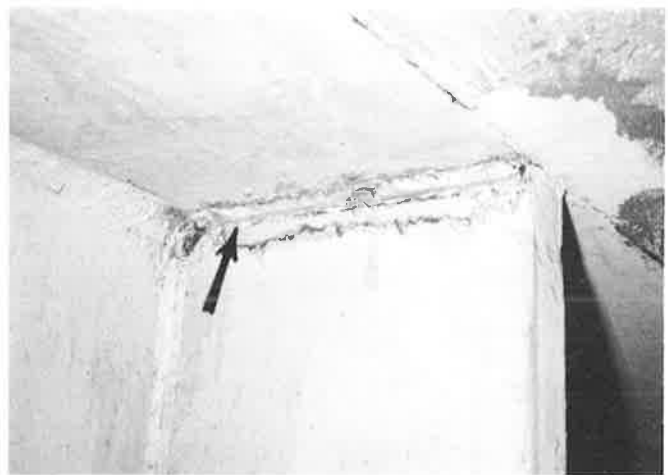
Figure 15. Crack in Weld Between Vertical Stiffener and Cap Upper Flange of Girder "T" Type Pier.

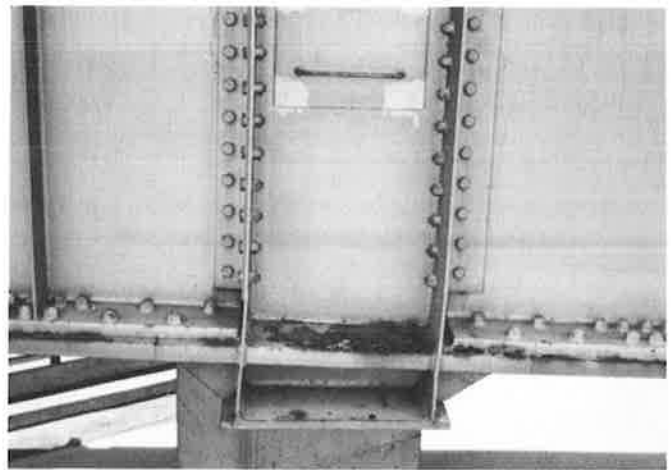
Figure 16. Cap Webs Bent at Cantilevered End of Box Cap Member

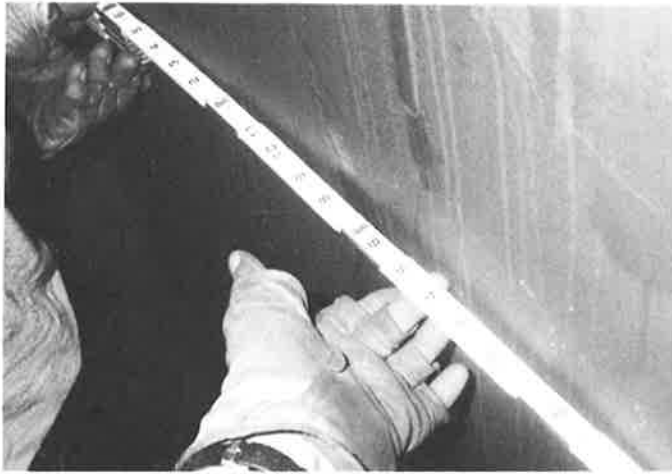
Figure 17. Cap Web Bowed at Web Splice Weld

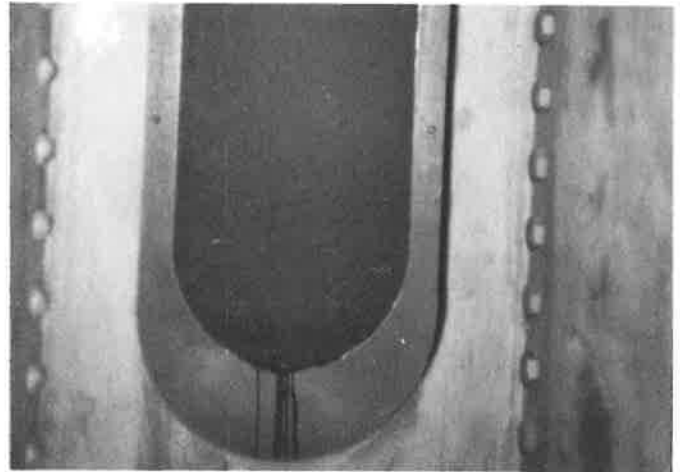
Figure 18. Access Hatch Gasket Inside Box Cap Member Beginning to Deteriorate

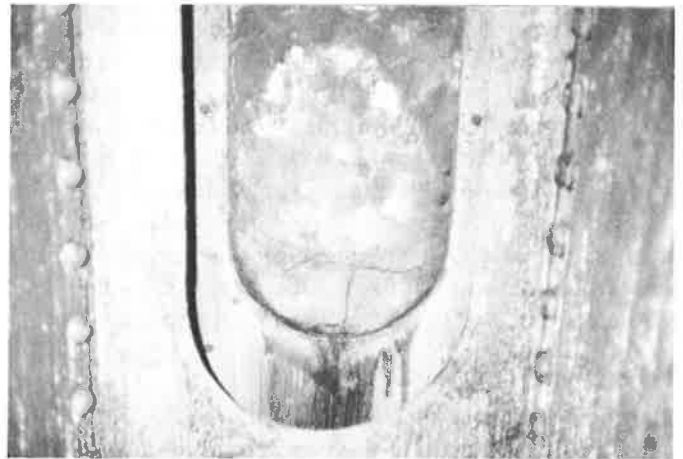
Figure 19. Access Hatch Gasket Inside Box Cap Member in Advanced Deterioration Stage

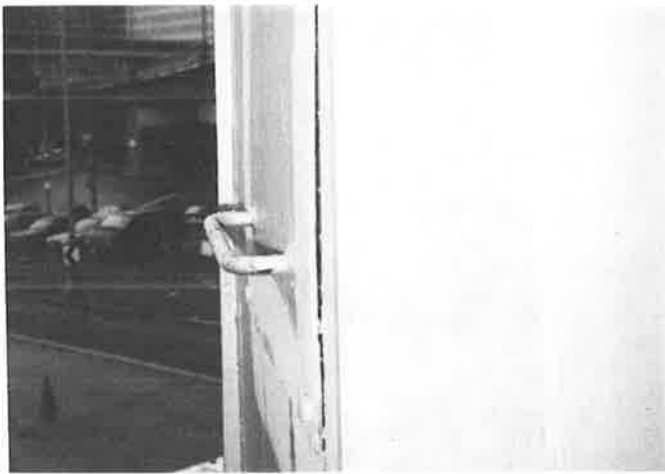
Figure 20. Access Hatch Cover Bowing Due to Corrosion

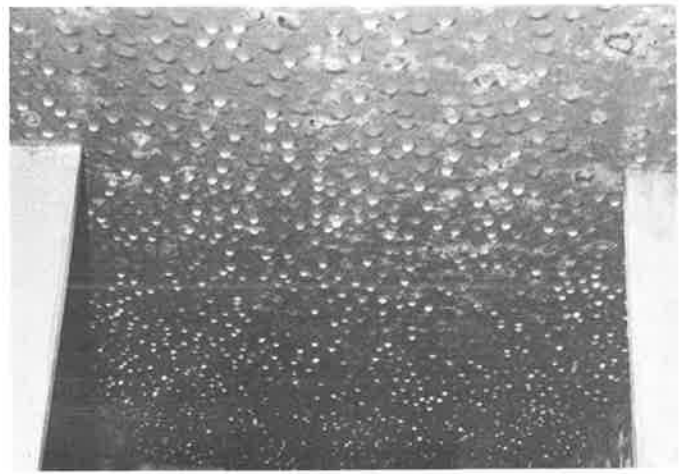
Figure 21. Condensation on Inside of Box Cap Member

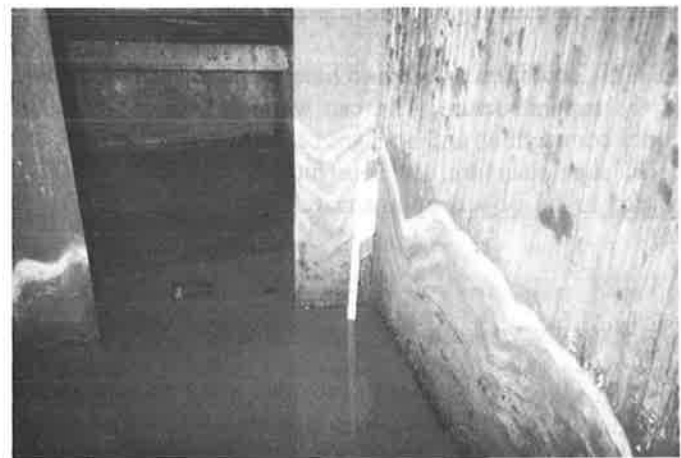
Figure 22. Water Accumulated Inside Box Cap Member Due to Leakage of Access Hatch Cover.

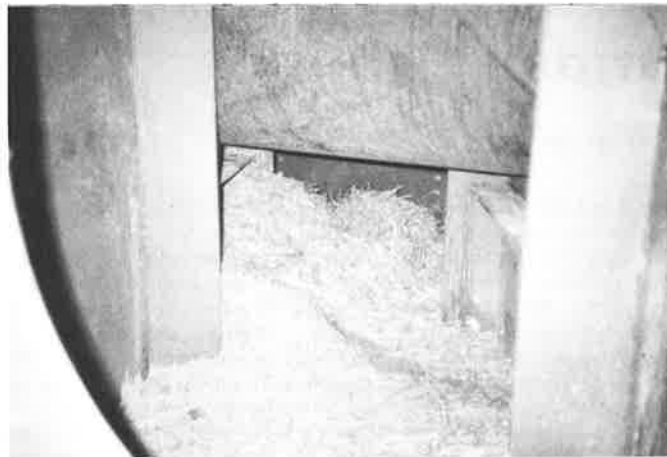
Figure 24. Nesting Material Inside Box Cap Member
