# Associations of Distress and Diagnosis of Bitumen-Surfaced Road Pavements

JOSÉ CARLOS DE O. S. HORTA

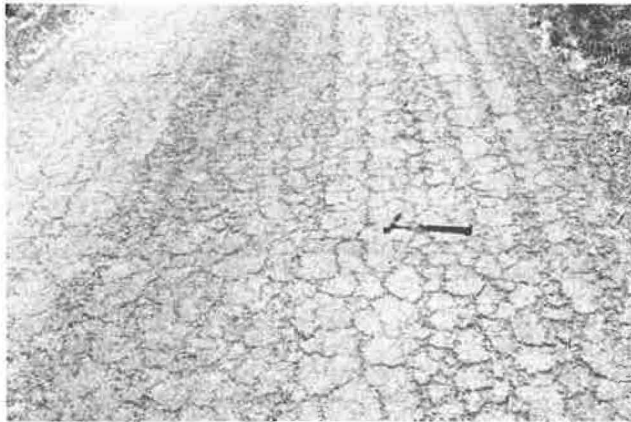
The association of alligator cracking, disintegration, and loss of aggregates and binder from an undistorted pavement surface is typical of bitumen aging and announces the end of the useful life of the bituminous wearing course (Figure 1). If resealing is not provided in due time, the pavement distress will quickly develop into functional failure by potholing and may require costly rehabilitation works such as recycling, overlaying, or reconstruction.

FIGURE 1 Alligator cracking and raveling without distortion indicating bitumen aging.

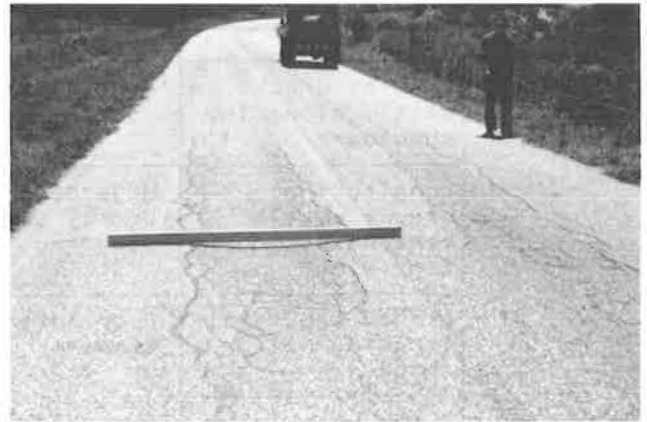
The association of wide ruts and alligator cracking (Figure 3) is the typical distress pattern of fatigue of granular pavements.

FIGURE 3 Wide ruts and alligator cracking indicating fatigue of a granular pavement.

Low-volume roads may usually exhibit this type of structural distress where the traffic includes heavy loads. Pavements exhibiting wide ruts and alligator cracking should be reconstructed or strengthened by overlaying or by recycling with particular attention to drainage. In the Malagasy rural

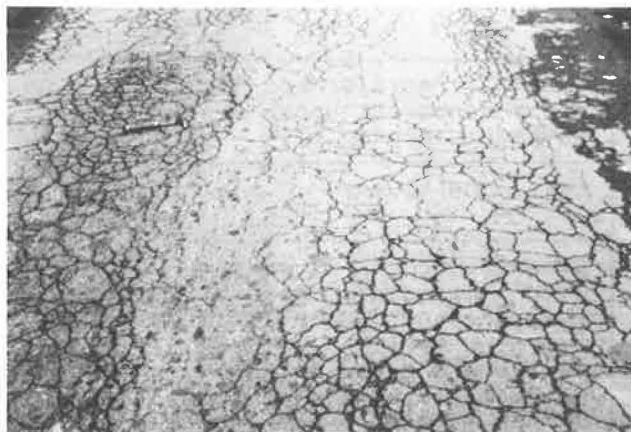
The association of alligator cracking with local surface depressions (bird bath) points to localized low bearing capacity of granular pavement structures (Figure 2).

FIGURE 2 Alligator cracking of a depressed area indicating low bearing capacity of pavement structure.

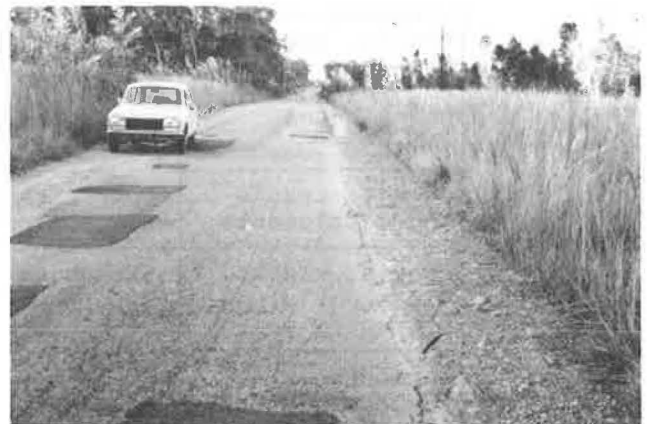
Sometimes wide ruts result from consolidation of open graded or soft pavement materials such as telford and macadam of lateritic boulders (Figure 4). In this case, a leveling course will restore driving comfort.

FIGURE 4 Wide ruts resulting from traffic consolidation of a lateritic boulder pavement on a lateritic plateau (National Road 4, Tampoketsa Plateau, Madagascar).

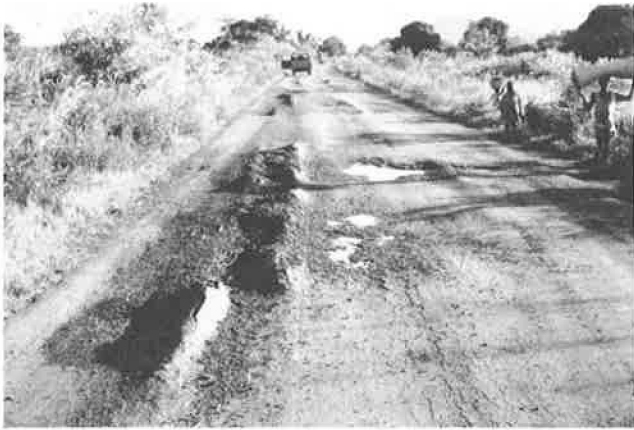
Narrow ruts indicate strain in the upper pavement layers, whereas adjacent heaving points to shearing. Hence, for pavements with adequate thickness this pattern of distress is symptomatic of low-grade materials in the base or wearing course. If the wearing course is thin, as in Madagascar, where hot-mixes usually have thicknesses of 1 in. or slightly more, the cause lies in the base course. Laboratory testing of the base material will provide diagnostic information such as inadequate grading (lack of gravel fraction or excess of sand fraction), high plasticity of fines, or in-service weathering of basaltic natural gravels (Figure 5).

**FIGURE 5** Narrow ruts and longitudinal heaving resulting from weathering of a basaltic natural gravel (National Road 5B, near Sambava, Madagascar).

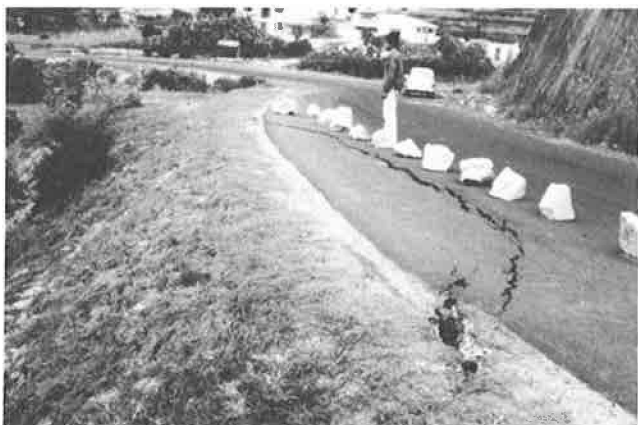
Branching, multiple parallel cracks or single cracks are actually the intersection of a slide surface with the pavement surface. In some cases, the cracks cross the pavement at variable angles and the difference in height of the crack edges exceed a few decimeters: the settlement and the cracks result from a landslide of the natural slope where the road is located. Transverse cracks and smaller settlements may result from slides of the transition surface between cuts and embankments where well-known construction codes were ignored. But slides and instability in embankment slopes causing longitudinal curved cracks with both ends on one side of the pavement (Figure 6) are most widespread.

**FIGURE 6** Longitudinal curved crack and settlement resulting from embankment slope slide, National Road 7, in the vicinity of Ambatolampy, Madagascar.

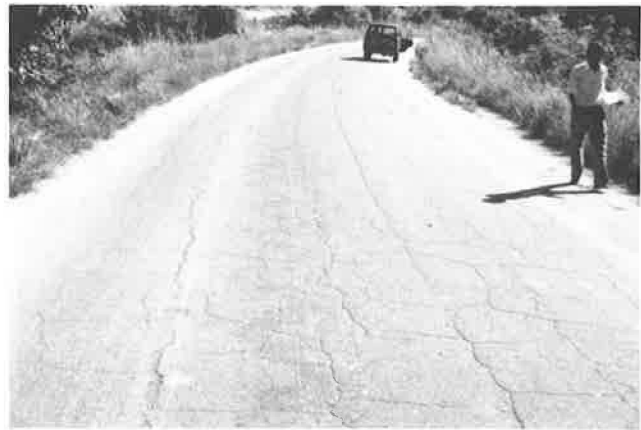
The pattern formed by regularly spaced transverse and longitudinal cracks is known as block cracking (Figure 7).

**FIGURE 7** Block cracking of a soil-cement base: Kilometer 89, National Road 6, Madagascar.

Shrinkage block cracking of stiff bases reflects to the wearing course. It is not associated with distortion and only requires crack sealing.

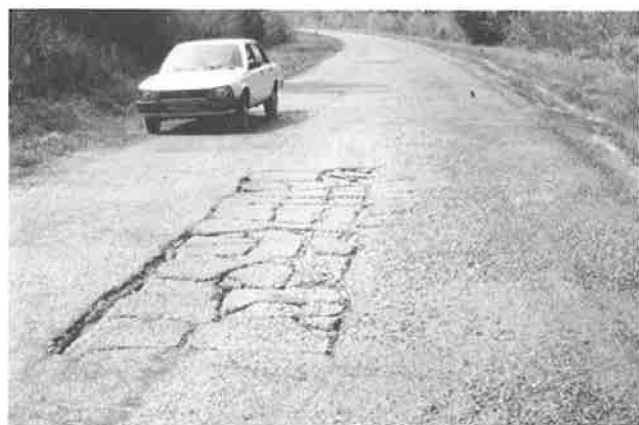
Block cracking resulting from failure of stiff pavement materials under loading has shorter transverse than longitudinal spacing. It may be associated with rutting. It develops along wheel paths and will require pavement strengthening (Figures 8 and 9).

**FIGURE 8** Block cracking resulting from tensile failure of a soil-cement pavement: Masiaka Road, Sierra Leone, 1982, before rehabilitation.

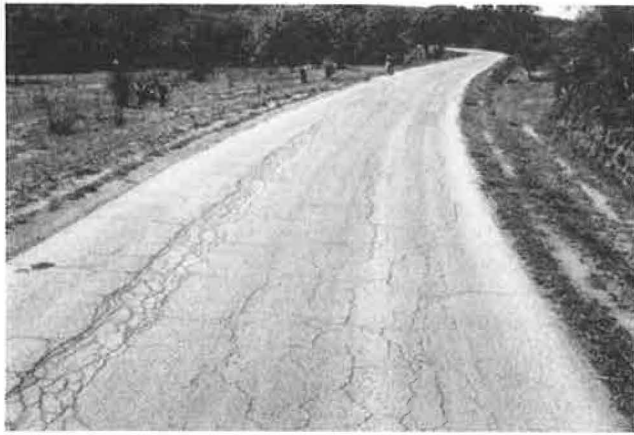
**FIGURE 9** Two different families of block cracking, Kilometer 0+200, National Road 32, Madagascar: widely spaced shrinkage cracks, and narrow tensile failure block cracks associated with ruts.

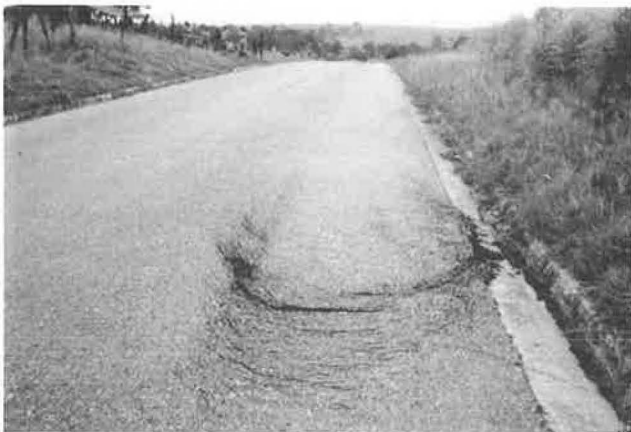
Peeling of the wearing course occurs following tangential shearing by traffic. It is often associated with crescent-shaped cracks pointing in the direction of traffic flow (Figure 10).

but in some cases the level of the shear surface is underneath the prime coat and results from construction defects such as low cement content of soil-cement bases or compaction of thin layers of base material for leveling purposes without previous scarification.

**FIGURE 10** Peeling and crescent-shaped cracks, National Road 1, Zaire: the tack coat binding the soil-cement base to the wearing course was sheared by driving up heavy vehicles.

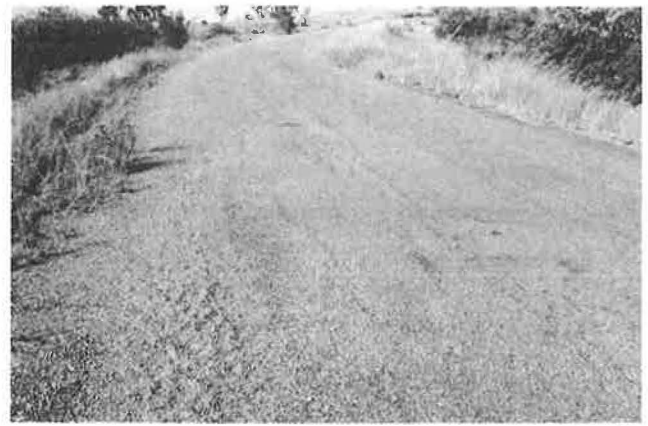
Traffic compaction of poorly compacted embankments results in longitudinal cracks and settlements with development of a concave cross section (Figure 11).

**FIGURE 11** Longitudinal cracks and settlements of a poorly compacted embankment between Malaimbandy and Miandrivazo, National Road 35, Madagascar.

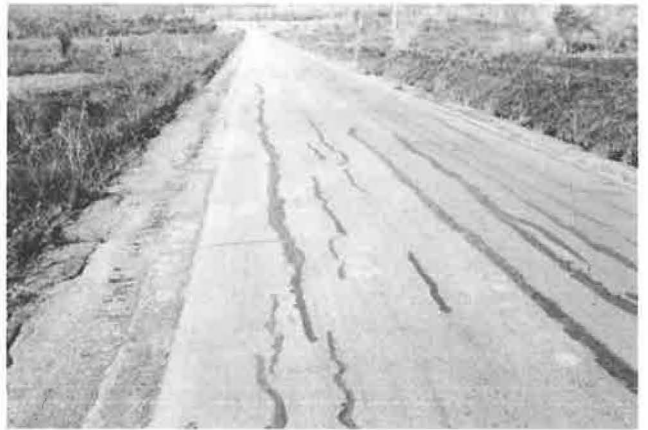
gressing to the axis. Transverse cracks do not develop (Figures 12 and 13).

**FIGURE 12** Longitudinal cracks developed during the first dry season in sections of National Road 3, Kilometer 73, Benin, where the embankment had been constructed with expansive clays (lama depression). The cracks were carefully sealed but reopened during the next dry season.

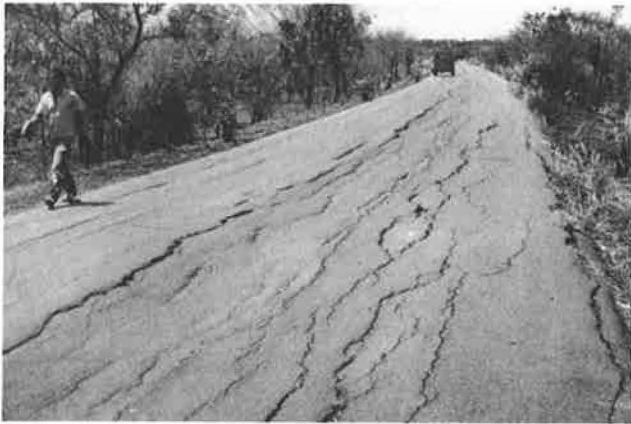
**FIGURE 13** Well-developed distress pattern typical of expansive subgrade soils; longitudinal cracks and differential settlements (National Road 6, Kilometer 225, Madagascar).

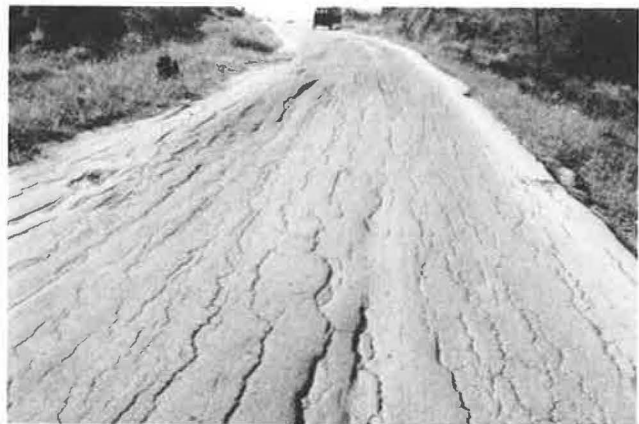
Differential swelling along the road results in longitudinal undulations (Figure 16). Transverse settlements are typically found above culverts.

**FIGURE 16** Longitudinal cracks, settlements, and undulations typical of expansive subgrade soils (National Road 6, between Mampikony and Port Bergé, Madagascar); the car is parked on a stable subgrade section.

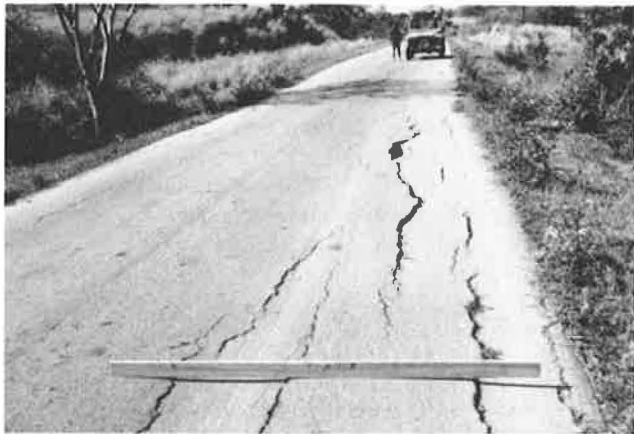
Rainfall during the wet season flows into the cracks causing internal erosion along the deep shrinkage cracks. After some climatic cycles, traffic loading and internal erosion will either cause differential settlements along the longitudinal cracks or collapsed voids (Figures 14 and 15).

**FIGURE 14** Longitudinal cracks and collapsed voids (National Road 6, between Port Bergé and Antsohihy, Madagascar).

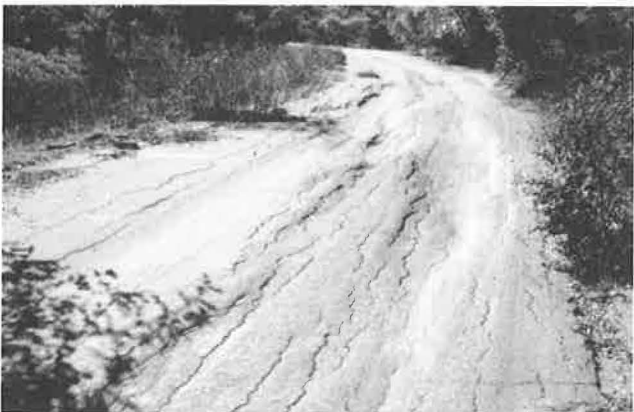
**FIGURE 15** Longitudinal cracks, settlements, and collapsed voids (National Road 6, between Mampikony and Port Bergé, Madagascar).

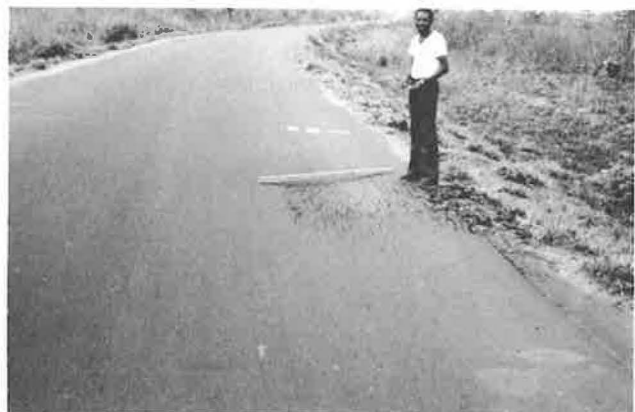
Local shearing of pavement or subgrade materials takes the form of rounded depressions with some peripheral heaving (Figure 17).

high local clay content or friable gravel fraction). Figure 17 shows a local shearing of a friable lateritic sandstone base.

**FIGURE 17** Local shearing of a soft sandstone gravel, Kilometer 3 from Pobe, National Road 3, between Porto Novo and Pobe, Benin, 1985, before rehabilitation.

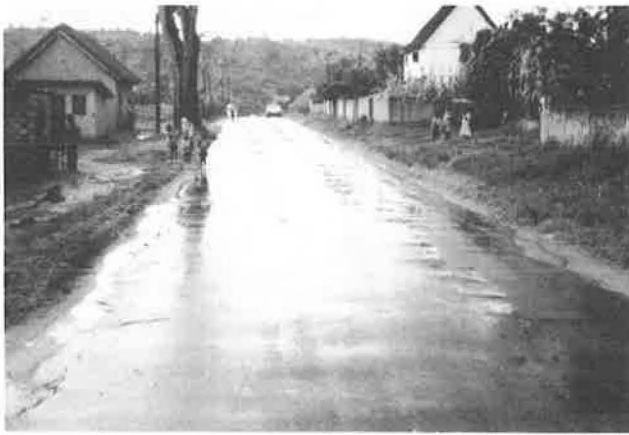
Corrugations of bitumen-surfaced roads usually result from oscillating traffic loading of unstable bitumen mixes, soft aggregates, or soft-penetration-grade bitumen (Figure 18).

**FIGURE 18** Corrugations at Kilometer 20, National Road 7, Madagascar.

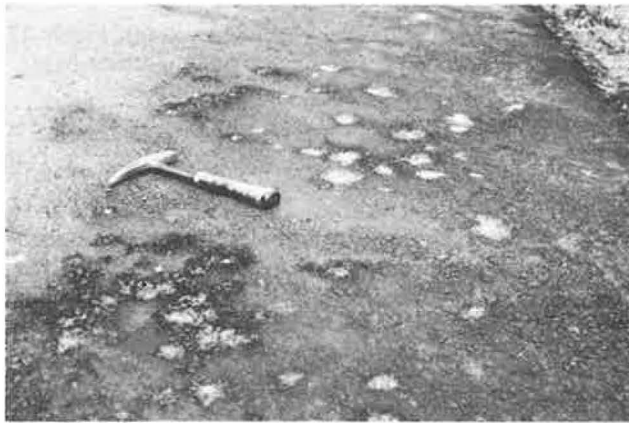
**FIGURE 19** Cracked blisters and rust staining along the shoulders of National Road 12, Kilometer 133, between Manakara and Farafangana, Madagascar.

Blisters developing along the shoulders of National Road 12, Farafangana, Madagascar, were found to be associated with small radiating cracks and rust staining (Figure 19). They resulted from tropical weathering of volcanic rock aggregates, subsequent migration of dissolved iron, and expansion of residual clay minerals being formed within the aggregates of the hot-mix wearing course.
