Reflective Cracking and Tenting in Asphaltic Overlays

ASHWANI K. SHARMA AND JAMES A. MCINTYRE

The effects of reflective cracking on the performance of recycled asphaltic pavement overlays were investigated. Two 1/2-mi sections for full removal of the existing asphaltic pavement and replacement with recycled material on the existing crushed gravel base course were selected. The pavement performance after partial removal of the existing asphaltic pavement and placement of a recycled overlay was compared with the performance after complete removal and replacement with recycled asphaltic pavement. Severe tenting (called tenting because of the tent-like structure produced at transverse cracks) developed during the freeze months of January, February, and March. The Present Serviceability Index (PSI), an indicator of ride quality, deteriorated from 3.4 in October 1985 to 1.7 in February 1986 (on a scale of 0 to 5, 5 being the best). In an attempt to solve this serious tenting problem, three different treatments were applied to the pavement. Retrofit edge drains were installed in 1987 to remove infiltrated water from the pavement structure. Retrofit transverse drains or transverse interc

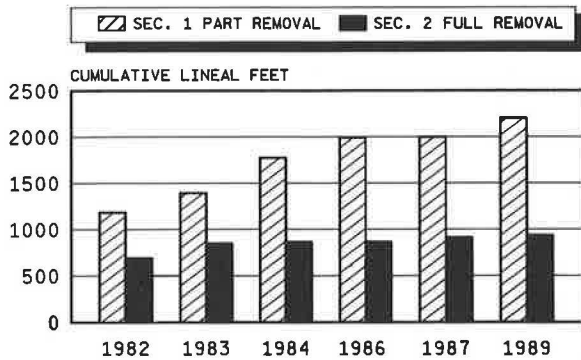
FIGURE 1 Transverse crack counts for test sections 1 and 2 (over gravel base).

Results of the transverse crack survey for Test Section 1 (partial removal and replacement) compared with Test Section 2 (full removal) is shown in Figure 1. Both sections were constructed over gravel base. Figure 2 shows the rate of reflective cracking, which could only occur in Test Section 1 (partial

The data show that there was 6,663 linear ft of transverse cracks in Section 1 in the old asphaltic surface after the milling operation and before the placement of the recycled asphaltic overlay in July 1981. By 1989, 8 years after construction, 2,164 linear ft, or 32 percent, had reflected through the 4-in. recycled asphaltic overlay. Figure 2 shows that of the total number of cracks that reflected in the first 8 years, 52 percent occurred in the first year, and an additional 29 percent occurred in the second year, totaling 81 percent in the first 2 years. This indicates that the majority of the reflective cracking takes place in the early years of the overlays.

The comparison of the amount of reflective cracking in Section 1 with the amount of cracking (nonreflective) in Section 2 (full removal) shows that there was 915 linear ft of cracking in Section 2; 58 percent more cracks occurred in Section 1. Figure 2 shows that of the total cracks that occurred in Section 2 in the first 8 years, 73 percent occurred in the first year, and an additional 17 percent in the second year, for a total of 90 percent in the first 2 years.

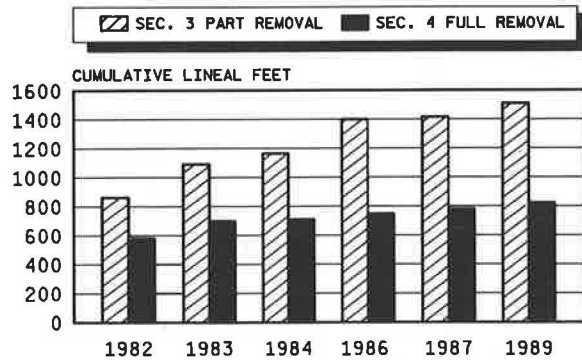
FIGURE 3 Transverse crack counts for test sections 3 and 4 (over old PCC with gravel interlayer).

Results of the transverse crack survey for Test Section 3 (partial removal and replacement) compared with Test Section 4 (full removal) are shown in Figure 3.

The reflective cracking that occurred in Section 3 shows that there was 4,425 linear ft of transverse cracks in the old asphaltic surface after the milling operation and before the placement of the recycled asphaltic overlay in July 1981. In 1988, 8 years after construction, 1,395 linear ft, or 32 percent, had reflected through the 4-in. recycled asphaltic overlay. Figure 4 shows that of the total cracks that reflected in Section 3 in the first 8 years, 56 percent occurred in the first year and an additional 17 percent during the second year, totaling 73 percent in the first 2 years.

The comparison of the amount of reflective cracking in Section 3 with the amount of cracking in Section 4 shows that 825 linear ft of cracking occurred in Section 4; 59 percent more cracking occurred in Section 3. Figure 4 shows that of the total cracks that occurred in the first 8 years in Section 4, 69 percent occurred in the first year, and an additional 16 percent occurred in the second year, for a total of 85 percent in the first 2 years.

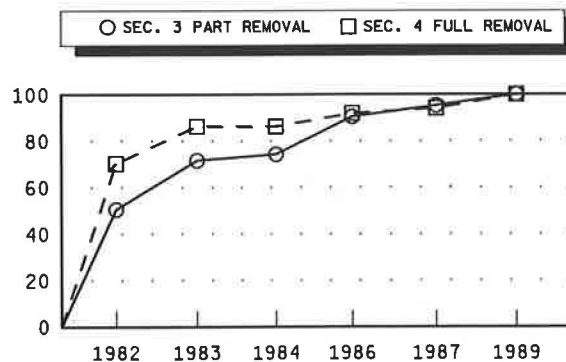
FIGURE 4 Rate (percent) of transverse cracking over old PCC with gravel interlayer, 1981-1989.

Figure 4 indicates the rate (percent) of transverse cracking that occurred in 8 years. Both sections were constructed over an old PCC and gravel interlayer.

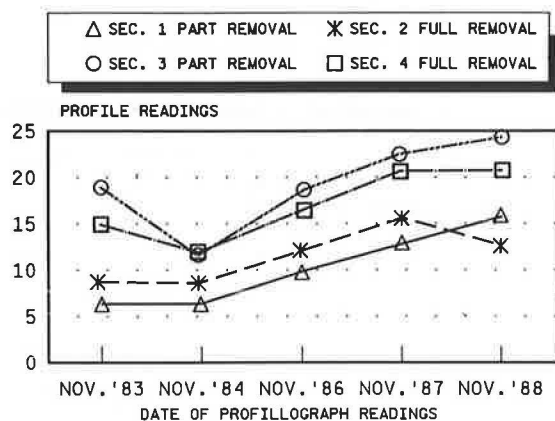
FIGURE 5 PI for test sections 1–4, 1983–1988.

Figure 5 shows the PI for test sections 1–4. The profiles were taken in November 1983, 1984, 1986, 1987, and 1988. The PIs shown in Figure 5 are the averages of the profiles taken in the two northbound and the two southbound wheel ruts. The November 1983 profiles were taken after the subgrade was frozen; thus, the results are not reliable and will not be used.

Results of the profilograph survey for Test Section 1 (partial removal and replacement) compared with Test Section 2 (full removal) are shown in Figure 5. Both sections were constructed over a gravel base. The data indicate that Test Section 1 had a lower initial PI (was less rough) than Section 2. The PI deteriorated at the same rate from November 1984 to 1987. In 1987, Section 1 continued to deteriorate at about the same rate, but the rate of deterioration in Section 2 leveled off or decreased.

Results for Test Section 3 (partial removal and replacement) compared with Test Section 4 (full removal) also are shown in Figure 5. Both sections were constructed over an old PCC with a gravel interlayer. The data indicate that Test Section 3 had a slightly higher initial PI (was rougher) than Section 4. The PIs deteriorated at the same rate from November 1984 to 1987. In 1987, Section 3 continued to deteriorate at about the same rate, but the rate of deterioration in Section 4 leveled off or decreased.

Both sections 1 and 2, constructed over the gravel base, have PIs about 10 points lower than those of sections 3 and 4, which were constructed over the PCC. Therefore, sections 1 and 2 are smoother than sections 3 and 4.

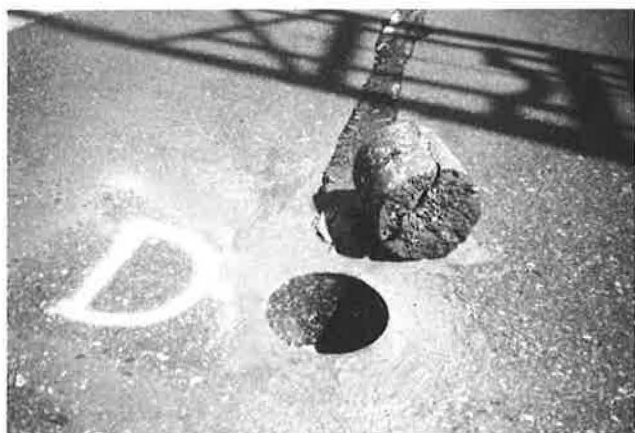
FIGURE 6 Core of transverse crack taken from high side of superelevated curve in Section 2.

Figures 6 and 7 are photographs of cores of transverse cracks in Test Section 2. The most important result of this investigation is the V-shaped deterioration at transverse cracks that occurred at the interface of the asphaltic pavement and the gravel base. Figures 6 and 7 show cores taken at Station 95+17. The core in Figure 6 was taken on the high side of a superelevated curve. It shows poorly developed V-shaped deterioration, whereas the core in Figure 7 was taken on the low side and shows a fairly well-developed V-shaped deterioration. This deterioration could be the result of pumping at the transverse cracks. The core of the high side of the superelevated curve would have less water, and therefore less pumping and less deterioration.

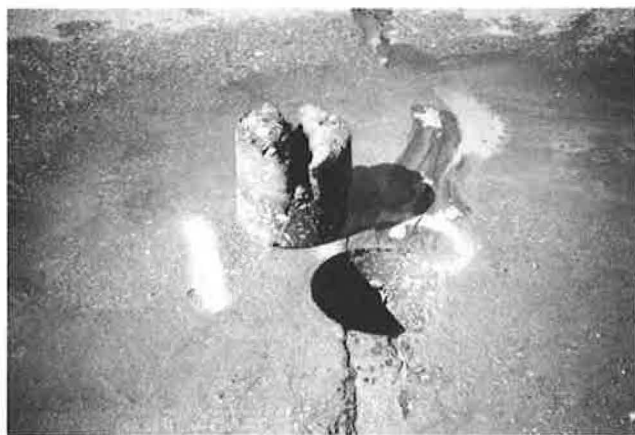
FIGURE 8 Core of transverse cracks in Section 1.

Figure 8 is a photograph of a core of transverse cracks in Test Section 1 at Station 108+10. Note the large well-developed V-shaped deterioration. The deterioration developed in the old asphaltic pavement placed in 1956, and was subjected to pumping for 32 years.

6. The severe deterioration (V-shaped void) at the interface of the transverse crack and gravel base in Section 1 (partial removal and overlay) was caused by pumping. The deterioration was less severe in the full removal section because the section had been exposed to pumping for only 7 years.

1. The transverse cracks should be investigated as part of the pavement performance evaluation in the selection of the type of pavement rehabilitation. If core samples show severe structural deterioration (V-shaped voids at the interface of the transverse crack and the gravel base) the asphaltic pavement should not be overlaid. The existing pavement should be completely removed and either relaid cold and compacted as a base course, or relaid as a recycled asphaltic material.
