Evaluation of Pavement Bleeding on I-55 in Illinois

E. R. BROWN, STEPHEN A. CROSS, AND JAMES G. GEHLER

Shortly after construction fat spots began to appear throughout the project on a 3-in. hot-mix asphalt (HMA) overlay of an existing portland cement concrete pavement. The fat spots appeared to occur at the end of truck loads. After time the fat spots developed into potholes and the asphalt appeared to be stripped from the aggregate at the bottom of the potholes. Some rutting and shoving also developed at the fat spots. The objective of this study was to evaluate the HMA and to determine potential causes of the fat spots. The test plan included inspecting the pavement visually and obtaining core samples from fat spots, adjacent to fat spots, and from random locations throughout the project. Rut-depth measurements were also obtained. The cores were tested for asphalt content, gradation, void content, and slag content. Several of the asphalt mix layers were split into top and bottom halves, and the asphalt content and gradation of each half were compared. The asphalt cement from several cores was recovered, and the viscosity and penetration were determined. The results of this stud

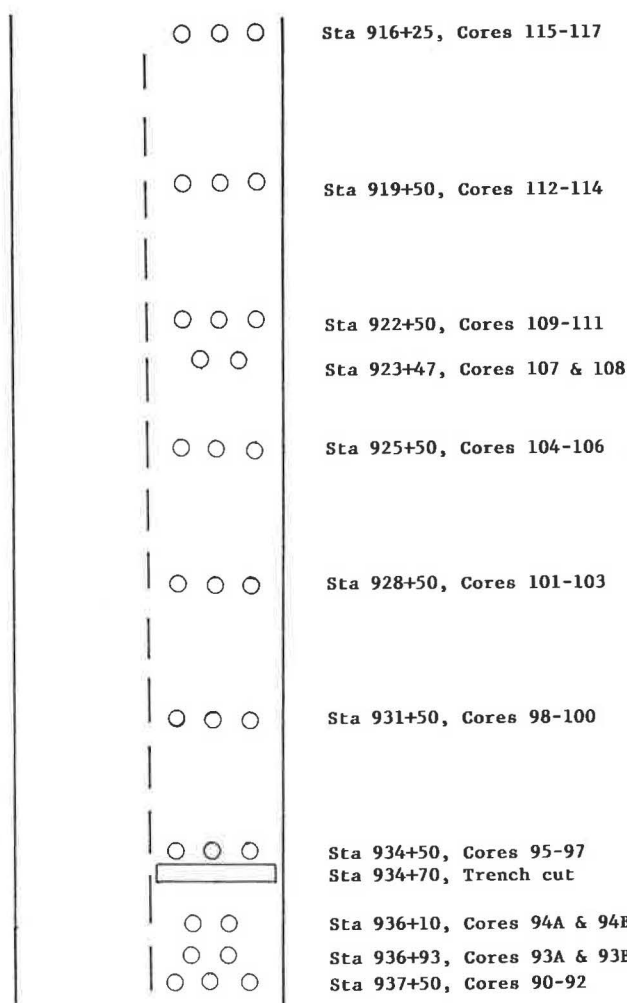
FIGURE 1 Layout of test section—northbound lanes of I-55 near Collinsville, Ill.

A test plan was developed for I-55 to determine the cause of localized bleeding. Samples of the asphalt mix were taken in the fat spots, adjacent to the fat spots, and at random locations from station 916+25 to station 937+50 (Figure 1). A total of thirty 4-in. cores was taken for testing. A trench approximately 2 ft wide and approximately full width was excavated at station 934+70, at a location that had bleeding spots, to determine if the problem could be identified by viewing the side of the trench.

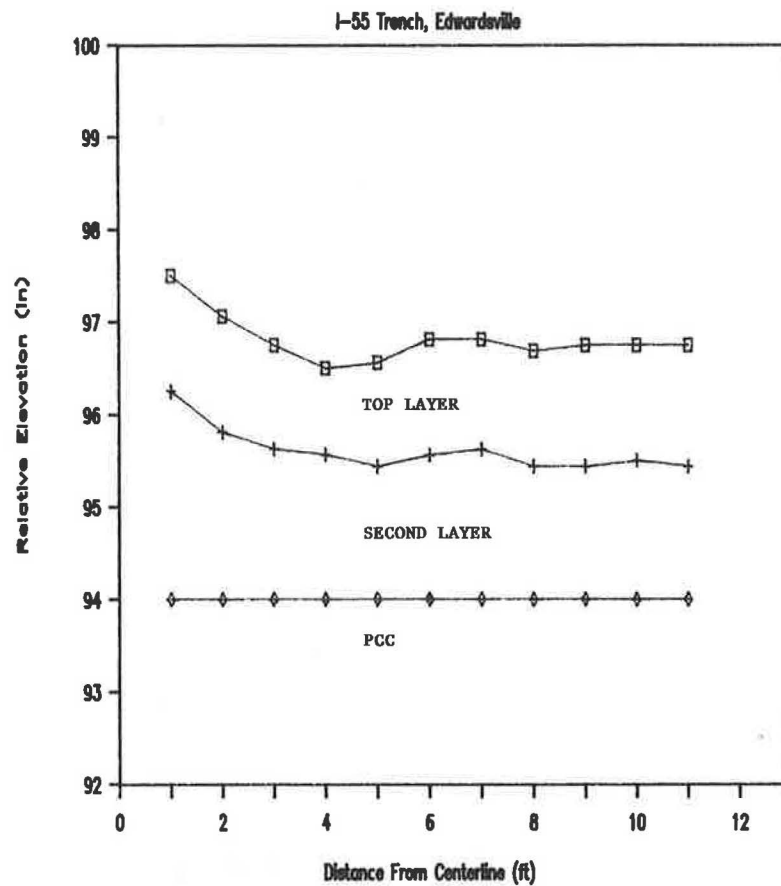
FIGURE 2 Trench cut at Station 934 + 70, northbound lane of I-55 near Collinsville, Ill.

Rut measurements were taken at the trench; the results are plotted in Figure 2. The rut depth at this location was approximately 0.6 in. A typical localized bleeding area is shown in Figure 3.

The pavement section (Figure 2) shows that two layers of asphalt mixture were placed over an existing layer of concrete. The total thickness of asphalt mixture was approximately 3 in. Figure 2 shows that rutting had occurred in the surface and binder course. The rutting was more severe at the locations that had localized bleeding than in the other areas. The major concerns at the time of inspection were the rutting problem in general and the ravelling and potholes that were developing at the localized fat spots.

An inspection of the pavement adjacent to the trench cut through a bleeding spot did not indicate the causes of the problem. This inspection did show that the problem was confined to the top layer of asphalt mixture and that the lower half of the layer had less asphalt cement than the top half.

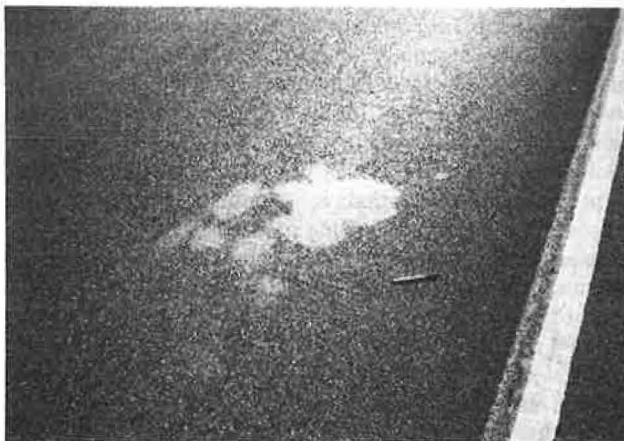
FIGURE 3 Typical localized bleeding area, northbound lanes of I-55 near Collinsville, Ill.

The distance between the fat spots varied, but it appeared that the problem was generally associated with some segregation that typically occurs at the end of truck loads. In some places it appeared that the asphalt in these fat spots had migrated to the pavement surface. In these places it appeared that the asphalt had been stripped from the underlying aggregates. The test plan was set up to determine whether stripping had occurred or if some other problem had caused the fat spots. The area of pavement adjacent to these fat spots had become rough in some cases, and it appeared that the roughness would increase with time.

The low viscosity of the recovered asphalt cement indicates some type of contamination. Because the viscosity of the asphalt cement recovered from samples taken adjacent to bleeding areas is reasonable, the contamination must have occurred after mixing. It is suspected that the contamination either came from the use of diesel or some other unacceptable release agent to coat truck beds or from some spillage of one of these materials on the binder course before overlaying. Diesel fuel is the most likely contaminant because it evaporates slowly, and thus would keep the viscosity of the asphalt low for a long period of time. The specific cause of the contamination problem was not identified.
