Crash Tests of a Retrofit Thrie Beam Bridge Rail and Transition

DORAN L. GLAUZ, ROGER L. STOUGHTON, AND J. JAY FOLSOM

Two crash tests each were performed on a Thrie beam bridge rail and on the adjoining transition section to the approach guardrail. The bridge rail was designed (a) as a retrofit to replace the rail portion of an inadequate bridge rail supported on W6X15.5 steel posts at 6 ft 3-in. spacing, or (b) as a completely new barrier installed using resin capsule anchors to attach the posts to the edge of an existing bridge deck. The transition uses the same rail element, a 10-gauge Thrie beam, supported on standard wood posts. The tests performed approximated those required for a PL-1 bridge rail outlined in the 1989 American Association of State Highway and Transportation Officials *Guide Specifications for Bridge Railings*. The bridge rail was struck by a 5,400-lb pickup truck at 44.9 mph at an angle of 21 degrees and a 1,830-lb car at 48.7 mph at an angle of 18¼ degrees. The transition was hit by a 5,400-lb pickup truck at a speed of 44.7 mph at an angle of 18 degrees and a 1,930-lb car at 49.1 mph at an angle of 20¾ degrees. The crash tests satisfied the requirements f

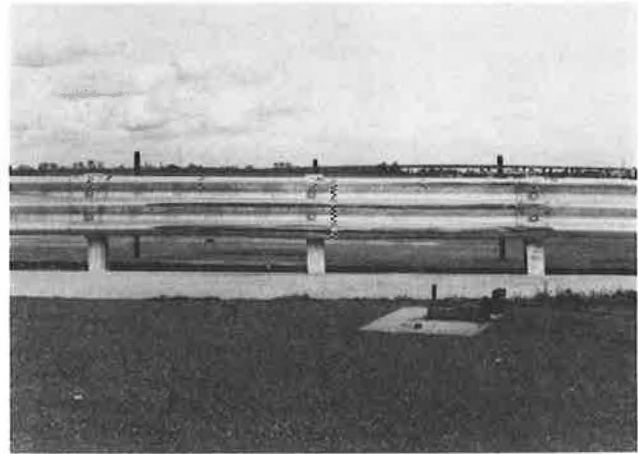
The right front bumper of the test vehicle struck the bridge rail near the midpoint between Posts 4 and 5 at a speed of 44.9 mph at an impact angle of 21 degrees. Vehicle contact with the Thrie beam began 2.7 ft downstream from Post 4 and continued for a length of about 16 ft (Figure 5). The vehicle was smoothly redirected, without exhibiting any tendency for the front wheel to snag on a post or wedge under the rail, and lost contact with the barrier at an exit angle of 6 1/4 degrees. The maximum roll was 10 degrees. The vehicle stopped on a safety berm about 140 ft downstream from impact and 37 ft in front of the face of the rail. It was lightly damaged (Figure 6).

FIGURE 5 Vehicle contact marks, Test 473.

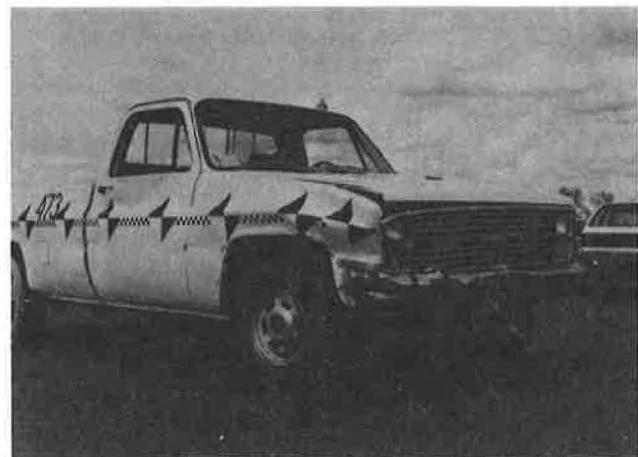
FIGURE 6 Vehicle after Test 473.

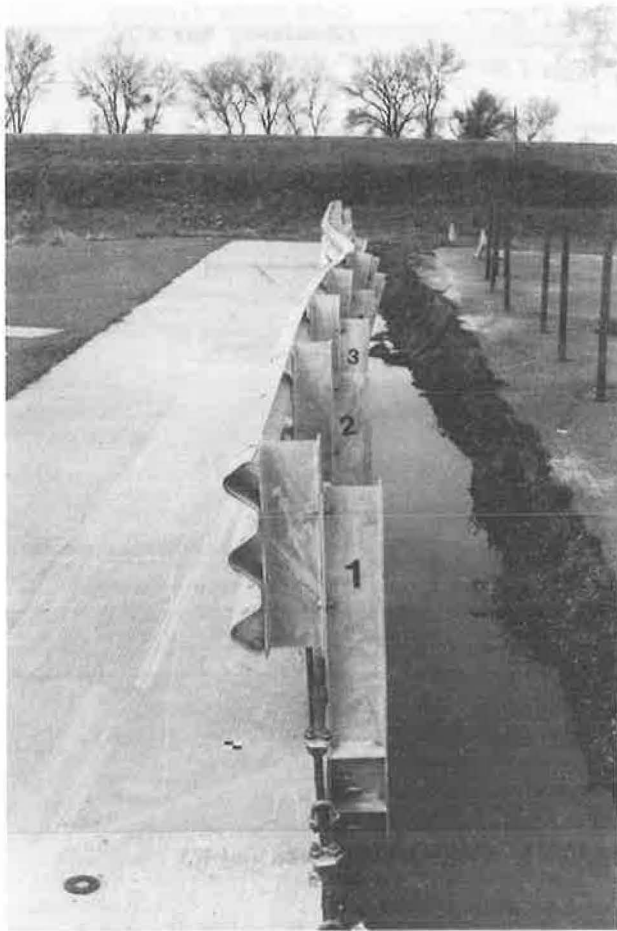
Post and rail damage were limited to the impact area. The permanent lateral deflection of the rail measured at the posts ranged from 1/8- to 3/16-in. deflection in a smooth long curve between Posts 2 and 9 (Figure 7). The displacements of each of the posts is shown in Table 2. The maximum dynamic lateral movement was 10.9 in.

FIGURE 7 Rail damage: bent rail, bent posts, Test 473.

After Test 473, the seven bent posts and three rail elements were replaced. Removal of Posts 5 and 6 was quite difficult; the holes and the post flanges were pushed around the washers

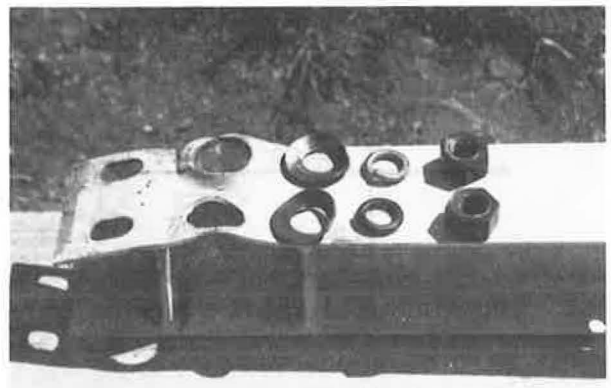
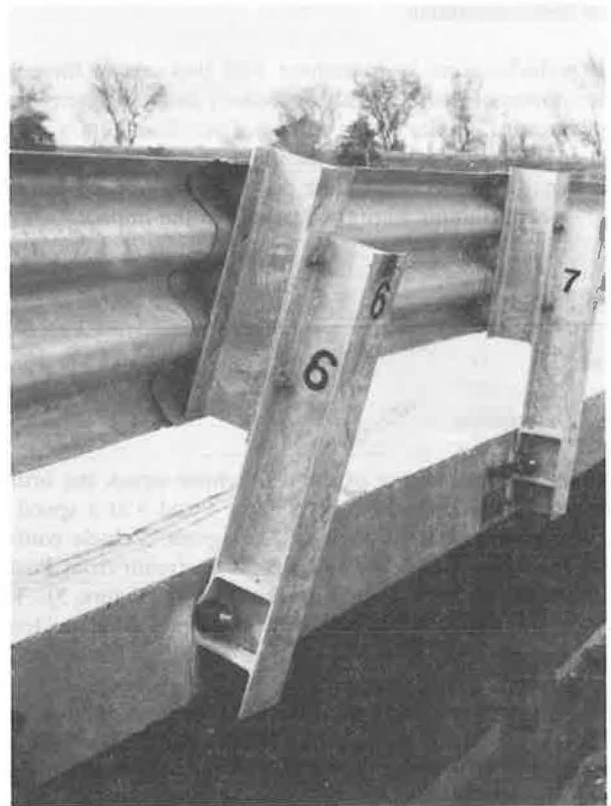
On Posts 4, 5, 6, and 7, the washers at the top mounting studs that attached the posts to the deck were pulled into the holes in the posts as the post flange was pushed around the nuts. The web was buckled at the bottom of Posts 4, 5, 6, and 7 (Figure 8). At Posts 5 and 6, the flange fractured at the upper mounting stud holes.

FIGURE 8 Post 6 was severely bent after Test 473.

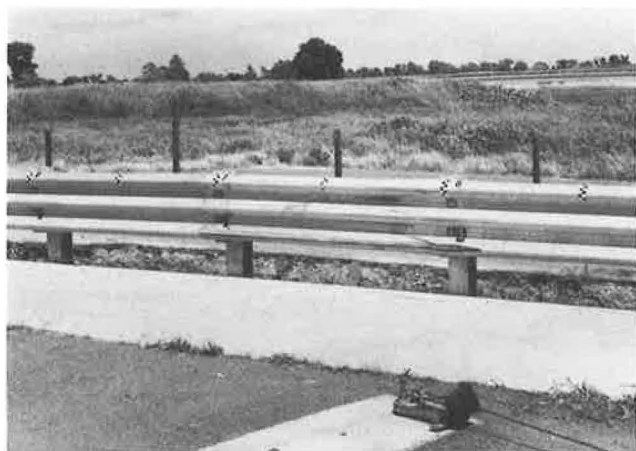
The right front bumper of the test vehicle struck the bridge rail upstream from Post 6 at a speed of 48.7 mph at an angle of 18 degrees. Vehicle contact with the Thrie beam began 1.0 ft upstream from Post 6 and continued for a length of 7.0 ft (Figure 9). The vehicle was smoothly redirected, without exhibiting any tendency to snag on a post or wedge under the rail, and lost contact with the barrier at an angle of 5 degrees.

FIGURE 9 Vehicle contact marks, Test 474.

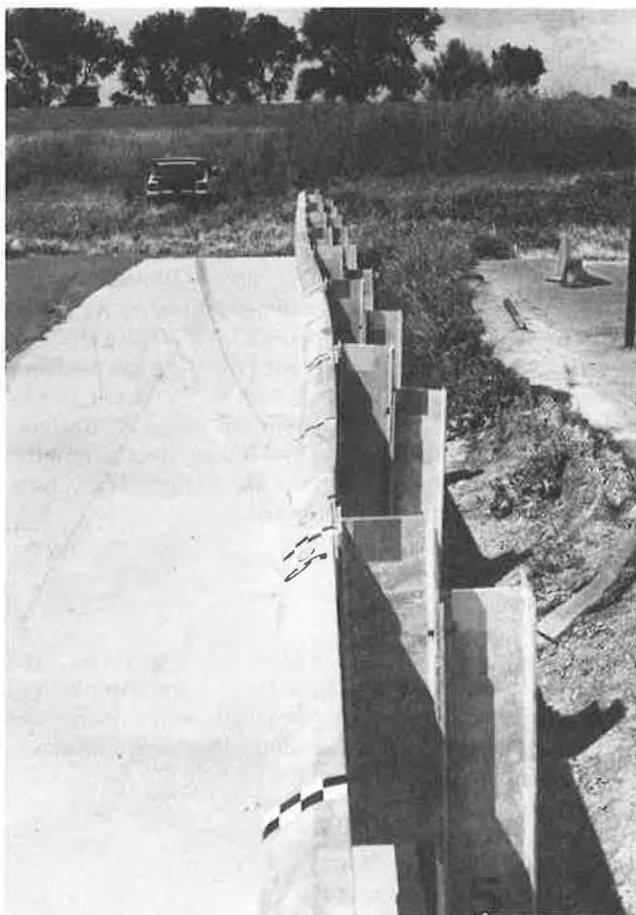
the posts ranged from $\frac{1}{16}$ to $1\frac{1}{16}$ in. (Figure 10). The displacements of each of the posts is shown in Table 2. The maximum dynamic barrier deflection was 3.8 in.

FIGURE 10 Rail damage: bent rail, bent posts, Test 474.

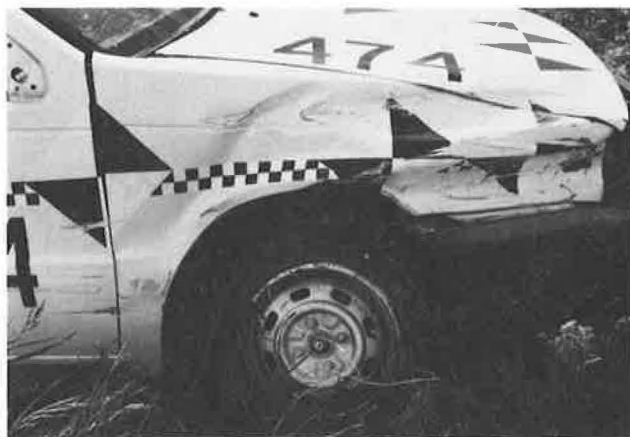
FIGURE 11 Damage to front of vehicle, Test 474.

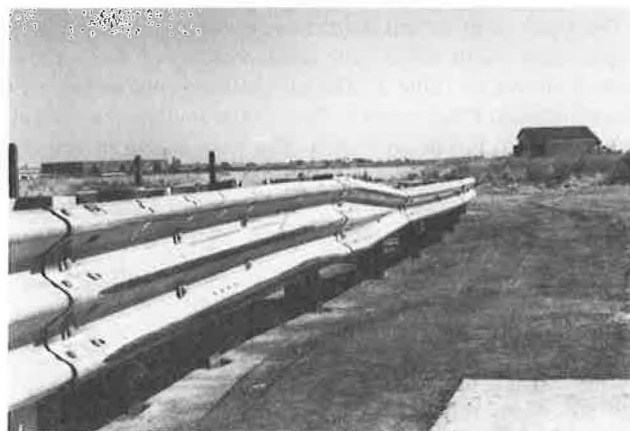
FIGURE 12 Vehicle contact marks, Test 475.

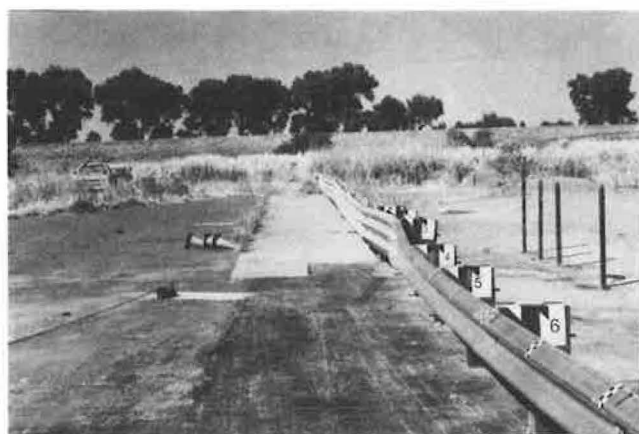
FIGURE 13 Rail damage: displaced posts, bent rail, broken post, Test 475.

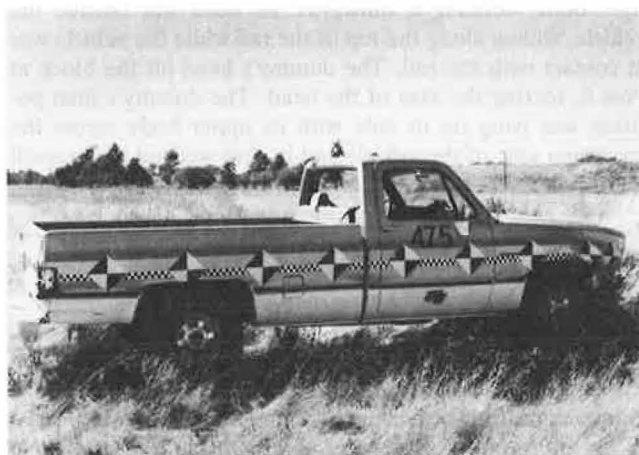
FIGURE 14 Vehicle after Test 475.

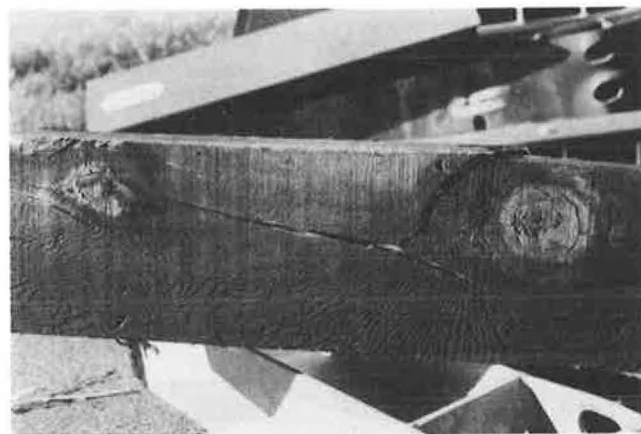
Post and rail damage was limited to the impact area. Damage consisted of a slight bend in the transition rail, displacement of posts, and one broken post (Figure 15). Post 3 was broken about 15 in. below ground level at a knot.

The permanent lateral deflection, measured at the posts, ranged from $\frac{1}{16}$ to $\frac{4}{8}$ in. The displacements of each of the posts is shown in Table 3. The maximum displacement was $\frac{5}{8}$ in. between Posts 2 and 3. The maximum dynamic lateral movement was 9.6 in. at Post 3. The total length of vehicle contact was about 15 ft. The approach transition was permanently bent and the Thrie beam-W-beam transition was damaged; both were replaced.

FIGURE 15 Rail damage, Test 475.

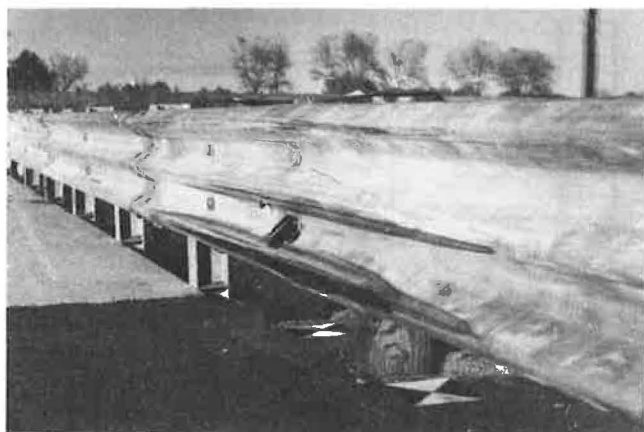
The right front bumper of the test vehicle struck the bridge approach transition near the midpoint between Posts 2 and 3 of the transition at a speed of 49.4 mph at an angle of $20\frac{3}{4}$ degrees. Vehicle contact with the rail began 3.3 ft downstream of Post 3 and continued for a length of 7.4 ft (Figure 16). The car was smoothly redirected without exhibiting any tendency to snag or pocket and lost contact with the barrier at an exit angle of $4\frac{3}{4}$ degrees. The maximum roll was $+2\frac{3}{4}$ degrees. The final location of the car was 118 ft downstream from the impact point and 58.5 ft in front of the barrier. The vehicle was moderately damaged (Figure 17).

FIGURE 16 Vehicle contact marks, Test 476.

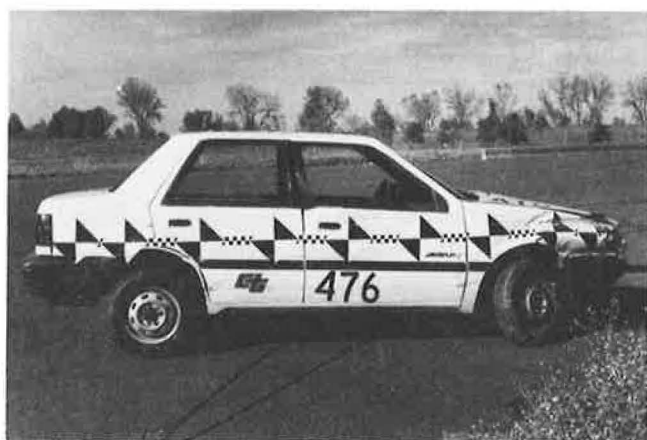
FIGURE 17 Vehicle after Test 476.

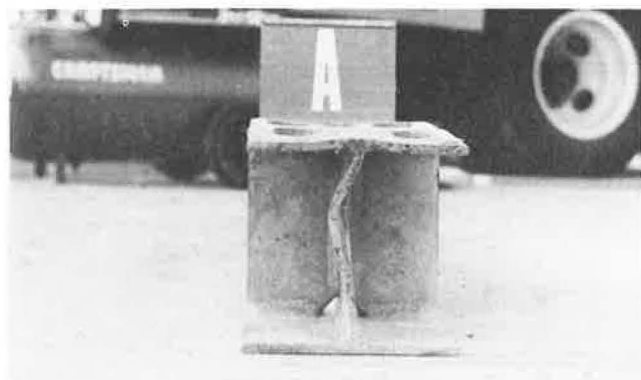
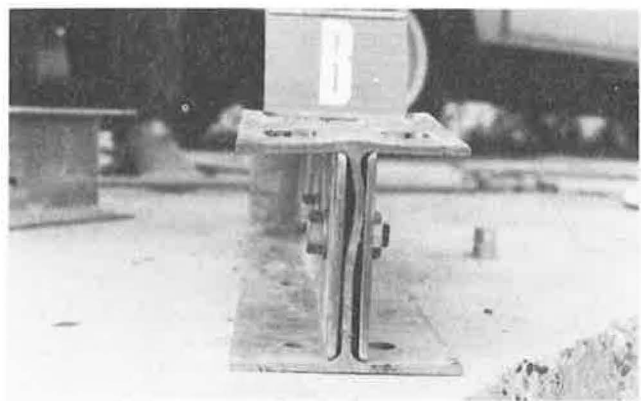
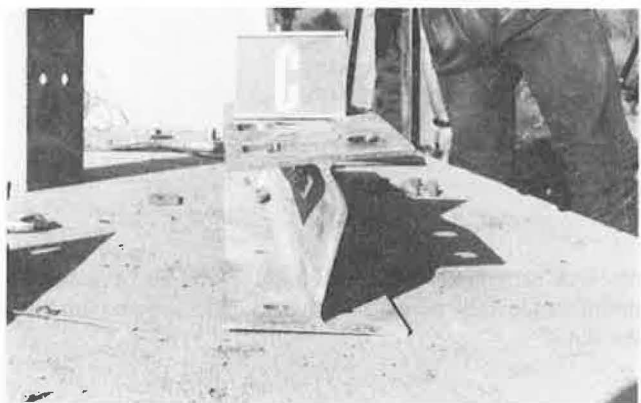
The test results are summarized in Table 4. Typically the web at the base of the post would buckle upon failure (Figure 20a, b, and c). In Tests A and B the web stiffeners and sandwich plates added sufficient strength so that the top anchor bolts pulled out. Total deformation of test Post A was less than two of the posts in Crash Test 473 (Figure 21).

FIGURE 20 Bottom end of three posts after static tests.

5. Some sort of post strengthening should be included on a Thrie beam bridge rail. Welded web stiffeners were crash tested; bolted-in sandwich plates would probably perform similarly at a lower cost.

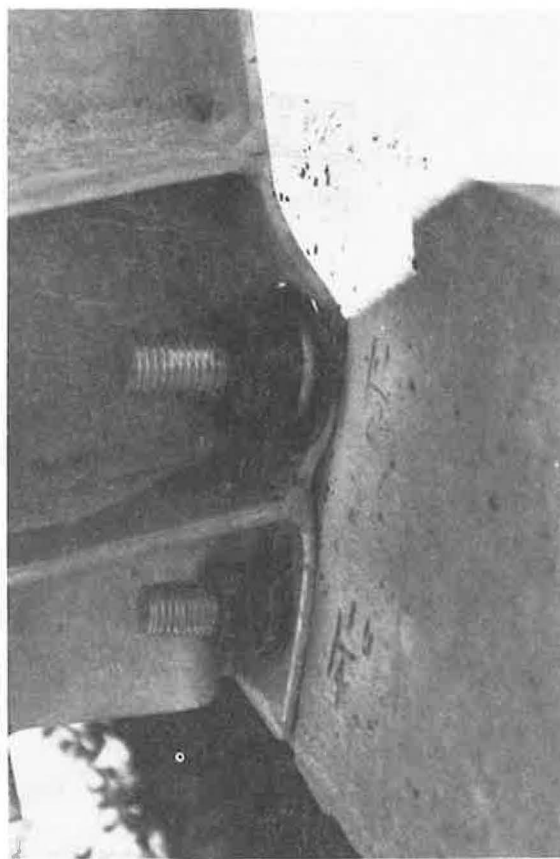
**FIGURE 21** Buckled web contacted lower fastening nut on Post 6.**TABLE 5** VEHICLE KINEMATICS

and nuts, making access to the top fasteners quite difficult. Also, the collapse of the web at the bottom of the post restricted the movement of one of the nuts (Figure 21). A cutting torch would be required to remove such a damaged post from a bridge deck with access only from the deck. The bridge approach transition was constructed and repaired by a guard rail maintenance crew by hand methods. No problems were encountered during installation or repair.
