Crack and Seat Performance

KEUN-WOOK YI

The effectiveness of the crack and seat process in preventing reflection cracking on asphaltic overlays of portland cement concrete pavement (PCCP) is evaluated. New Mexico has approximately 145 mi of PCCP existing on the Interstate system. In a 4-year period from 1984 to 1988, 110 mi was rehabilitated using the crack and seat process. The existing portland cement concrete was cracked and seated and overlaid with asphalt concrete. To further reduce reflection cracking, a paving fabric was used. The areas that were cracked and seated were inspected for distresses, mainly reflection cracking. Roughly 3 percent of the cracked and seated sections exhibited low-severity transverse reflection cracking, whereas the experimental sections not cracked and seated exhibited a high rate of transverse cracking. The crack and seat process with paving fabrics is greatly reducing the reflection cracking that has been a major problem in asphalt overlays of PCCP. This method seems to be a sound alternative for rehabilitating the existing PCCP.

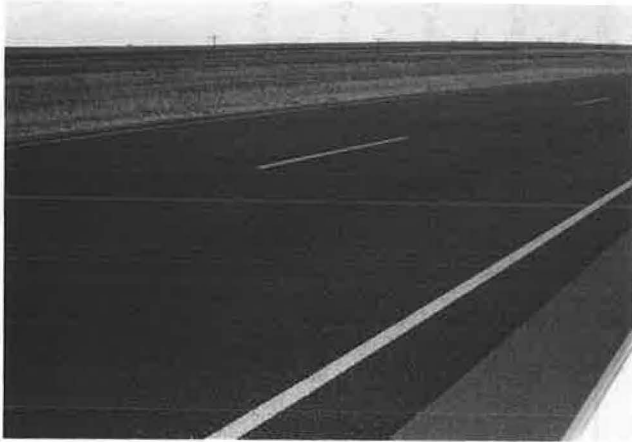
interlayer was the standard paving fabric called AmoPave. The other was Glasgrid, the experimental interlayer used in this project. Glasgrid is a fiber reinforcement mesh for asphaltic concrete purported to prevent reflection cracking. Sections 1 through 6 were cracked and seated. These sections are exhibiting no signs of cracking in the driving lane. Sections 7 through 9 were not cracked and seated. These sections are exhibiting some cracking. Section 7, which contains no interlayer, is exhibiting twice as many cracks (see Figure 2) as Sections 8 and 9, which had the interlayers. The test sections were inspected by James A Scherocman, P.E., consulting engineer, on February 18, 1990. The resulting numbers of cracks are presented in Table 4. The rest of the project was constructed using one of the standard paving fabrics. The project exhibits some transverse cracking in the shoulders and low-severity rutting at the beginning of the project, but no reflection cracking.

FIGURE 2 Condition of the roadway on Project IR-040-5(40)282 in the control section without cracking and seating or paving fabric. Note the two transverse cracks spaced approximately 40 ft apart.

1. Crack and seat projects need to be monitored and evaluated on a yearly basis.
2. Areas with reflection cracks should be observed for further deterioration. These cracks need to be sealed to minimize any future subgrade damage.
3. The crack and seat process should continue to be used.
4. The test sections on Project IR-040-5(40)282 should continue to be monitored for the crack retarding effect of the interlayer.

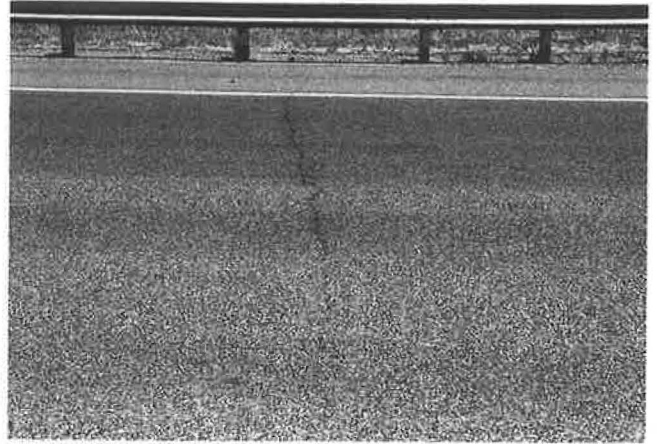
• IR-040-5(42)300. This project was completed in 1985. At approximately MP 300.5, they are low-severity transverse cracks. These cracks are in the westbound lane approximately 40 ft apart (see Figure 3). When a core was taken at one of

FIGURE 3 Reflection cracking evident in a section near MP 300.5 on Project IR-040-5(42)300.

the cracks, it revealed that the PCCP was cracked and faulted underneath the transverse crack. In the same lane, there are low-severity transverse cracks near MP 304.5. These are approximately 60 ft apart. There are longitudinal cracks along the center of the eastbound lanes. In one particular area near MP 306.5, there is a cracking pattern that can best be described as a reflective corner break (see Figure 4).

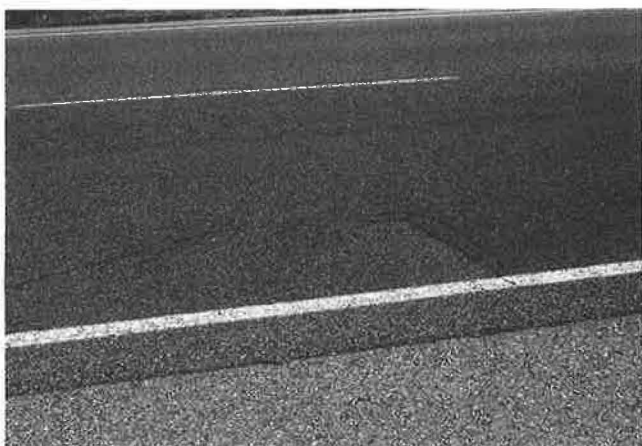
FIGURE 4 Reflection cracking, better described as reflective corner break, on Project IR-040-5(42)300.
