Concrete Pavement Rehabilitation and Overlay: Ontario's Experience

THOMAS J. KAZMIEROWSKI AND HARRY J. STURM

a project on Highway 126 in London, Ontario, undertaken during the summer of 1989.

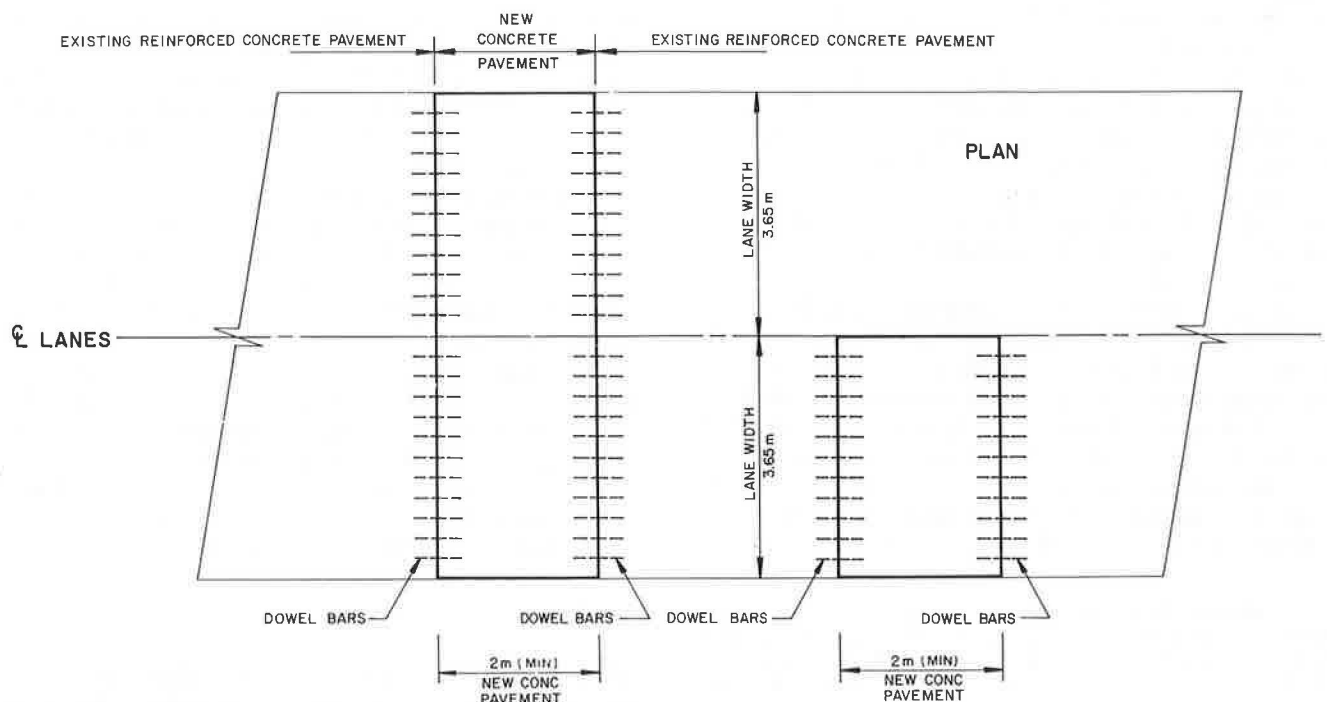
FIGURE 1 Full-depth concrete repairs plan view.

A plan view of the full-depth repair is shown in Figure 1. The standard repair size is 2 m long by either one or two lanes wide. General dowel bar layout and references to jointing are also provided on this drawing. Longitudinal tie bars were only used in repair sections greater than 2 m in length, and consisted of 15-mm deformed bars placed on 600-mm centers.

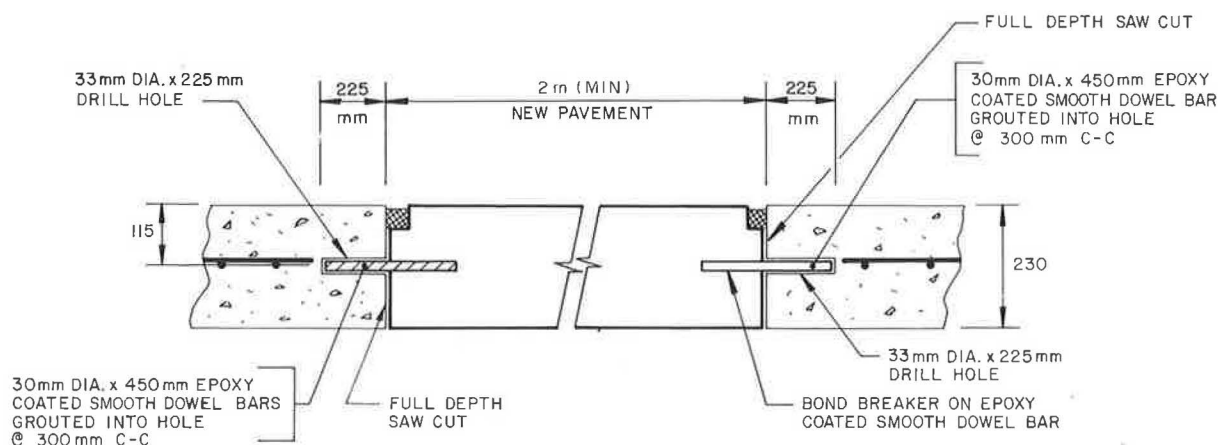
FIGURE 2 Full-depth concrete repair cross-section.

To provide load transfer between the existing and repaired slabs, 32-mm-diameter by 450-mm-long epoxy-coated smooth dowels were resin grouted into the existing pavement at 300-mm intervals, midheight in the slab. The exposed length of the dowel and the concrete face were coated with a bond breaker to ensure that a working contraction joint was provided. A 25-MPa portland cement was used in the repairs.

Figure 2 shows the details of the full-depth repair and placement of the dowel bars.

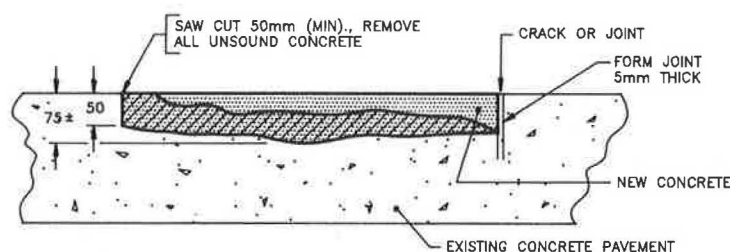
FIGURE 3 Concrete spall repairs.

Partial depth repairs with PCC had not previously been undertaken in Ontario, so new drawings and specifications for this work were developed. Typical drawings used for this work are shown in Figure 3. The specification required all unsound spalled concrete to be removed; an average removal depth of 75 mm was used for estimating. Where spalls extended deeper than half the slab thickness, a full-depth repair was specified. Following removal and immediately before placement of 25-MPa concrete, the exposed surfaces had to be abrasive blast-cleaned, and then coated with a PCC paste. Where the repair was adjacent to a crack or joint, a gap had to be formed in this area to allow for expansion at the joint or crack and to prevent spalling of the patch. Proper patch isolation is critical to minimize compression failure of the patch.

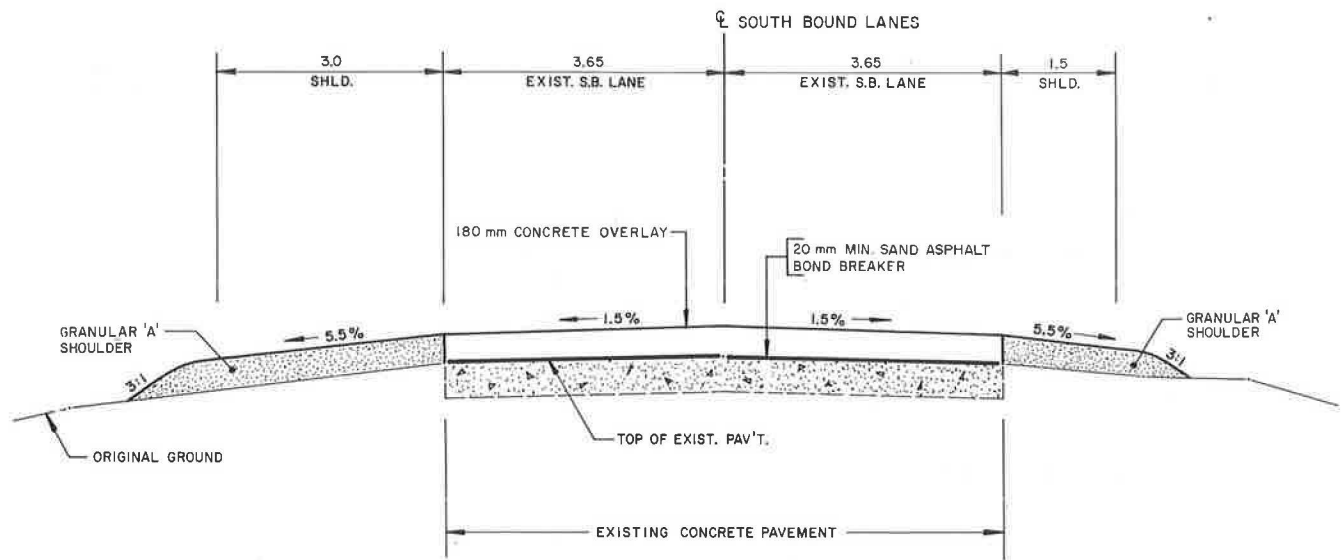
FIGURE 4 Unbonded concrete overlay.

The design of the unbonded concrete overlay on the SBLs included the removal of any loose spalled material from the existing badly cracked pavement. The spalled areas (427 m²) were then patched with hot mix and a 20-mm asphaltic sand mix bond breaker (884 tonnes) was specified over the existing pavement surface. The sand mix was placed to prevent bonding between the new and old PCC pavements and minimize reflection cracking in the overlay. Following placement of the bond breaker, a 180-mm-thick unreinforced plain-jointed concrete pavement (38 200 m²) was placed. A typical cross section showing these details is provided in Figure 4.

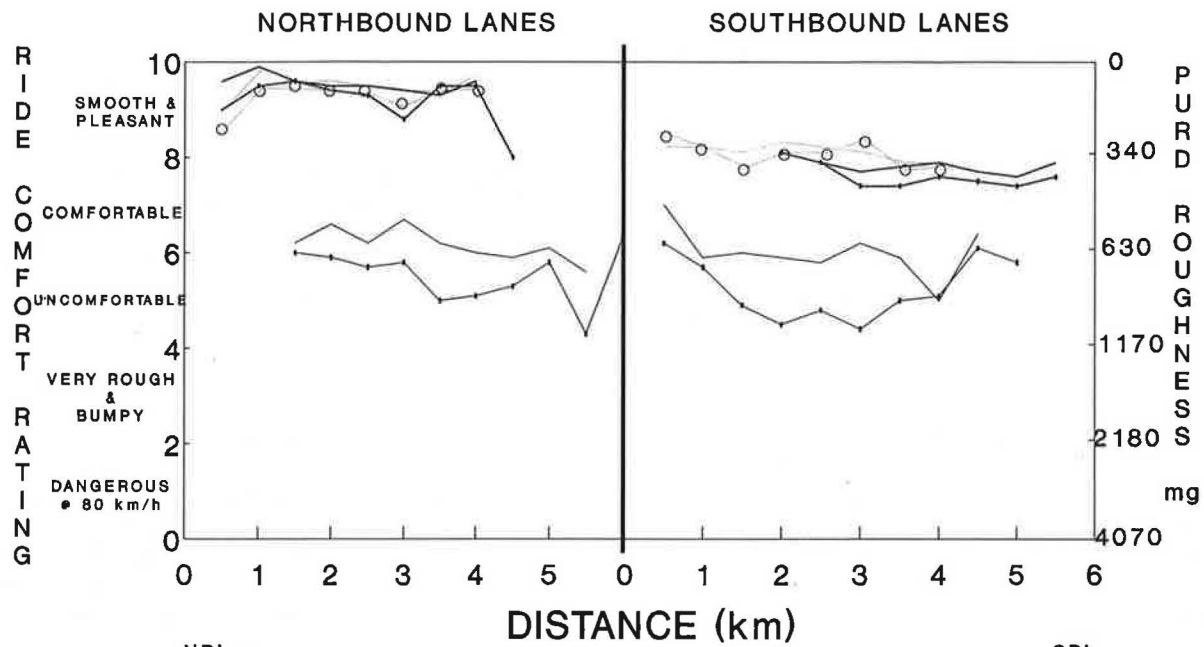
FIGURE 5 PURD roughness survey.

The ride was improved significantly following rehabilitation with a reduction in roughness from an average of 800 mg for all lanes (RCR of 5.8) to 230 mg (RCR of 9.2) for the NBLs and 360 mg (RCR of 7.8) for the SBLs. See Figure 5 for the details. The 8-month postconstruction PURD testing does not indicate any significant change in ride except on the SBLs where the ride has improved slightly. This effect is probably because of wearing of coarse projections on the tined surface. The detailed PURD measurements are shown in Figure 5 and summarized in Figure 6.

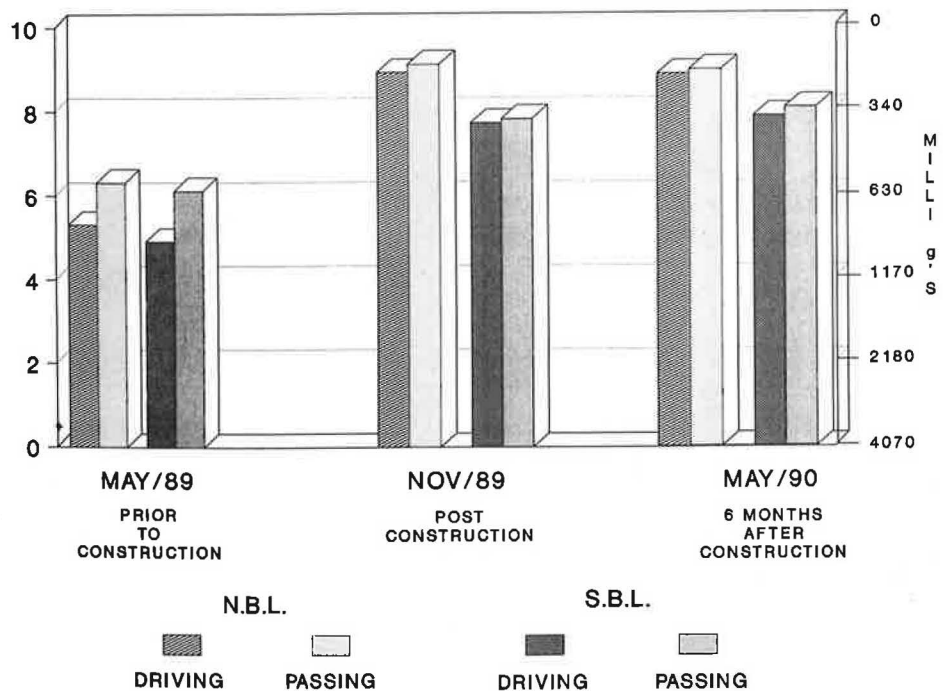
FIGURE 6 Summary of PURD survey.

The roughness numbers for the diamond-ground surface indicate a very smooth surface was obtained. The slipformed concrete, which averages 360 mg, is somewhat rougher than the diamond-ground surface; however, it is only slightly rougher than the ride achieved on a new asphalt surface.

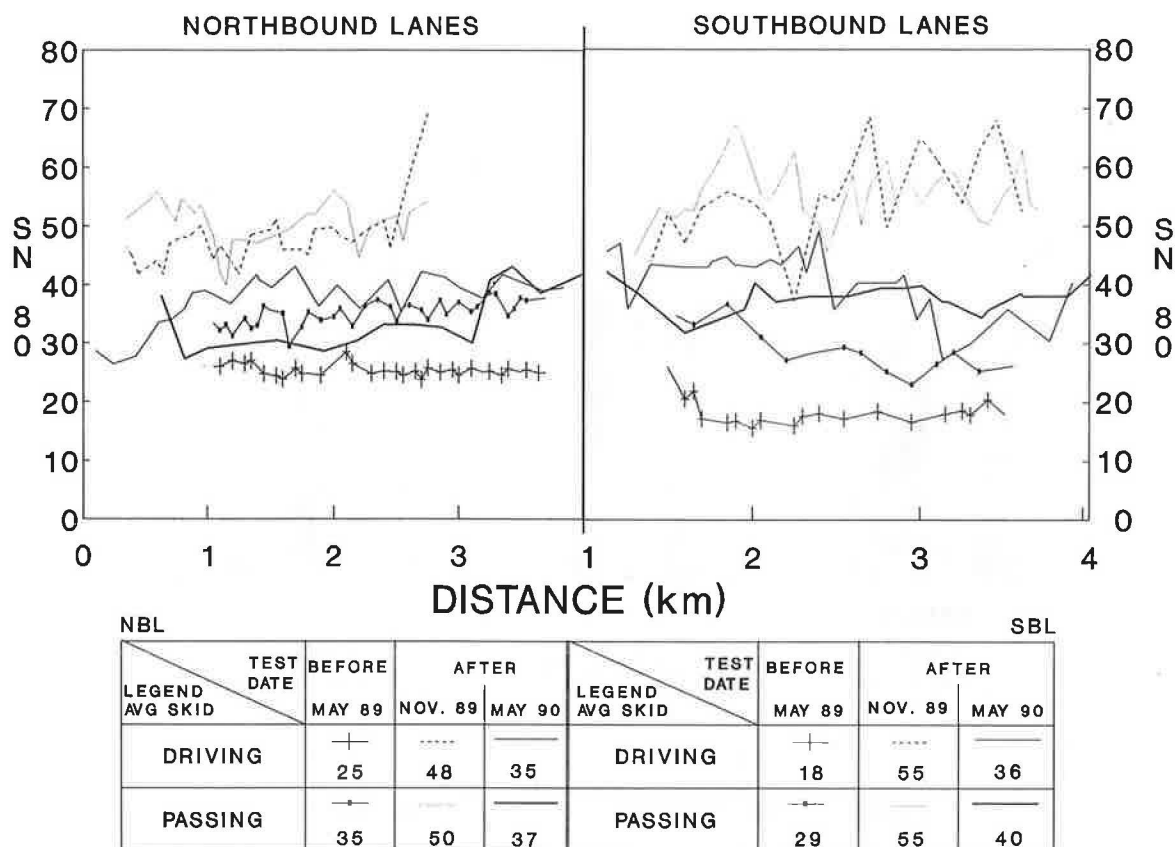
FIGURE 7 Skid resistance survey.

Skid resistance testing was completed before construction and twice after construction and the data are detailed in Figure 7 and summarized in Figure 8. The test results immediately after construction indicate there was a substantial increase in skid resistance on both the NBLs and SBLs, as expected. The skid numbers in the SBLs increased to an average of 55 for both lanes from 18.3 and 28.9 in the driving and passing lanes, respectively. On the diamond-ground surface, the skid numbers improved from an average of 24.8 and 35.1 to 48.0 and 50.4 for the driving and passing lanes, respectively.

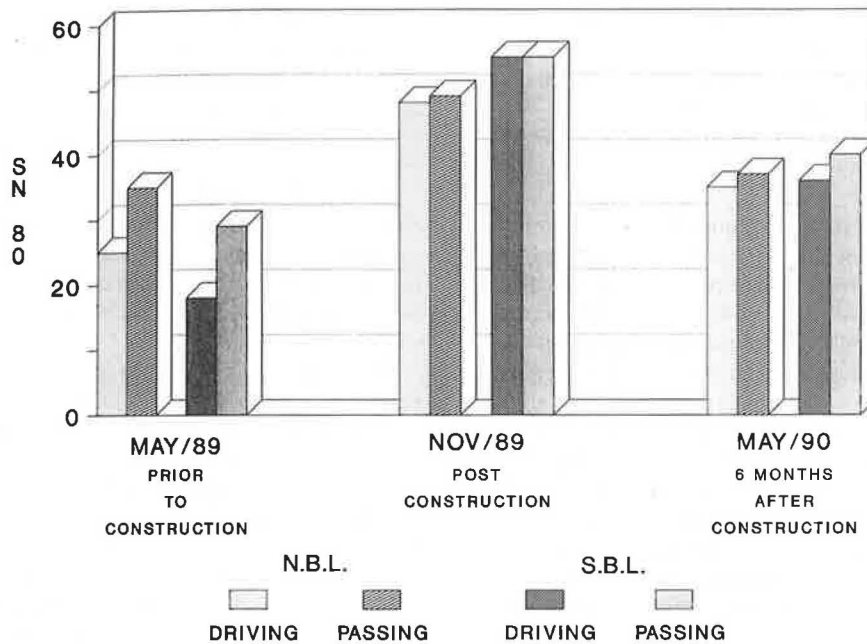
FIGURE 8 Summary of skid survey.

Testing in the spring of 1990 has shown a fairly significant reduction in skid number from the initial postconstruction number and confirmed expectations. The 1990 skid tests provided average numbers of 37 and 40 in the passing lanes and 35 and 36 in the driving lanes for NBLs and SBLs, respectively. These numbers are somewhat lower than those ranging from 48 to 55 obtained in the immediate postconstruction tests.

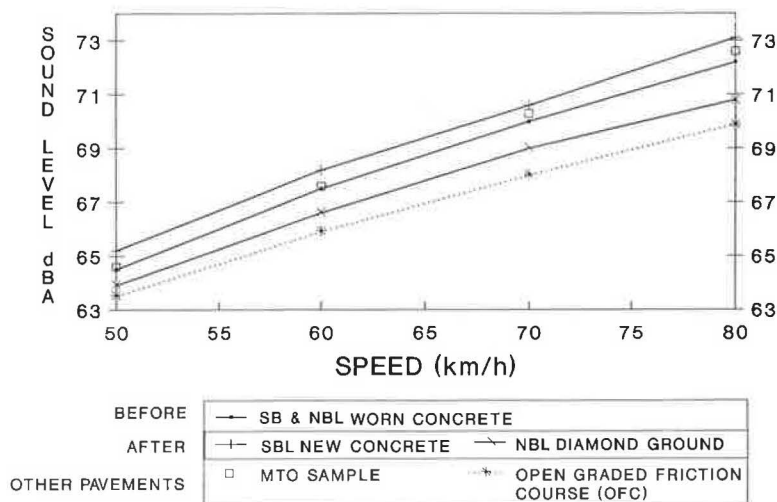
FIGURE 9 Pavement noise emission of automobiles.

The procedure used to evaluate pavement noise on this project was to measure sound emissions from individual vehicle passbys at a 15-m distance from the traveled lane. The results are plotted on Figure 9 and indicate that the diamond-ground surface was approximately 1 dBA quieter than the old worn concrete and the MTO sample. The ground surface is only 1 dBA louder than the open-graded friction course used for its low noise and good skid resistance characteristics. The MTO sample was provided by Jung et al. (6) and was derived by testing several hundred vehicles on a variety of pavement surfaces across the province.

The burlap-dragged and transversely tined concrete surface was approximately 1 dBA noisier than the worn concrete and

MTO sample. The new concrete on the SBLs should become quieter as some of the very coarse tining wears off.

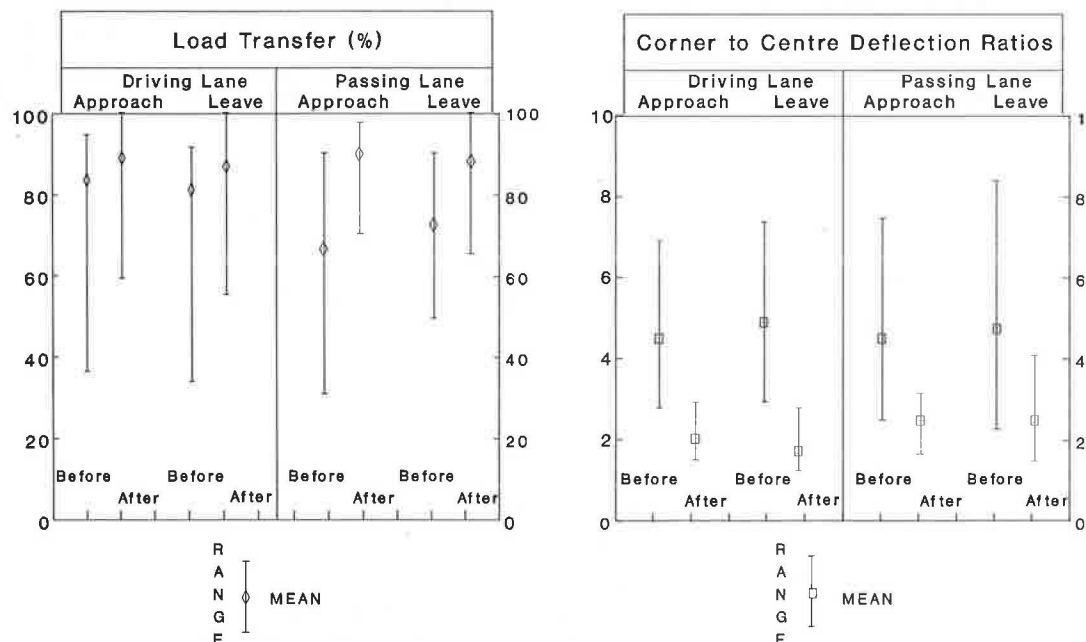
FIGURE 10 Load deflection results, SBLs.

Testing on the unbonded concrete overlay indicated a substantial improvement in both load transfer and corner to center deflection ratios, as expected. The postconstruction load transfer testing indicated mean values ranging from 88 to 91 percent, an increase of 5 to 24 percent over mean precon-

struction levels. The load transfer was also more uniform among the joints tested as evidenced by the reduction in the range and standard deviation of test values. The corner to center deflection ratios were also substantially improved after rehabilitation with similar trends to those observed for load transfer. This information is shown graphically in Figure 10.

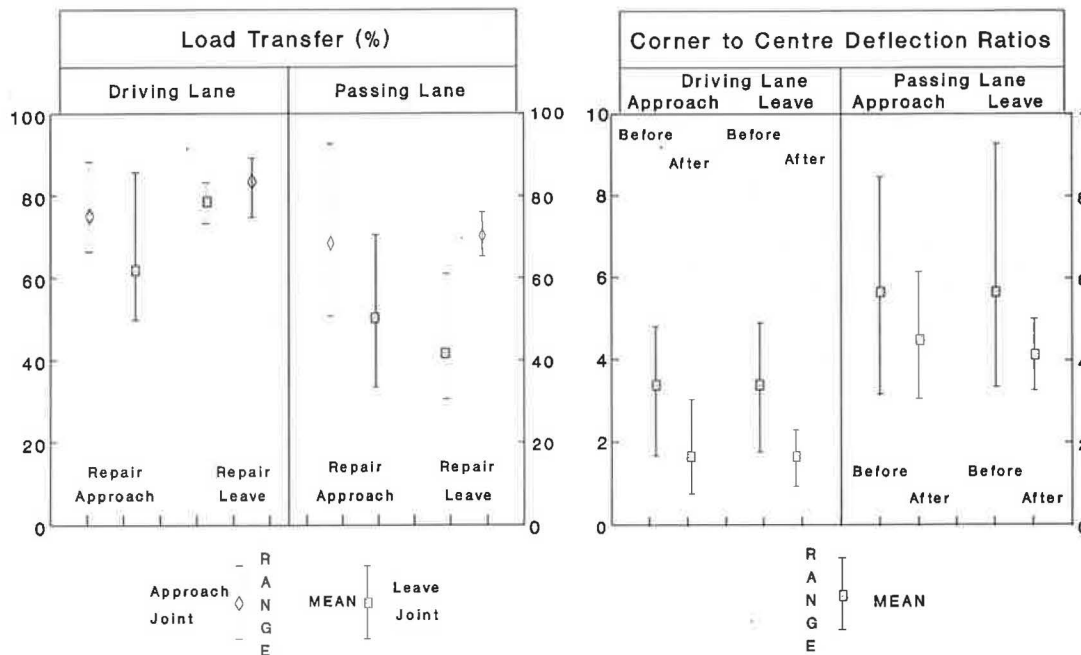
FIGURE 11 Load deflection results, NBLs.

The results of FWD testing across the full-depth repair joints indicated load transfer had been reduced in areas where improvements were anticipated. A general pattern of lower load transfer values, in the order of 20 percent, was observed when loads were applied on the repair itself versus loading on the old concrete. These data are shown graphically in Figure 11a.

This pattern may be explained by surficial loosening and softening of the granular base in the repair area during full-depth repair activities. These activities may create a thin loosened zone susceptible to deformation. The mechanism for the reduction of load transfer is inconclusive and will require further investigation.

The use of grease as a bond-breaking agent on the dowel bars in the repair has also been suggested as a possible contributor to reduced load transfer. The grease may create a small void around the dowel bar. Further investigation will also be required in this area.

Generally corner to center slab deflection ratios were improved following rehabilitation, as anticipated. The most significant improvement was in the reduction of the range of values obtained for corner to center deflection ratios. This result indicates that the weakest locations were improved and the entire length of the pavement has experienced an increase in stiffness and slab support, as shown in Figure 11b.
