# Analysis of Three Concrete Restoration Techniques

B. F. McCULLOUGH, DAVID W. FOWLER, JAMES R. LUNDY, AND  
BROCK E. HOSKINS

Three concrete pavement restoration techniques are described and the field performance of each is evaluated. Two of the three methods are used to restore the condition of continuously reinforced concrete pavements (CRCP) and the other was used to repair failed joints and broken slabs in an old plain jointed concrete pavement (JCP). Each of the techniques and the analysis results are described. A repair technique using polymer concrete to restore load transfer and seal surface cracks in several lane-miles of IH 610 in Houston, Texas, is described. This project, constructed in 1980, was surveyed in 1990. Results indicated that the majority of the repairs were intact after 10 years of heavy traffic. The area encompassing these polymer concrete repairs is currently being rehabilitated using a bonded overlay. One experimental section in the overlay project investigated the effectiveness of methyl methacrylate as a mop on pretreatment of the existing CRCP. Falling weight deflectometer (FWD) measurements taken before and after the treatment, as well as core analy

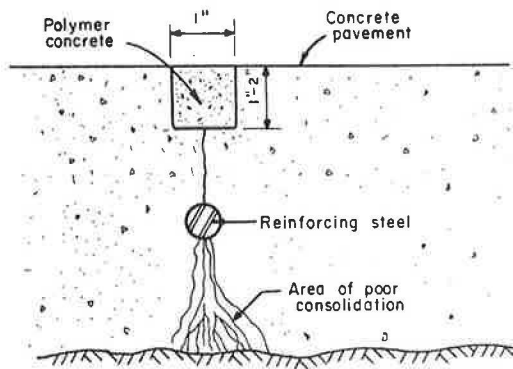
Uncontrolled longitudinal cracking was a commonly observed distress in CRCP in the Houston, Texas, area in the late 1970s. Uncontrolled longitudinal cracking may be defined as any longitudinal cracking not occurring at a construction joint or sawed joint. An investigation indicated that the primary contributing factors to this type of cracking included inadequate saw-cut depth, pavement thickness in excess of planned values, and concrete strength variability (1). An analysis of several cores indicated that the cracking typically occurred around steel bars, because of a plane of weakness created by the bar itself and by poor consolidation of the concrete beneath the bar as shown schematically in Figure 1. The deterioration associated with these cracks prompted an investigation into possible repair methods.

**FIGURE 1** Cross section of distress and repair.

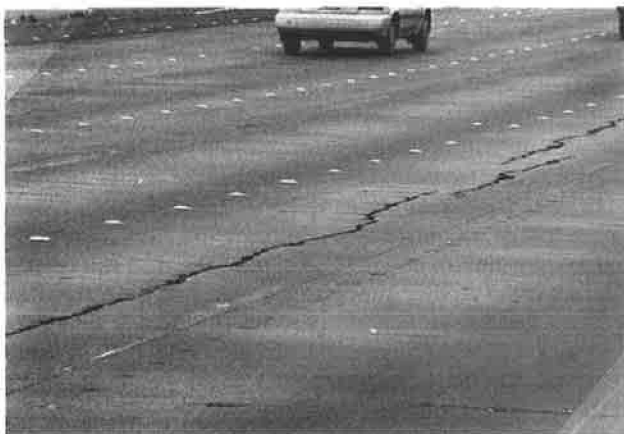
The University of Texas at Austin, CTR, and the SDHPT developed and implemented a repair procedure for the uncontrolled longitudinal cracking that was present on IH-610 in Houston (see map shown in Figure 2). An example of this type of cracking is shown in Figure 3. The objective of the repair procedure was to seal the cracks to prevent water intrusion and further corrosion of the reinforcing steel.

**FIGURE 3** Uncontrolled longitudinal cracking.

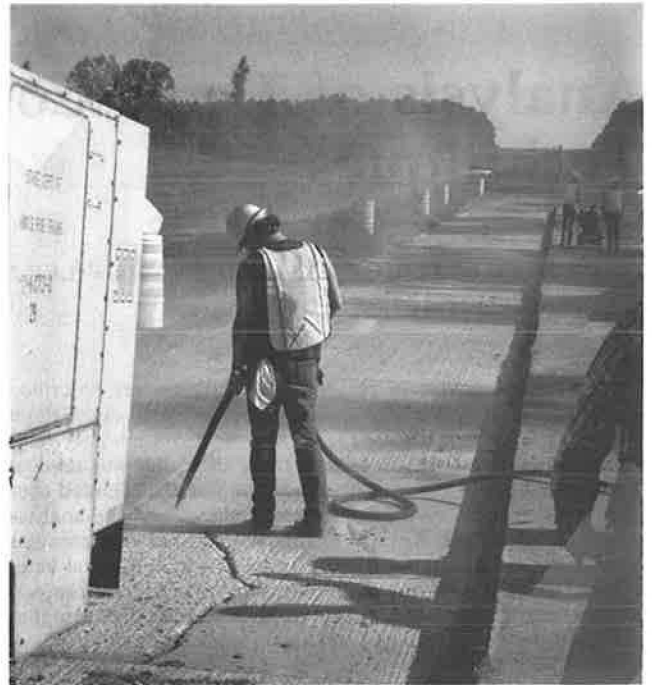
**FIGURE 4** Crack router in operation.

The repair procedure is described as follows. The cracks were enlarged to a depth and width of approximately 1 in. using a single-piston pneumatic crack router (see Figures 4 and 5). The crack was filled with dry concrete sand. A methyl methacrylate (MMA) monomer system was then poured over the sand until it was completely saturated (see Figure 6). This polymer concrete bonded to and sealed the crack.

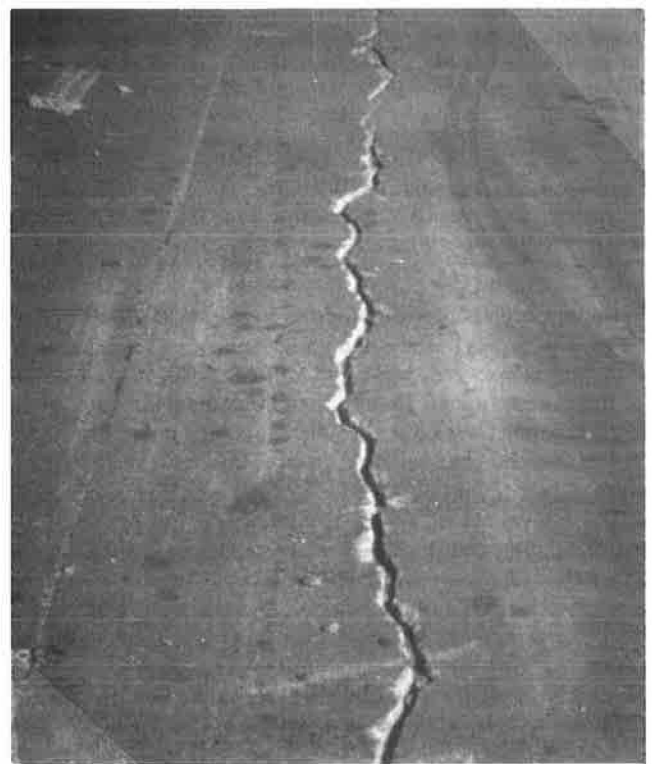
**FIGURE 5** Routed crack ready to receive polymer concrete filler.

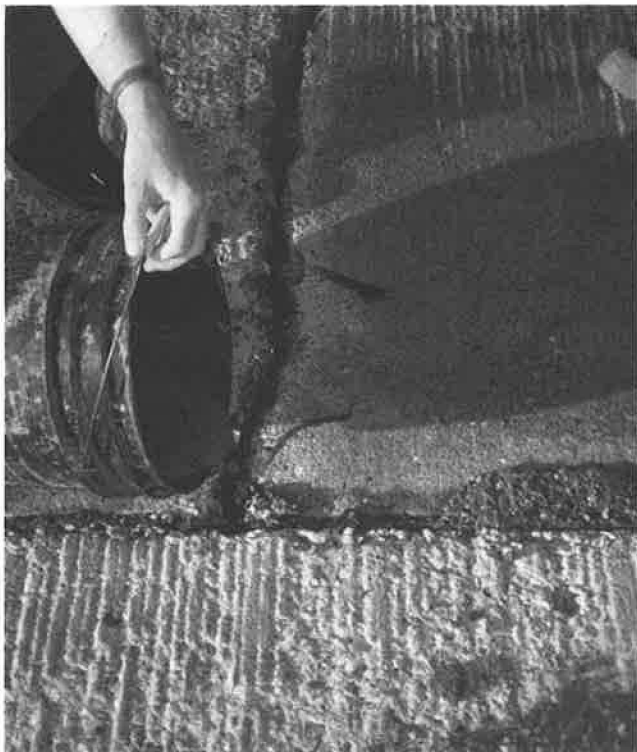
**FIGURE 6** Application of monomer.

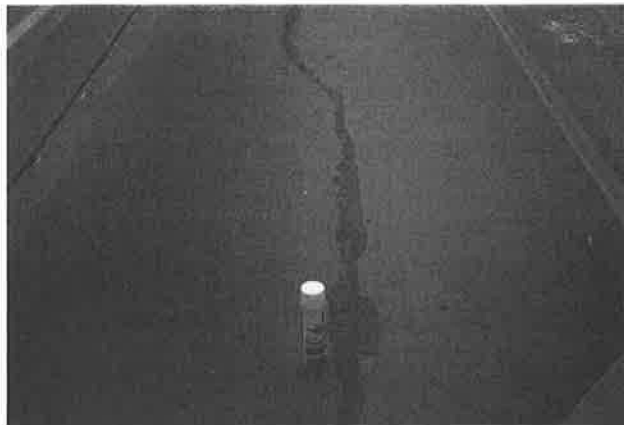
A followup survey was conducted in April 1990 to determine the long-term performance characteristics of the polymer concrete crack repairs. Five 200-ft sections were selected randomly. Three of these sections were located in the outside two lanes in the eastbound direction; the other two sections were located in the outside two lanes in the westbound direction. The repairs were again evaluated as being in good, fair, or poor condition. A rating of good required that the crack still be completely filled and sealed with the repair material. To be classified as fair, the majority of the repair material must be in place, but small infrequent cracks could be evident. A rating of poor required that all of the repair material had spalled out. Photos representing each rating condition are included in Figures 7–9. Rating quantities were based on linear feet of repair. The data obtained from the survey are presented in Table 1. Of the repaired longitudinal cracks surveyed, 85 percent were found to be in good condition, whereas only 10 and 5 percent were found to be in fair and poor condition, respectively.

**FIGURE 7** Repaired area typical of areas receiving a rating of good.

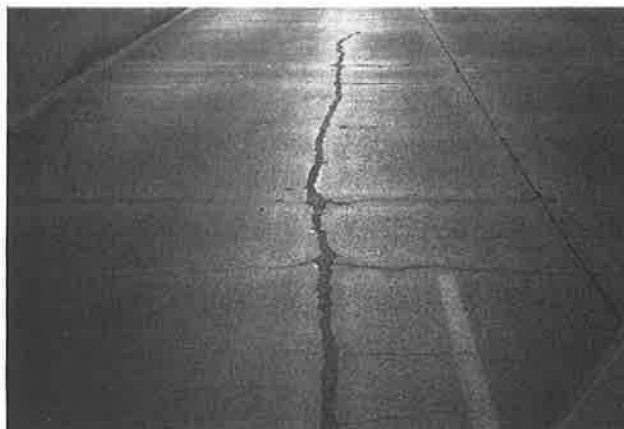
**FIGURE 8** Repaired area typical of areas receiving a rating of fair.

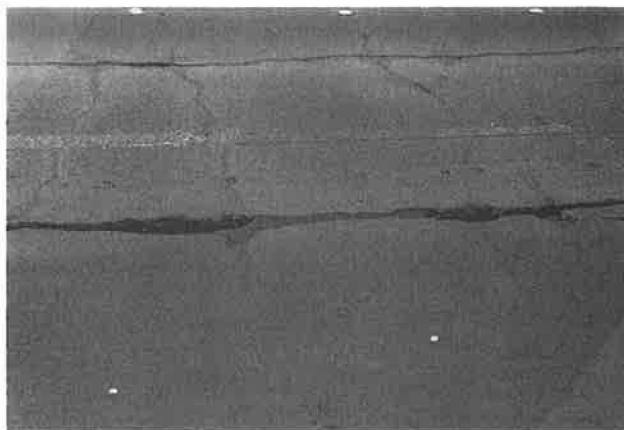
**FIGURE 9** Repaired area typical of areas receiving a rating of poor.

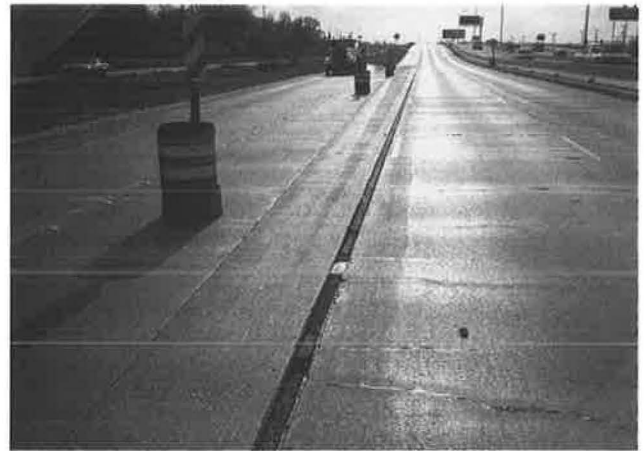
A common problem found in multilane facilities is the separation of lanes, particularly at the longitudinal construction joint shown in Figure 10. The parting of the adjacent lanes is particularly severe on horizontal curves where separation of 6 in. have been found. Uncontrolled longitudinal cracking may also be present on CRCP being considered for a bonded overlay. Although these cracks are narrow initially, with time they propagate and spall, resulting in a reduction in load transfer efficiency. The widths of these uncontrolled cracks are generally less than 1 in.

FIGURE 10 Separation of longitudinal construction joint.

These gaps, whether between lanes or midlane, represent a structural deficiency of the pavement. Transverse steel at these locations is deteriorated or nonexistent, thus eliminating load transfer. The opening allows the infiltration of water and incompressible fines, further aggravating the problem. Faulting and the associated traffic safety hazard eventually result if this problem is left untreated. Restoration of the structural integrity of the underlying slab is necessary before the placement of a bonded overlay.

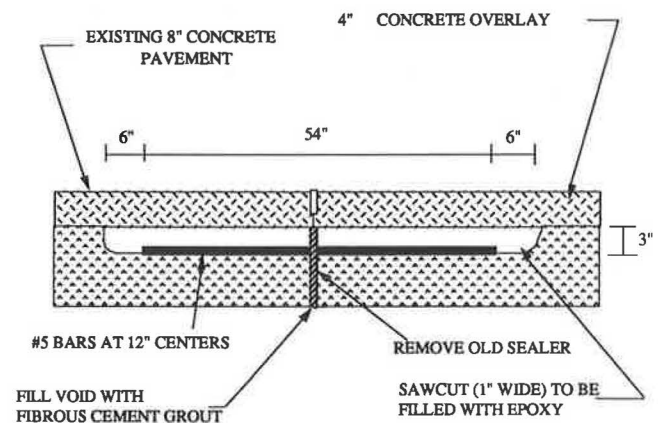
FIGURE 11 Schematic of longitudinal construction joint repair technique.

Several types of repairs were performed on an existing CRCP in Houston, Texas, before the placement of the 4-in. bonded overlay. One form of repair attempts to reestablish load transfer across failed longitudinal joints and cracks by stitching the two sides of the crack together. In this context, stitching refers to cutting 1-in.-wide slots at 12-in. centers perpendicular to the joint. These slots are cut to a depth of 3 in. and an overall length of about 54 in., centered on the joint. After the slot is cleaned, a No. 5 tiebar is epoxied in the groove. Normal surface preparation follows after the specified curing time. A schematic of the repair is shown in Figure 11.

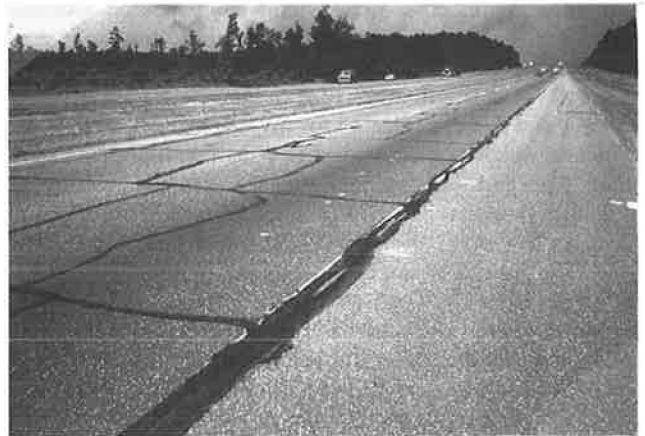
FIGURE 13 Repair site before construction.

Figure 13 shows the repair site before milling. Approximately 7 in. of asphalt concrete was removed. After milling was completed, three joints were selected for replacement using the precast drop-in unit (see Figure 14). Sawing and subsequent removal required approximately 4.5 hr. The precast joint was placed on a graded bed of cement-stabilized sand. Set 45 was used as the filler material, or zipper, for two of the slabs and polymer concrete for the other.

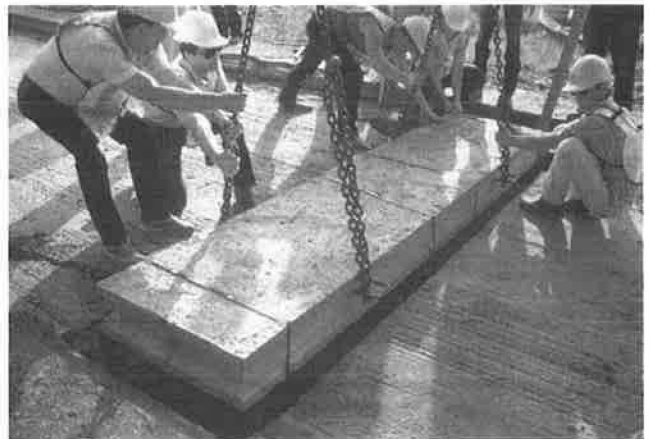
FWD measurements were taken on the concrete pavement before and after repairs. Analysis of the measurements in the entire repair section showed a 20 percent overall reduction in deflection because of the repairs. The precast slab showed a 22 percent reduction in deflection, on the basis of measure-

FIGURE 14 Placement of precast joint section.

ments taken at the joint and adjacent to the slab on both sides of the joint. This reduction represents improved load transfer across the joint, which causes lower stress and subsequently increases pavement life. This reduction also reduces the probability that faulting will occur at the joint and subsequently reduces the severity of reflective cracking.

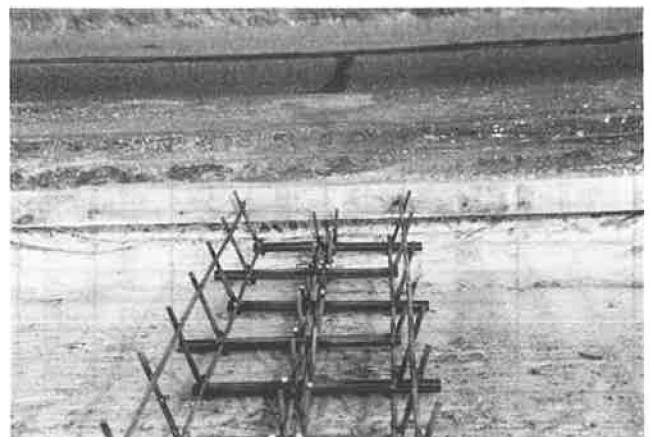
FIGURE 15 Milled joint and dowel basket assembly.

Another joint was milled to a depth of about 3.5 in. and a width of 4 ft using the milling machine. On the following day, this joint received a prefabricated dowel basket assembly and Type III concrete. The milling operation required approximately 30 min (see Figure 15). Because both joint repair preparation techniques (sawing and milling) use water to lubricate the cutting heads, there was considerable water standing on the slab following joint preparation. Several hours were spent removing the water and cleaning the slab for monomer placement the following day.
