Rehabilitation of the Lower Chariton River Levee by Lime/Fly Ash Slurry Injection

JUAN I. BAEZ, ROY H. BORDEN, AND JAMES F. HENRY

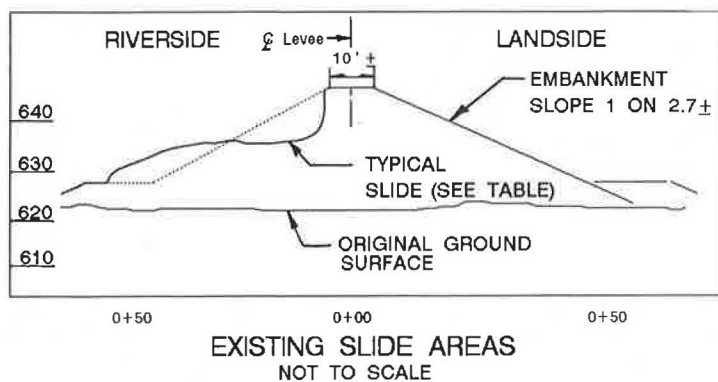
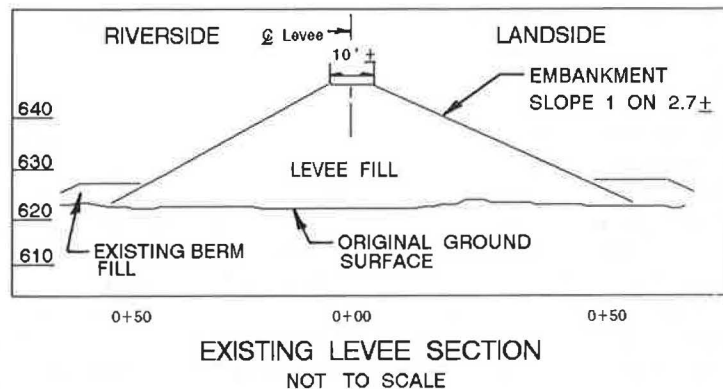
FIGURE 2 Typical levee slide and levee geometry.

The levee conditions prior to the beginning of the L/FA stabilization and rehabilitation program in 1987 indicated that before 1983 the levee unit appeared to be in stable condition. However, since that time numerous slides occurred, mostly on the riverside. There were no obvious reasons for the slides starting to occur more than 12 years after the levee was constructed.

Investigations indicated that as much as 13,600 ft of levee was in unstable conditions. When this Corps of Engineers internal report was written in 1985, approximately 1,300 linear feet of levee had been weakened by slides. Figure 2 shows the typical slide geometry and levee profile.

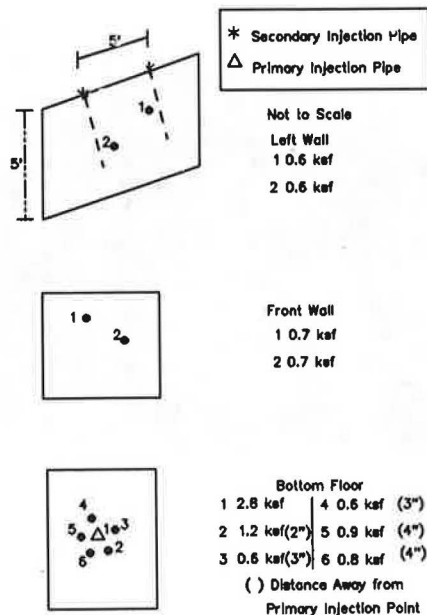
FIGURE 3 Hand vane shear results at Station 265+00.

A further analysis of data where this noticeable change is more apparent (Test Pits 3, 6, and 7) reveal a trend toward decreasing shear strength with distance away from the primary seam or injection pipe, as shown in Figure 4. Shear strength values ranged from 2.8 ksf on the seam or primary injection, to 1.6 ksf at 2 in. away, and 0.6 ksf at more than 4 in. and the remainder of the intact soil where no L/FA is apparent. These shear strength values correspond to net increases of 366 and 166 percent, respectively, over the shear strength of the intact soil (0.6 ksf).

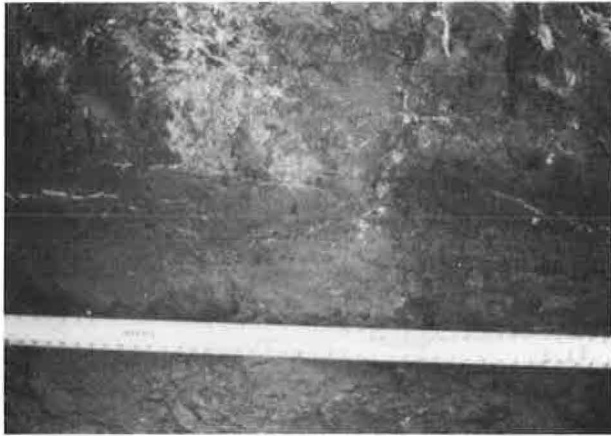
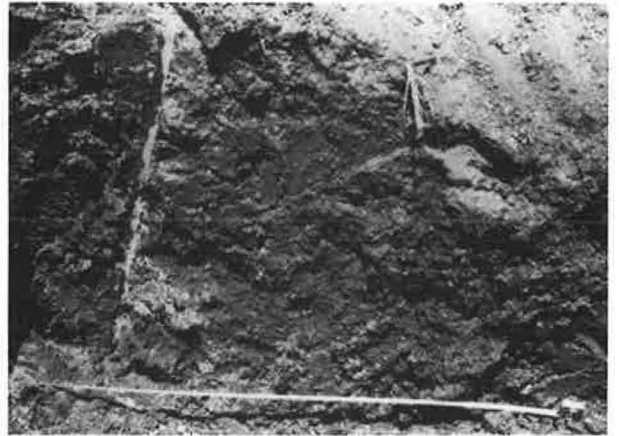
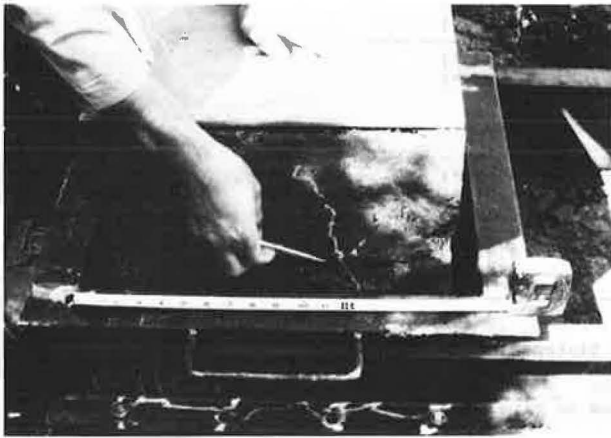
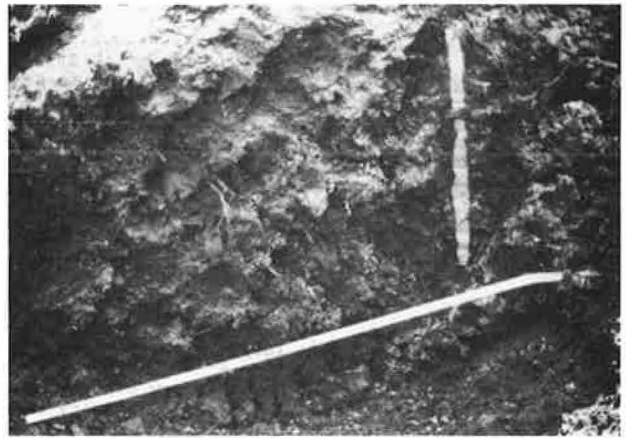
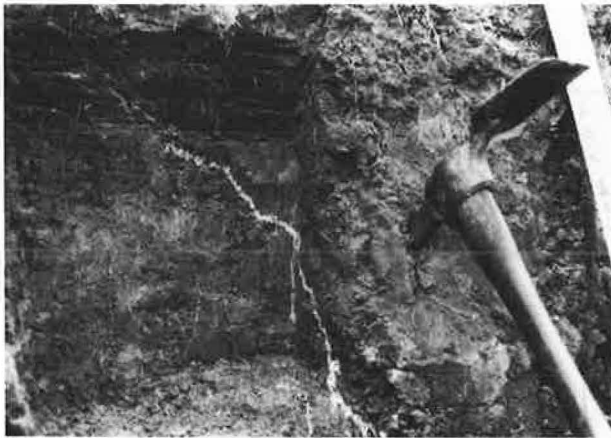
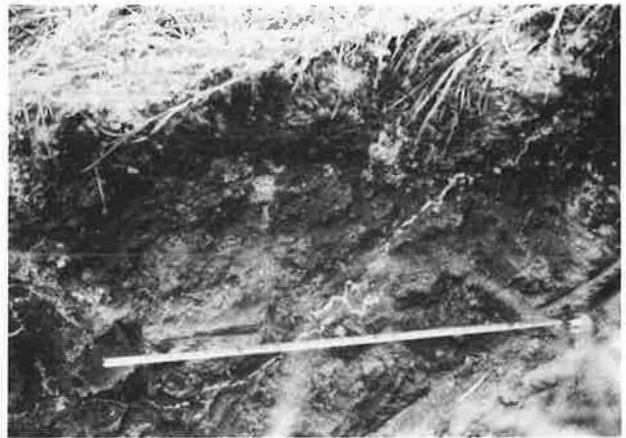
FIGURE 5 L/FA patterns at selected test pits. (a) Station 100 + 15, (b) Station 127 + 00, (c) Station 128 + 50, (d) Station 187 + 50, (e) Station 229 + 50, (f) Station 265 + 50.

In an attempt to quantify the frequency of L/FA-filled seams within the injected slopes, the side walls and floor of each test pit were carefully observed and photographed, and the evidence of slurry was documented. Figure 5 shows a group of pictures obtained from six test pits where the L/FA patterns were studied. The L/FA distribution was very irregular and not easily quantifiable. However, representative 2.5-ft by 2.5-ft areas on each of the side walls and floors were selected for analysis. Typically, the representative area was composed of slender seams and virgin soil. Seam thickness varied, but was generally less than 0.25 in. However, on one of the test pit walls (Station 100 + 15), L/FA coverage appeared over a large surface area, as shown in Figures 5a and 6. An analysis of the control area covered by the lime and fly ash indicated that approximately 0.3 ft² of the 6.25-ft² control area showed evidence of the L/FA. This represents an observed maximum coverage of 3.4 percent. However, the average coverage of the six treated test pits was approximately 1.6 percent.

Table 4 shows the estimated L/FA coverage for each phase of the six test pits and several significant average values. The test pit at Station 187 + 50 was the only section where a tertiary injection was performed; it was also the test pit showing a significantly higher L/FA coverage on the side walls.

Field observations of L/FA slurry patterns showed that the slurry fills opening and fissures that are intersected by the penetrating injection pipe. Sometimes a fissure may be intersected by more than one injection pipe, and during injection the slurry may travel to a previously penetrated injection location and exit to the ground surface. The test pits also showed that some existing fissures do not come in contact with the L/FA slurry.

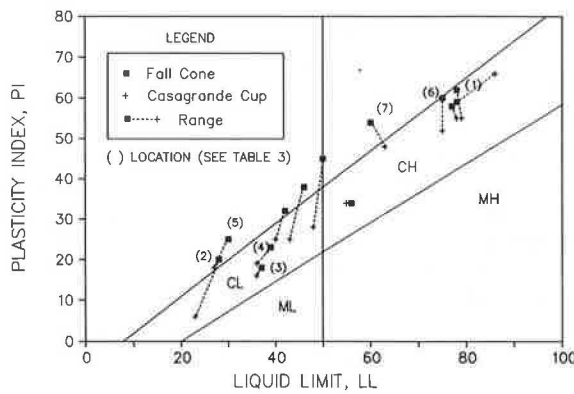
FIGURE 7 Plasticity chart showing range of soils obtained from Lower Chariton River right bank levee.

Soil samples obtained from the Lower Chariton River right bank levee were taken to the NCSU laboratory. Preliminary tests included grain-size analysis and plasticity indices. The majority of the tests indicated the presence of medium to highly plastic clays, as shown in the plasticity chart in Figure 7. Notice that many of the data plot near the U-line, indicating the presence of high-activity clay minerals (possibly montmorillonite).

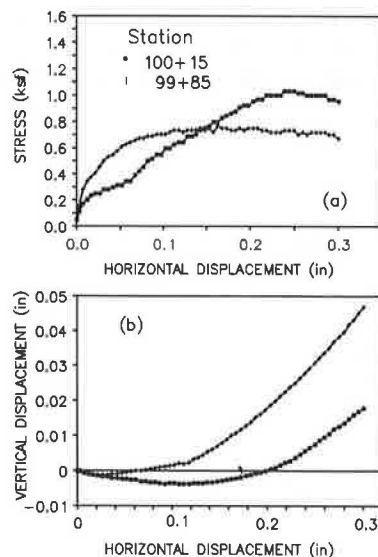
FIGURE 8 Average response of three direct shear tests from Stations 100+15 and 99+85.

Figure 8 shows the average direct shear test results from three samples obtained at Stations 100 + 15 and 99 + 85. These results indicate that the soil from Station 99 + 85 is stiffer in

the first 0.1 in. of horizontal displacement, but that as the sample continues to be displaced, the maximum shear stress levels off. On the other hand, the soil from Station 100+15 (treated with L/FA) shows a continuous increase in shear strength until a peak is reached near a horizontal displacement of 0.25 in. The average maximum shear strength for Station 100+15 is about 1.05 ksf, whereas the average peak shear strength for soil from Station 99+85 is about 0.75 ksf. This finding represents a difference of 40 percent in favor of the treated soil. However, care must be exercised in this interpretation because the soil at Station 100+15 is both drier and denser than the soil from Station 99+85. Table 5 summarizes the pertinent data. The above direct shear results are valid for a vertical stress equal to 364 psf (the existing overburden stress at the average depth of the previously observed failure surfaces).

The results from the drained direct shear tests seem to indicate that the L/FA slurry is helping in some way. It is difficult to quantify the improvement provided by the addition
