# Field Performance of Precast Reinforced Concrete Box Culverts

JOHN OWEN HURD

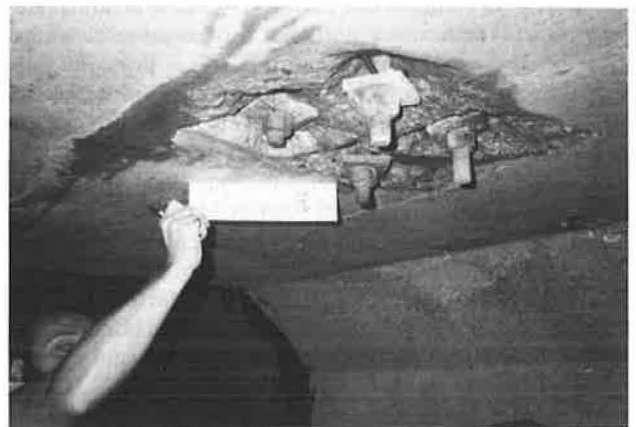
- **Lift hole and guardrail bolt holes:** The condition of the concrete around the bottoms of lift holes and guardrail bolt holes where through-bolting was used was noted. Any damage to the concrete was recorded and later subjectively rated as slight, significant, or severe. Serious spalling around guardrail bolt holes is shown in Figure 4.

**FIGURE 4** Spalling of concrete around guardrail bolt holes.

Corrosion at guardrail bolt holes is in part due to exposure of steel at the side of the hole. However, more severe corrosion occurs when a large part of the inner reinforcing cage is exposed by spalling of concrete, as shown in Figure 4. Seventeen of the 23 culverts with through-bolted guardrail connections had spalling rated severe or significant around the bottom of the bolt holes. This is thought to be caused by the impact of the drill striking the inner cage of reinforcement.

5. Where guardrail posts must be mounted to the precast box culvert tops, through-bolting should not be permitted.

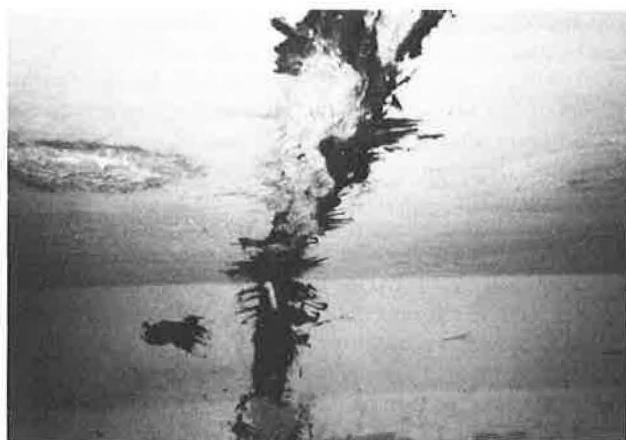
and recorded. On the basis of ODOT's experience with bridge deck and cast-in-place box culvert deterioration, there was concern that joint deterioration might cause progressive deterioration of the culvert tops and affect the condition of the highway fill or the road surface, or both. Joint leakage was later rated from photographs and descriptions as slight, significant, or severe. Severe joint leakage, salt deposits, and corrosion are shown in Figure 5.

FIGURE 5 Serious joint leakage, salt deposits, and corrosion.

Unwrapped joints sealed only with mastic or butyl joint material were ineffective in preventing leakage. This was true regardless of joint material, joint configuration, or joint fit. Leakage, salt deposition, and corrosion observed on joints were limited to the top of the box culvert and did not appear on the sides. The absence of any relationship between leakage severity and culvert age is probably due to a combination of the small age range of the culverts inspected and the ineffectiveness of the internal joint material in preventing leakage.

1. External joint wrap should be required on the tops and sides of precast reinforced concrete box culvert joints. If full membrane waterproofing of the top is provided, it need only extend 1 ft down the sides of the culvert.

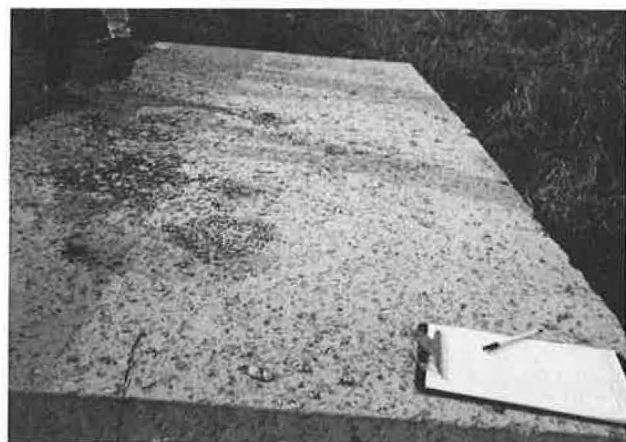
- Condition of exposed top surface: The condition of exposed box culvert top surfaces outside the pavement or back-fill was observed. Any spalling or other deterioration or damage was noted. Spalling on the unprotected top surface of one box culvert is shown in Figure 6.

FIGURE 6 Spalling on top surface of box culvert.

Surface deterioration of the top slab of the end sections on nine culverts was observed (see Figure 6). To date this has been limited to culverts without clear sealant or membrane waterproofing and with total earth and pavement cover less than or equal to 3 ft. The deterioration is probably due in part to exposure to roadway deicing salts. Air entrainment was suggested as a remedy for the surface deterioration. However, maintenance of consistent levels of air in the precasting process has been difficult for other precast structures.

2. A surface sealer (either full membrane waterproofing or clear sealant) should be required on the external top slab of precast reinforced concrete box culverts, especially those with

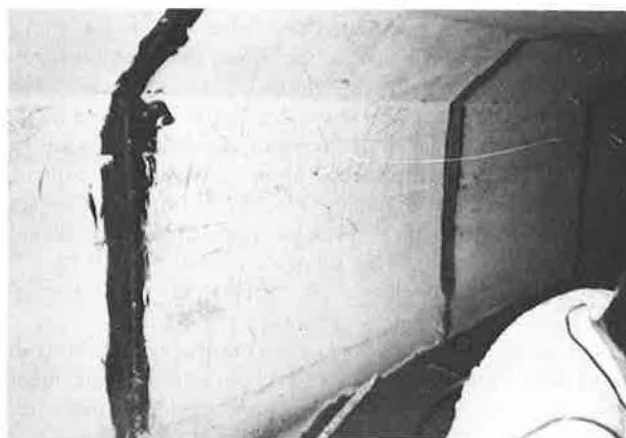
Observation of the joints on many box culverts was difficult because additional bituminous plastic cement joint filler had been spread around the exposed interior joint gap (see Figure 7). Some ODOT district construction personnel interpret

FIGURE 7 Joint material spread on inside of joint.

the ODOT specifications as requiring this application, whereas others do not. This not only prevents adequate inspection of the joint but also may trap moisture and salt in the joint and induce or aggravate deterioration.

6. Additional joint material should not be placed in the inside of the joint on the top and sides of the box culvert.
