Video Evaluation of Highway Drainage Systems

ROBERT F. STEFFES, VERNON J. MARKS, AND KERMIT L. DIRKS

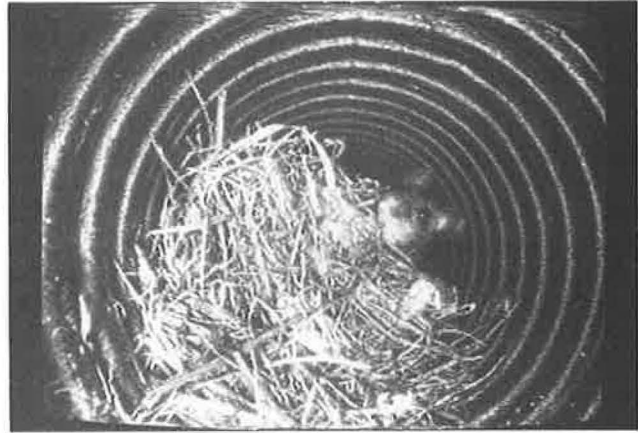
FIGURE 8 Rodent nests in subdrains.

Drought conditions prevailed across Iowa in 1989. With little or no water flow through the 4-in.-diameter edge-drain pipe, the conditions were favorable for rodent nesting in the drains. The rodent guards used were a hanging finger type, and they did not prevent small rodents from entering. The video evaluations in the fall of 1989 showed rodent nests in approximately 50 percent of the drains inspected.

No rodents nests were encountered by video evaluations during the rainy spring of 1990. There was evidence of rodent nest material—grass and fur—around the outlet of the drain. From these observations, it appears that water flows in the drains were sufficiently high or turbulent to flush out the rodent nests. A rodent guard made from $\frac{1}{2}$ -in. mesh is more suitable to prevent small rodents from entering.

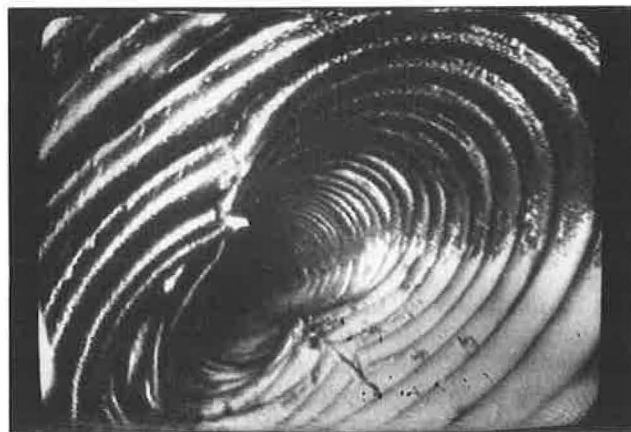
Excessive tension applied to the polyethylene corrugated pipe during installation can, in the worst case, cause it to tear and leave an opening. The opening is likely to allow backfill to enter and a cavity may develop above the opening. Pipe opening can also be caused by an oversized sharp stone, 3-in. diameter or larger, in the backfill, which may puncture the pipe during compaction. The pipe could also be stretched, which reduces its stiffness, resulting in collapse. If a drain is collapsed or plugged completely, the water flow will travel outside the pipe through the porous backfill.

FIGURE 9 Collapsed subdrain.
