Evaluation of Pumping Pavement on Interstate 77

JOHN S. BALDWIN

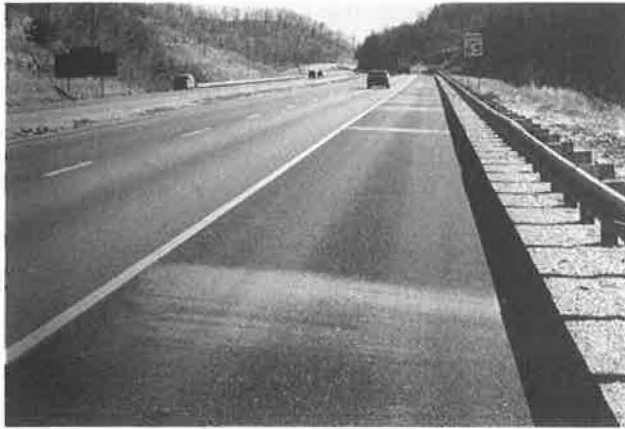
In March 1989 unusual sporadic staining of the paved shoulders of a rehabilitated section of Interstate 77 just north of Charleston was observed (Figure 1). Closer examination indicated that the staining appeared to emanate from the pavement-shoulder interface and to consist of fine soil particles that had pumped from the pavement substructure. A cursory inspection of the associated outlets indicated relatively good outflow, although similar staining was evident in the outwash.

FIGURE 1 Soil-stained shoulders.

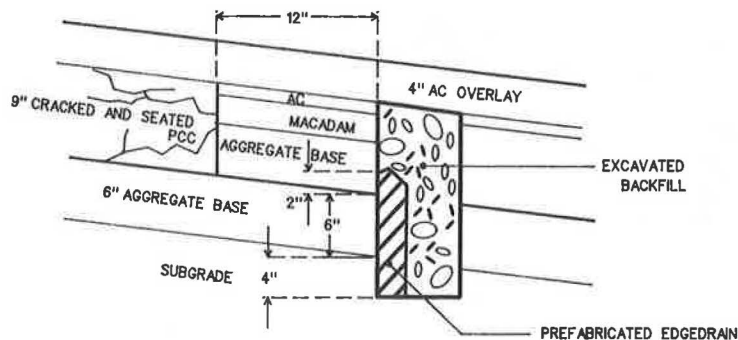
All prefabricated edge drains on Interstate 77, regardless of brand used, were installed 1 ft away from the edge of the pavement in the shoulder, as shown in Figure 5. The edge drain was placed at such a depth that its top 2 in. was on the same plane horizontally as the bottom 2 in. of the pavement slab. With a base course 6 in. deep, the bottom 4 in. (vertically) of edge drain was in the native soil. Consequently, because the material excavated from the trench was used as backfill, one-third of the backfill consisted of soil.

FIGURE 5 Original edge-drain installation design.

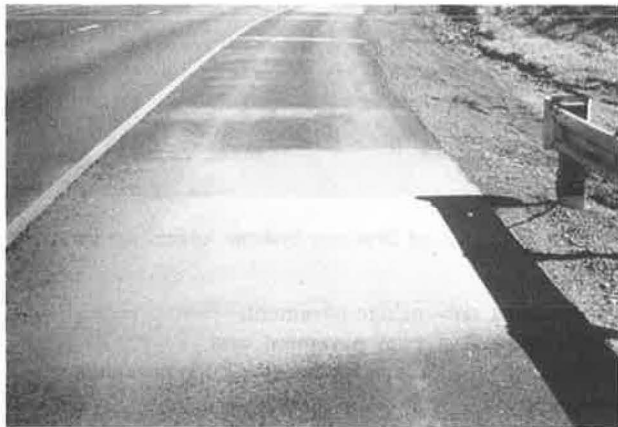
As shown in Figure 6, Test Pit 1 was excavated in an area that not only showed the most severe signs of pumping, but was still moist from pumping as the excavation was begun, even though it had not rained in several days. Although considerable information was collected, the most significant had to do with the base course and the soil contamination of the edge drain.

FIGURE 6 Site of Test Pit 1: severe staining of shoulder.

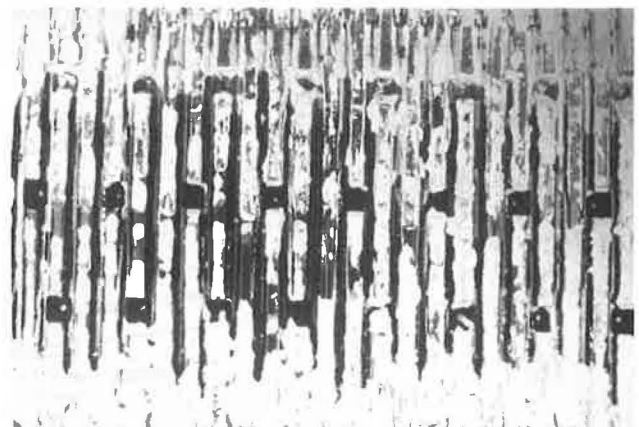
Soil contamination of the edge drain appeared to have a substantial effect on the ability of water to reach the internal flow channel of the AdvanEdge core (Figure 9). It is believed that most of this soil came from the backfill placed during the installation of the edge drain. Examination of the excavated sample revealed that less than 50 percent of the core wall slits remained open. The remainder of the slits were either partially blinded or totally plugged with soil sediment.

FIGURE 9 Soil-contaminated AdvanEdge core, Test Pit 1.

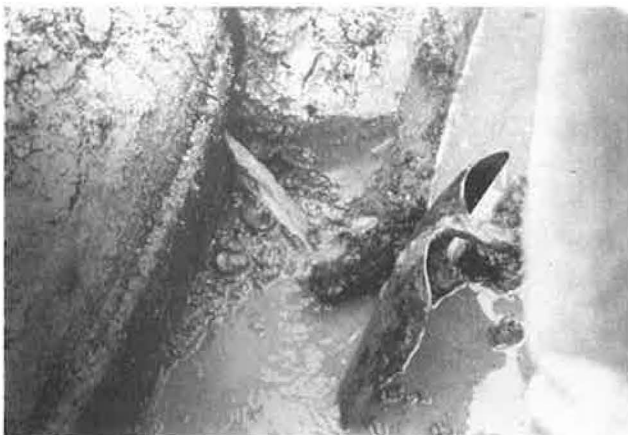
Earlier field reviews revealed only one small section of pavement (100 to 150 ft) drained by Hydraway that was showing signs of pumping. Although a test pit was excavated in the approximate center of the pumping area, it appeared that the area was located on a slight vertical curve that had not been provided with an outlet. Confirmation of this suspected cause of pumping was made when the test pit was opened. As the

hand digging got close to the edge drain, water began to flow rapidly from it, washing much of the backfill away from the shoulder side of the drain (Figure 10).

FIGURE 10 Water flow from hydraway, Test Pit 2.

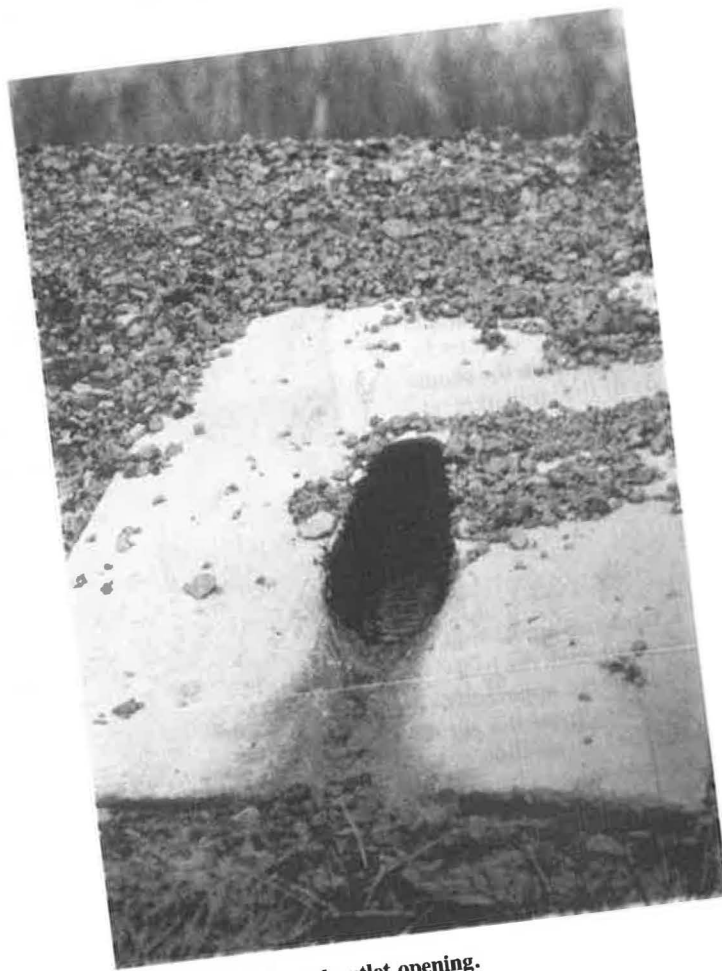
All outlets examined were constructed of 4-in. corrugated plastic pipe. The outlet openings were encased in a concrete headwall as shown in Figure 12. All outlets associated with pumping pavement appeared to be functioning, although soil staining of the outwash was apparent. Occasionally, an outlet was encountered that appeared to have a slight reverse grade, which may have slowed the drainage process. In addition, a

calcium carbonate crystalline growth was observed on several of the rodent screens and in the corrugations on the bottom of the outlet pipes.

FIGURE 12 Typical outlet opening.

2. Outlets should be constructed with smooth-walled rigid pipe to help ensure that the proper outlet grade is maintained.

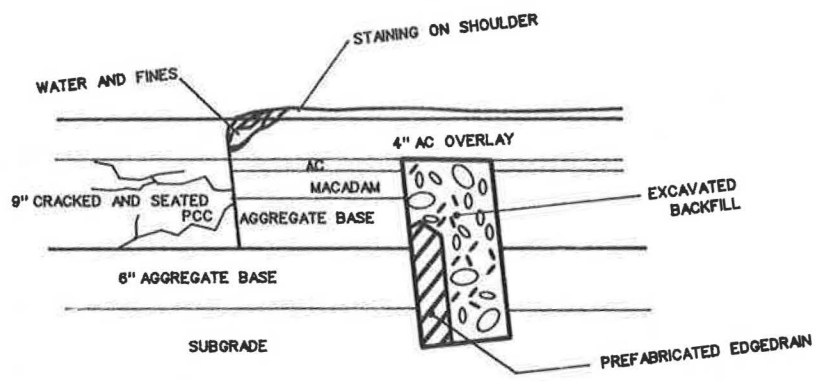
As shown in Figure 13, the staining of the shoulder is the result of water infiltrating the asphalt overlay into the cracked and seated PCC pavement slab. There it travels through the fractures in the slab to the pavement-shoulder interface. At that point, if anything impedes the flow of water to the surface drainage, it is essentially trapped in the fractures of the pavement. The main flow problem appears to be the very dense base course that surrounds the pavement and the location of the edge drain.

FIGURE 13 Origin of Interstate 77 shoulder staining.

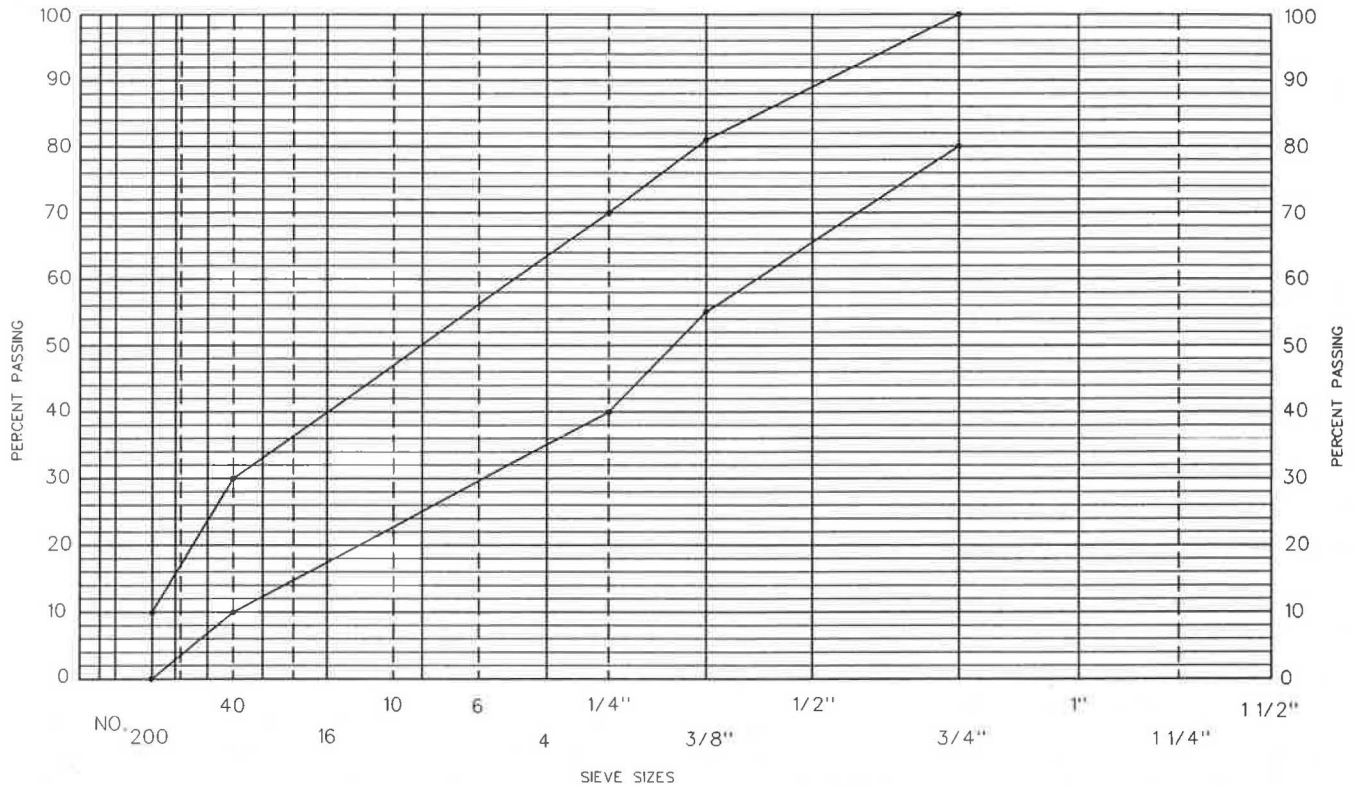
As shown in Figure 14, much of the base course used on Interstate 77 is very dense, almost to the point that it is impermeable. Because the edge drain was placed 1 ft out into this base course, free flow of water to the surface drainage in many locations is not possible. Under the circumstances, free water and suspended fine particles have only one way to go under traffic loadings—up through the asphalt and onto the pavement surface. In an effort to reduce, if not eliminate, the same problem on future rehabilitation projects, the following recommendations have been made:

FIGURE 14 Gradation range used for original base course (sieve sizes raised to 0.45 power).
