Evaluation and Performance of Geocomposite Edge Drains in Kentucky

DAVID L. ALLEN AND JOHN FLECKENSTEIN

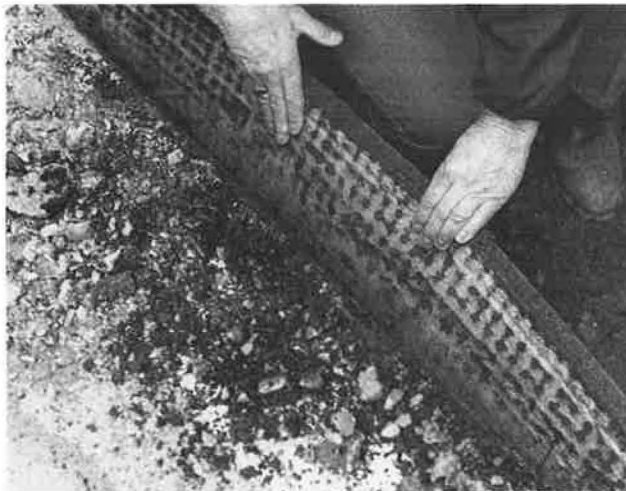
After the panel drain had been in service for 2 years, approximately 15 ft of the material was dug up and examined. The drain appeared to be in good condition. The fabric was clean and there was no evidence of clogging (Figure 4). The core also was in good condition. The drain was borescoped approximately 2 years later at several locations. Some minor distress was observed in the core because of compaction of the sand backfill. Observations at other sites that used the excavated trench material as backfill showed considerably more damage. It is apparent that the first installation in Kentucky was one of the best. Less effort had to be used to compact the sand backfill, which minimized the potential for damage to the panel drain.

FIGURE 4 Excavated Type-A drain on I-64, Franklin County.

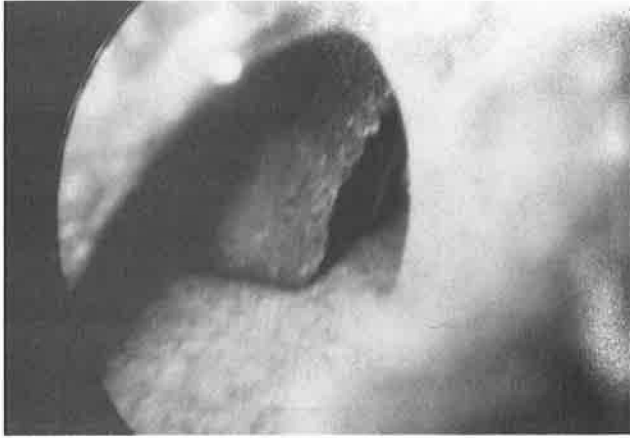
After the drains had been in service for approximately 2 years, a borescope was used to examine and photograph the condition of the core of both brands. The interior of the cores of both brands appeared to be relatively clean, with only trace amounts of silt present. The Type-B core was in good condition (Figure 7). However, the Type-A core appeared to

FIGURE 7 Open Type-B core showing no signs of overcompaction.

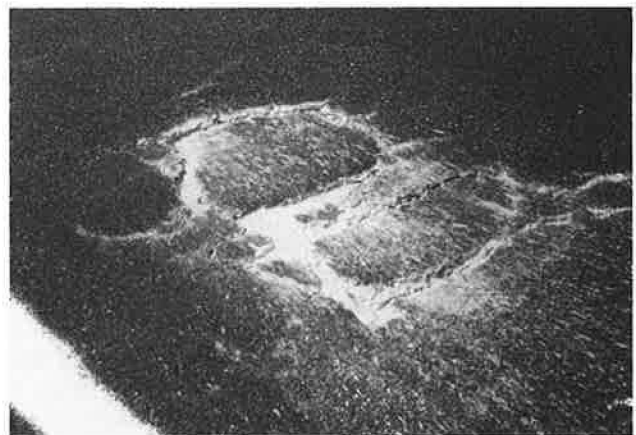
In April 1988, approximately 8 months after the project was completed, an average of five sites per mile showed signs of severe distress. Water and white, silty fines were pumping up through the new asphalt overlay, severe potholes were beginning to form in the overlay, and many of the sites required patches (Figure 9). In addition, water was pumping up through the asphalt overlay at the old joint between the shoulder and the broken slab (Figure 10).

FIGURE 9 Water and silty fines pumping up through pavement on Pennyrile Parkway.

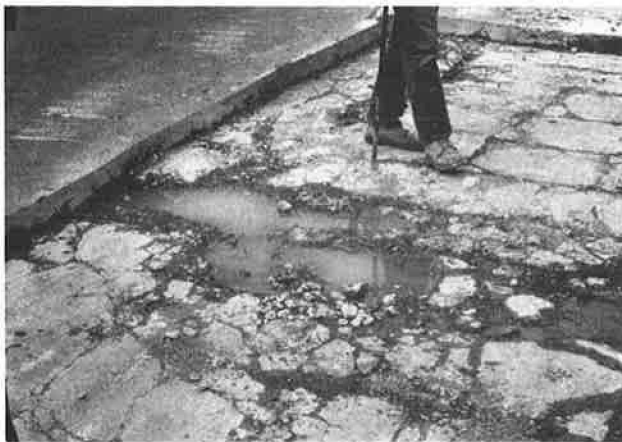
Two of the sites at which severe distress was evident were excavated to determine if the panel drains were working properly. When the 4-in. asphalt overlay was removed, the old broken slab was found to be full of water (Figure 11). After the newly installed panel drain was excavated and pulled away from the side of the old slab, water drained freely from the old slab for almost an hour. It appeared that the drain had actually been acting as a dam (Figure 12). The panel drain was cut and a piece removed for examination. The core had

FIGURE 11 Water ponding in old broken slab.

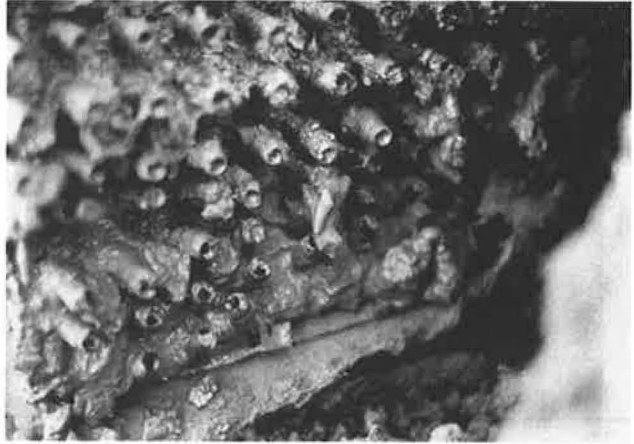
FIGURE 16 Exposed inner core showing siltation.

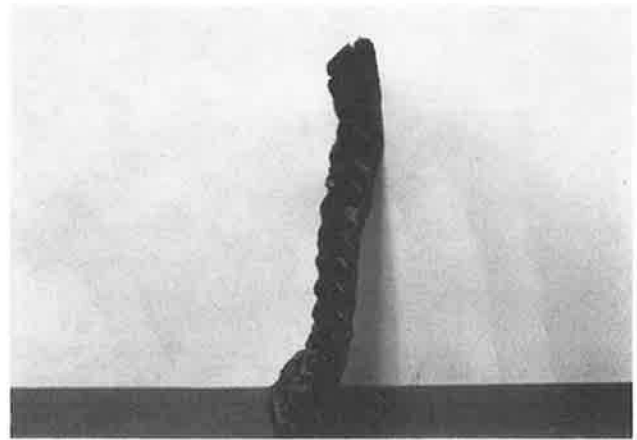
Sections of Type A and Type C were excavated in 1989 after being in service for approximately 1 year. Both products appeared to have some silt in the core, but water was flowing freely through them. The Type-A core was reduced from its original height of 12 in. to approximately 10 in. and many rows of columns were compressed (Figure 19). The Type-C core appeared to be in good condition, although a small amount

FIGURE 19 Excavated Type-A drain showing compression.

Because of the known compaction problem and the possibility of a silting problem, the Kentucky specifications on installation of panel drains were changed in 1989. The new specifications require the panel drain to be installed on the shoulder side of the trench instead of on the pavement side. Backfilling with the trench cuttings is no longer permitted; a clean, coarse sand is specified for backfill material (Figure 20). The sand must also be compacted by flushing the trench with water, thus avoiding the use of heavy compaction over the panel drains. The sand backfill should prevent much of the silt from the broken concrete slab and possibly the dense-graded aggregate from reaching the fabric on the drain core. All projects constructed since the latter part of 1989 have used the new specifications. Later borescope inspections of these projects, after they were completed, showed no damage to the core of the panel drains.

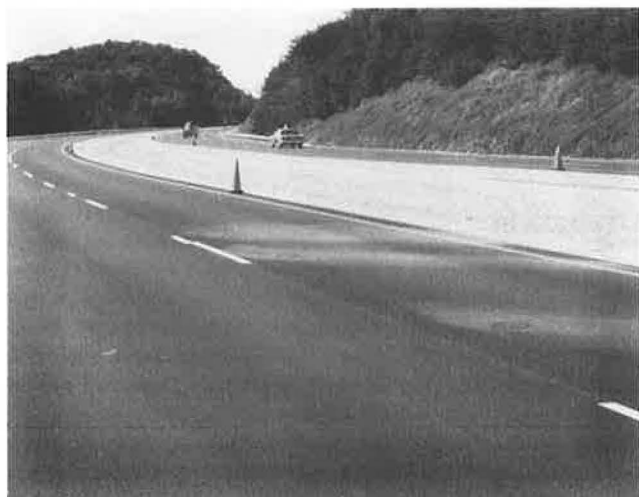
However, in 1989 some spot distresses were beginning to appear in the rehabilitation projects completed on the Mountain Parkway in 1988. At some sites, silt was pumping up through the 8-in. asphalt overlay at the shoulder joint and in the middle of the passing lane (Figure 21). Excavation of two of these sites showed evidence of poor construction practices. At one the outlet pipe had not been connected to the headwall and consequently it was completely blocked. At another the outlet pipe was crushed just before it entered the headwall. Of 14 outlet pipes inspected by using the borescope, 11 had

FIGURE 21 Silt being pumped up at centerline of Mountain Parkway.

guardrail posts driven through them. All the edge-drain outlet pipes on the inside shoulder were connected to the bottom of the drop inlet boxes located in the median. This allowed silt and trash in the bottom of the box to block the outlet pipe.
