# Transverse Pipe Underdrains for Highway Groundwater Control: A Case History

JOHN O. HURD AND HERBERT DUNCHACK

Longitudinal pipe underdrains and transverse pipe underdrains spaced at approximately 60-ft intervals were used to provide groundwater control on one section of the Kirtland-Chardon Road highway project in Lake County, Ohio. This area was designated spring area by the geotechnical consultant because of extremely severe groundwater problems in the subgrade. Normal practice is to provide aggregate drains spaced at 50-ft intervals on uncurbed flexible pavements, but the severe groundwater problems on this section warranted additional drainage. Aggregate drains were placed on the remaining uncurbed sections of the project per normal practice. Four years after construction, the pavement in the spring area, where the improved drainage system was provided, is in excellent condition. Severe distress has been observed in the areas with standard drainage that abut the spring area.

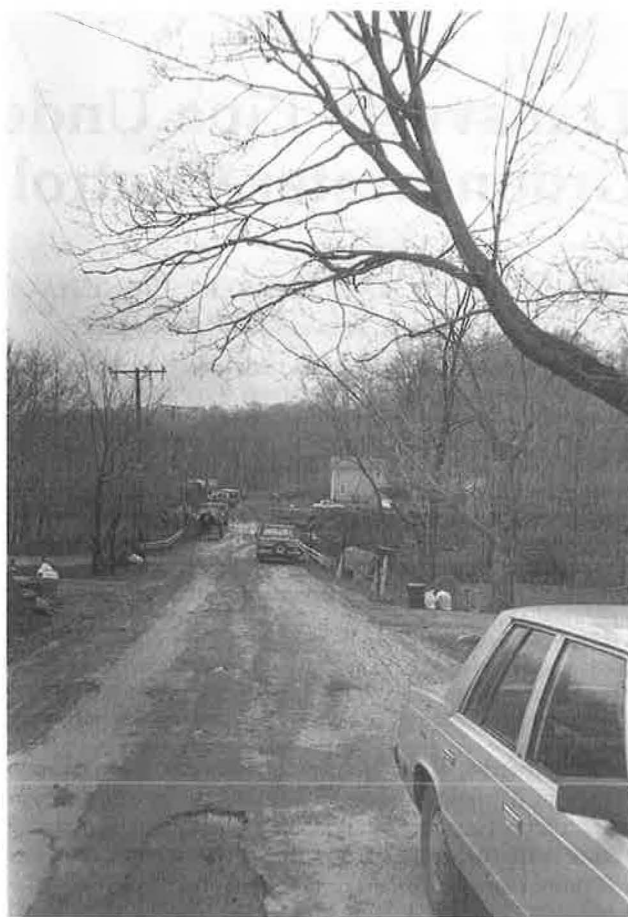
Despite the fact that the traffic loads on the highway were relatively light, the pavement and base had deteriorated to the point that complete replacement of the pavement structure was required on approximately 75 percent of the roadway length in Lake County (Figure 5). The remaining 25 percent needed salvage construction requiring spot repair, leveling, and a surface overlay. The locations of the replacement and salvage sections are shown in Figure 6. All salvage areas were

FIGURE 5 Pavement condition before construction.

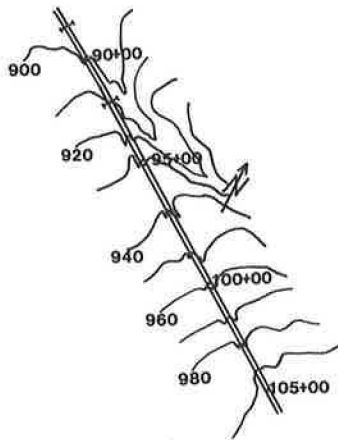
The subgrade soils in the borings were found to be generally clayey silt, silty clay, and clayey silty sand. At many boring locations, the subgrade soil was moist to wet. Groundwater was observed flowing into the test borings at several locations. One particular steep 1,500-ft section of the highway was designated "spring area" in the foundation consultant's report (1). Water had been observed percolating up through the pavement surface at several locations along this section. The spring area is indicated in Figure 6; Figure 7 shows the steep topography of that section.

FIGURE 7 Spring area topography.

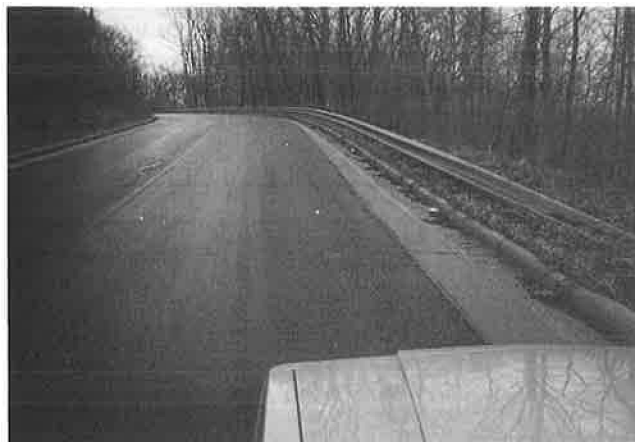
No significant pavement distress had been observed on the curbed sections. Only a few thin longitudinal cracks or cracked spots were observed (Figure 13). The longitudinal underdrains appeared to have provided adequate subsurface drainage.

FIGURE 13 Condition of pavement on typical curbed section.

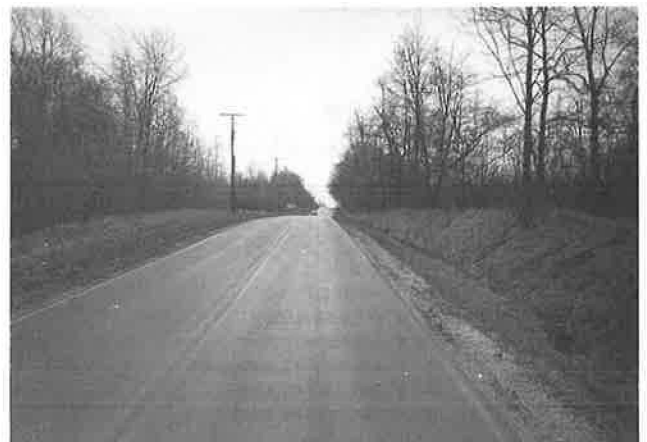
No pavement distress had been observed in the spring area (Figure 15). The inspections indicated (in retrospect) that the spring area subsurface drainage system should have been extended in a somewhat westerly direction outside the delineated spring area. There was little doubt that the spring area drainage system had provided adequate subsurface drainage. Figure 16 indicates subsurface flows through the outlet pipes under relatively dry conditions. Detailed monitoring of subsurface drainage discharge was beyond the scope of this project.

FIGURE 15 Condition of pavement in spring area.

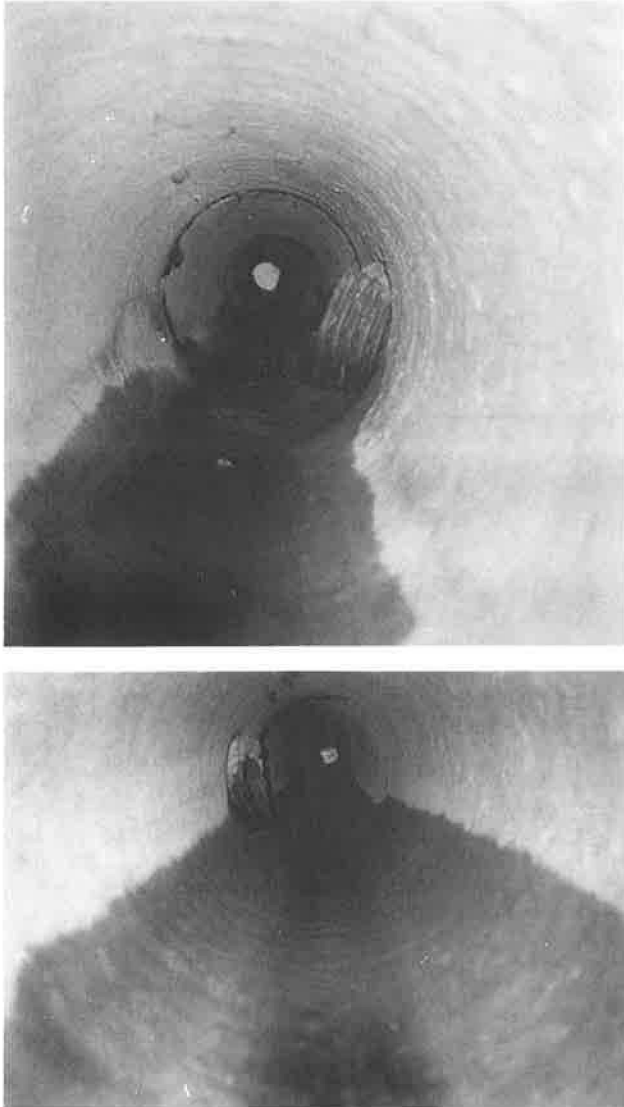
**FIGURE 16** Dry-weather flow in outlet pipes, two views.

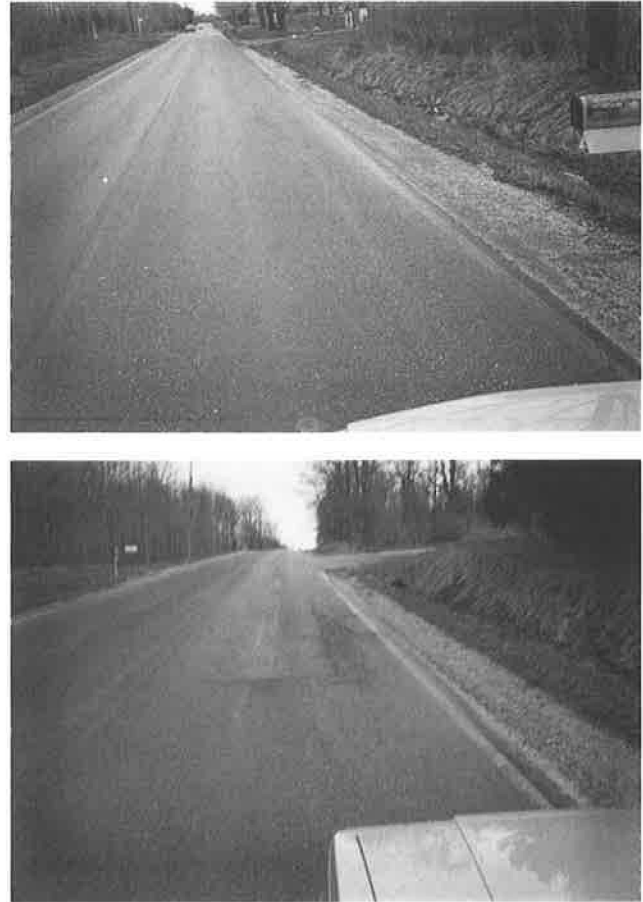
No significant pavement distress had been observed on the typical uncurbed section east of the spring area. Its condition (Figure 17) was similar to that of the typical curbed section. The aggregate drains appeared to have provided adequate drainage. It should be noted that most of this area was composed of salvage sections that were in fair condition before construction.

**FIGURE 17** Condition of pavement on typical uncurbed section east of spring area, two views.
