TRANSPORTATION RESEARCH  
**RECORD**

No. 1329

**Geocomposite Pavement  
Drain Systems  
1991**

# Transportation Research Record 1329

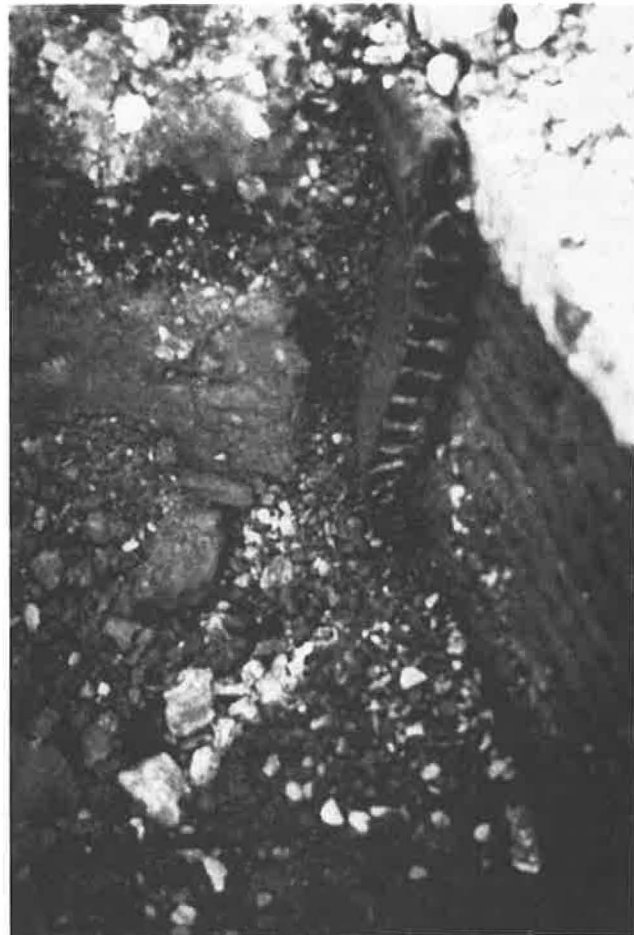
**FIGURE 3** Excavated geocomposite showing similar fabric intrusion to that in Figure 2.

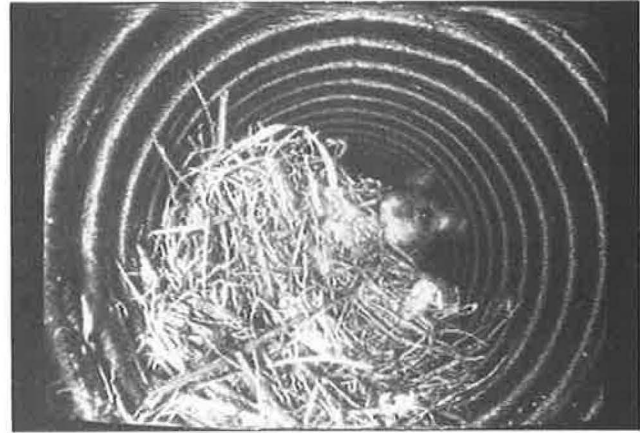
1. Rodent nests in the drain (Figure 8),

FIGURE 8 Rodent nests in subdrains.

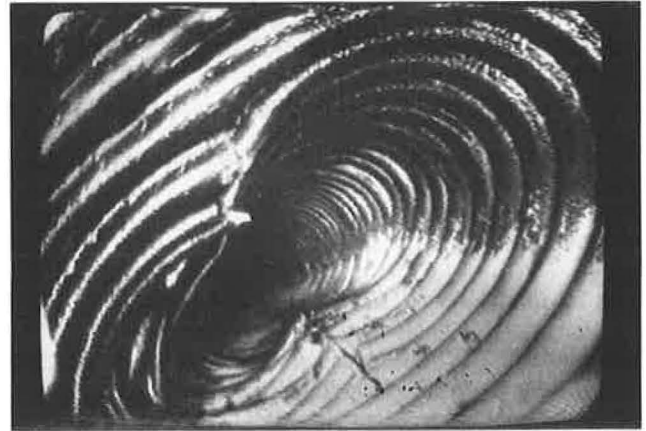
FIGURE 9 Collapsed subdrain.

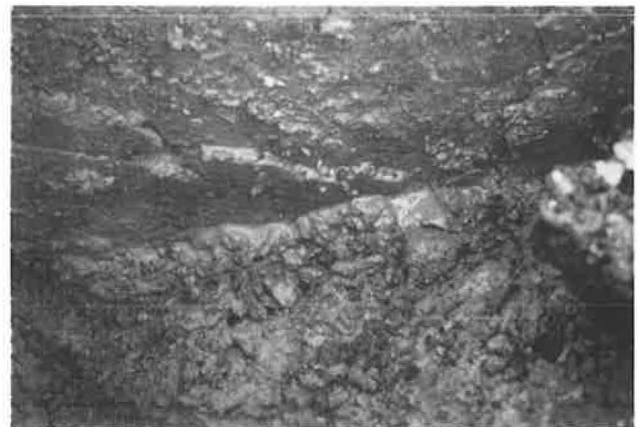
FIGURE 8 Free water from cracked pavement slab, Test Pit 1.

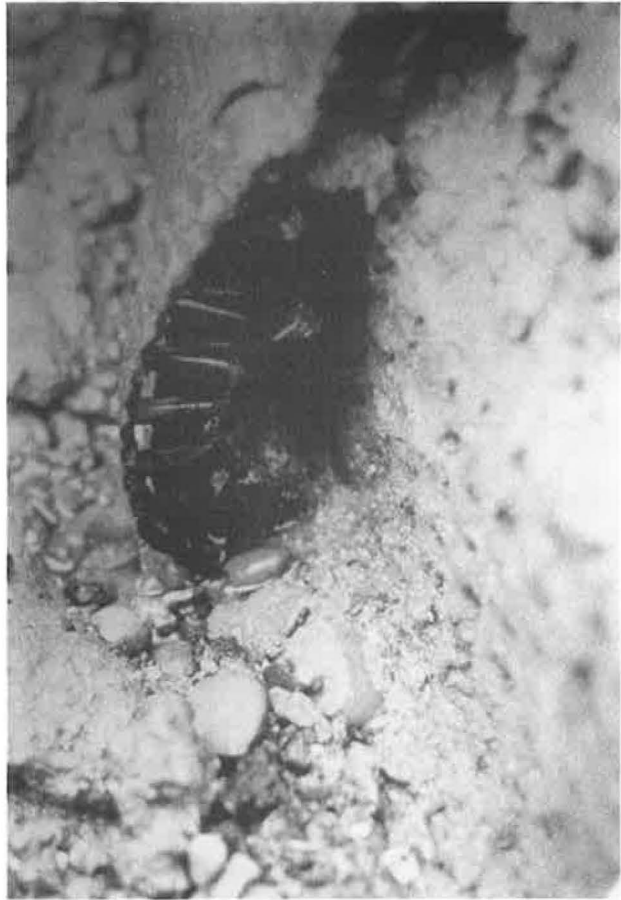
FIGURE 11 Hydraway deformation, Test Pit 2.

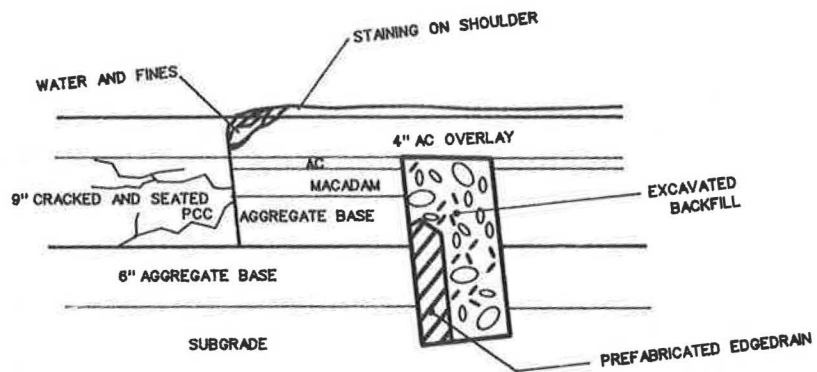
FIGURE 13 Origin of Interstate 77 shoulder staining.

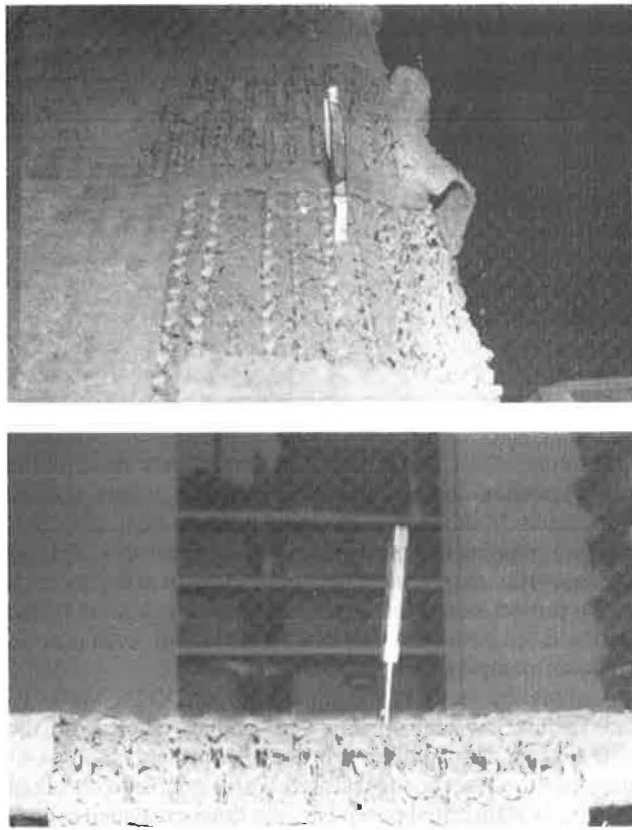
**FIGURE 1** Clogged prefabricated pavement base drain (two views).

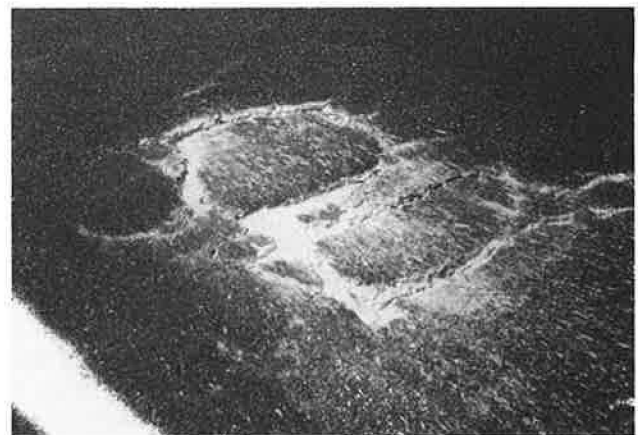
**FIGURE 9** Water and silty fines pumping up through pavement on Pennyrile Parkway.

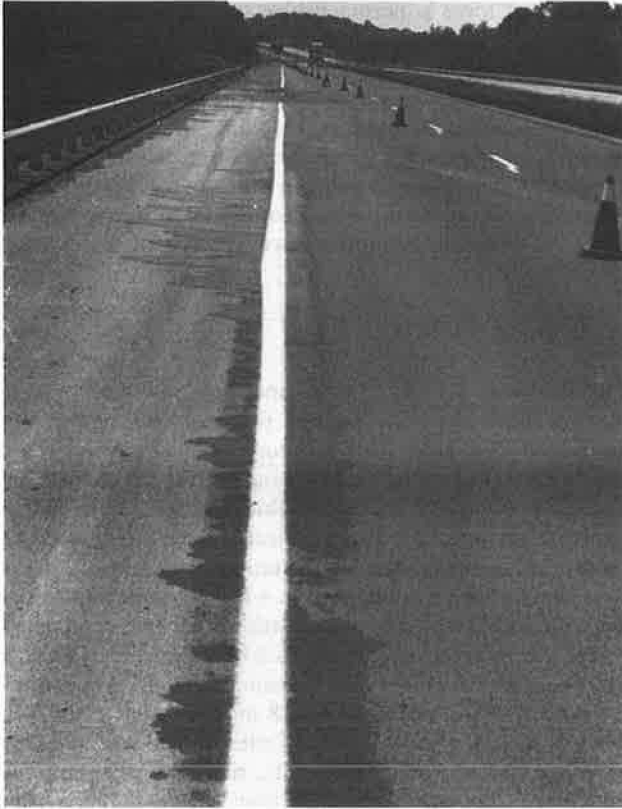
**FIGURE 10** Water pumping up through asphalt overlay directly above edge drain.

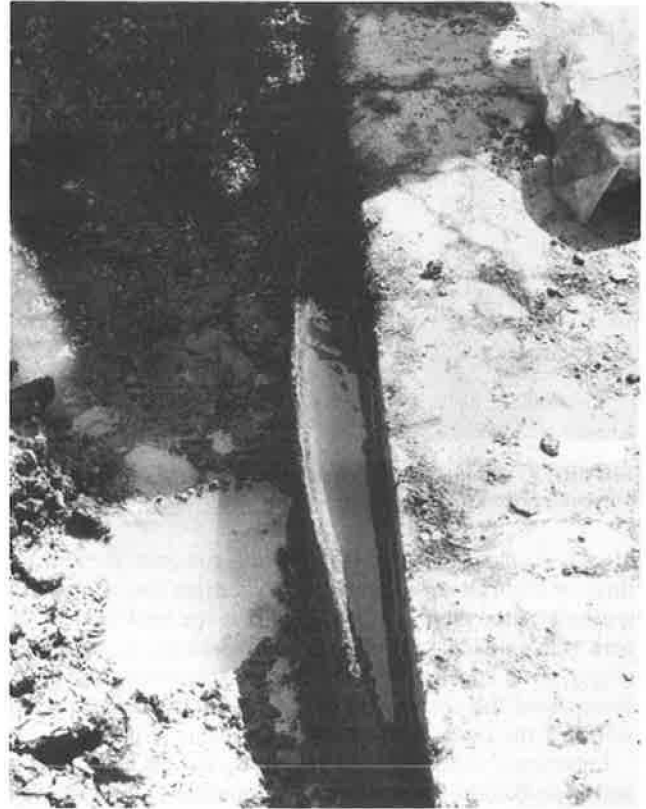
**FIGURE 12** Water ponding behind Type-A edge drain.

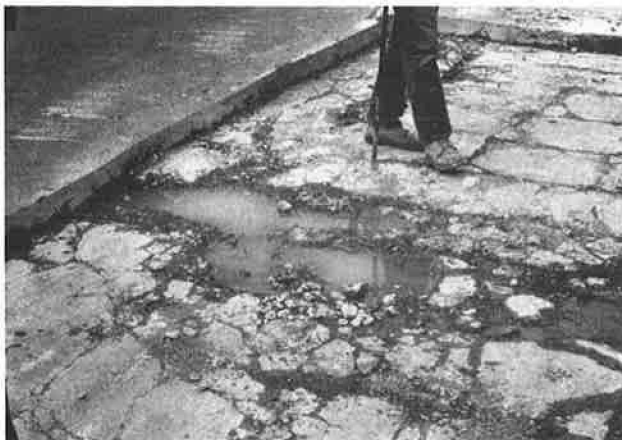
**FIGURE 11** Water ponding in old broken slab.

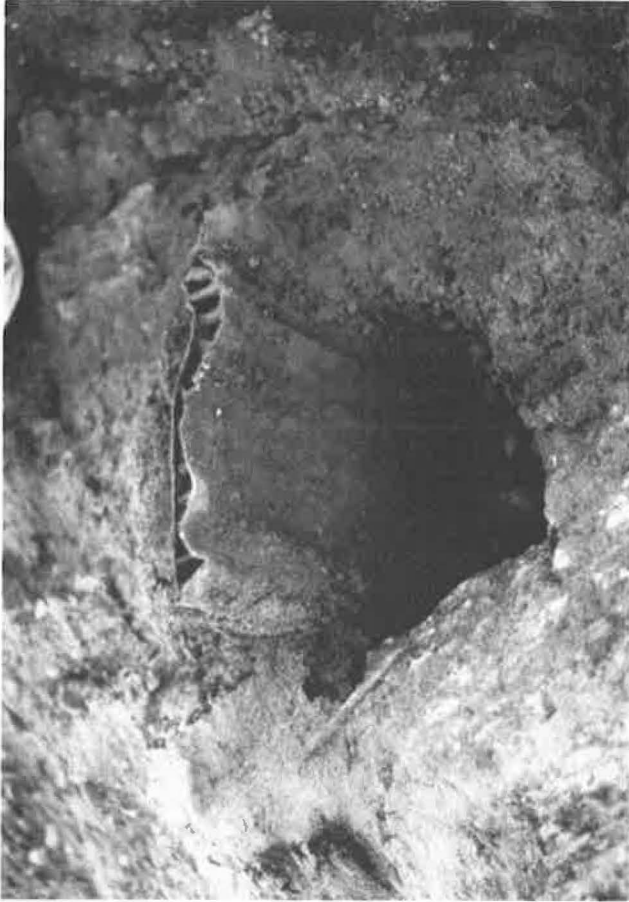
**FIGURE 14** Severely compressed Type-A drain.

Improper installation of the outlet pipes and overcompaction of the backfill material in the trench, which caused crushing of the core, appeared to be the principal causes of the failure of the panel drains on this project (4). The outlet pipes were made of flexible polyethylene. At both of the sites excavated, the outlet pipes were partly crushed, and one appeared to have a 4-in. hump, which decreased the water ve-

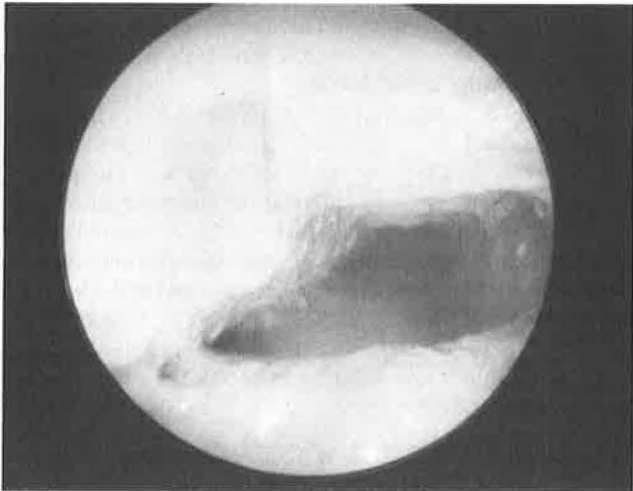
**FIGURE 15** Severely silted inner core of Type-A drain.

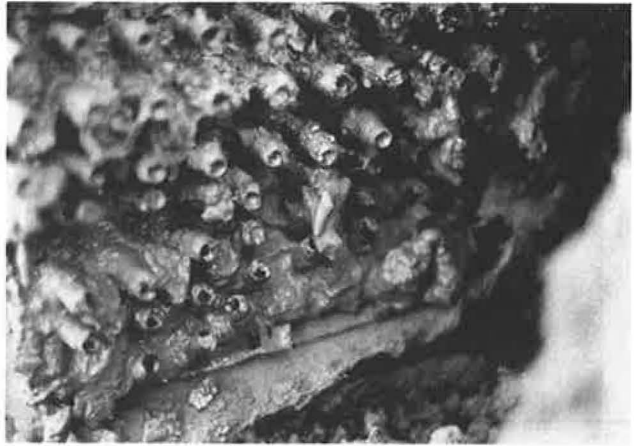
**FIGURE 16** Exposed inner core showing siltation.

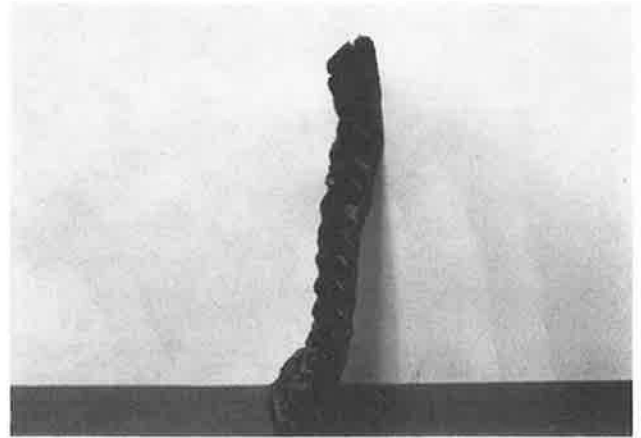
FIGURE 19 Excavated Type-A drain showing compression.

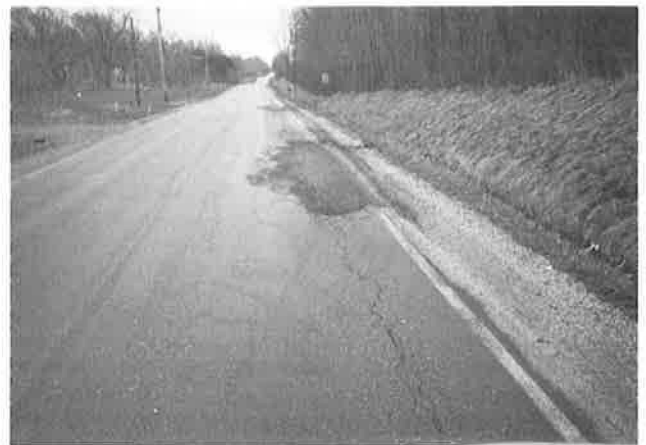
Significant distress, including alligator cracking, rutting, or both, had been observed on the typical uncurbed section west of the spring area (Figure 14). Repair of the pavement had

FIGURE 14 Condition of pavement on typical uncurbed section west of spring area.
