Pile Integrity Testing To Determine Storm-Induced Damage

WILLIAM CAMP AND MOHAMED HUSSEIN

Hurricane Hugo made landfall in 1989 near Charleston, South Carolina, causing extensive damage. A pleasure boat marina was exposed to the full force of the storm. The marina consisted of concrete floating docks held in place by 14-in.-square prestressed concrete piles. The 42-ft-long piles had been driven 2 years before, and installation records were not available at the time of the testing (1990). The water depth was between 2 and 10 ft, and the soil conditions consisted of approximately 10 ft of soft mud overlying the Cooper Marl. During the storm, the surge floated the docks to nearly the pile tops and the extraordinary winds and waves pushed the large pleasure boats against the piles. After the storm, it was observed that some piles could be moved several inches laterally simply by pushing on them while standing on the docks, thereby causing the pile integrity to be questioned. Short on time for the new season, the owner was faced with a serious problem with potentially expensive remedies. Low-strain integrity testing performed on each of the 78 piles provided a timely and cost-effective

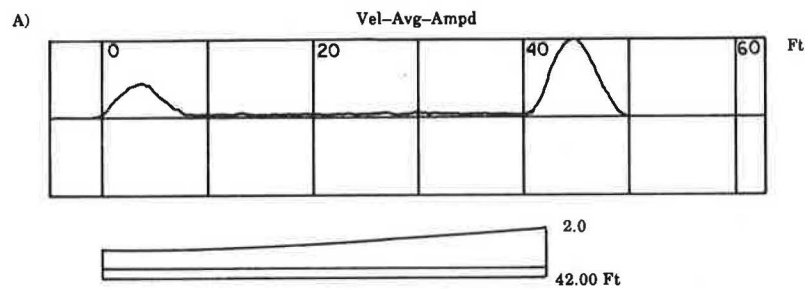
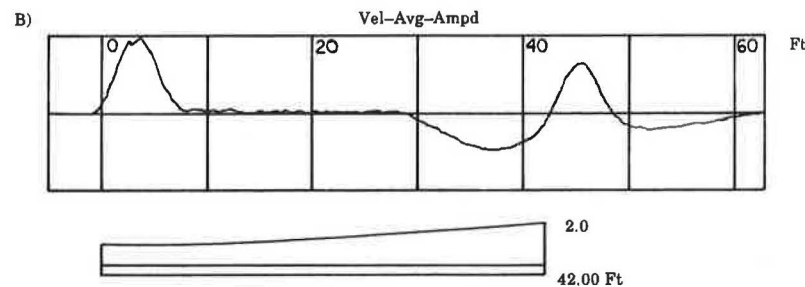
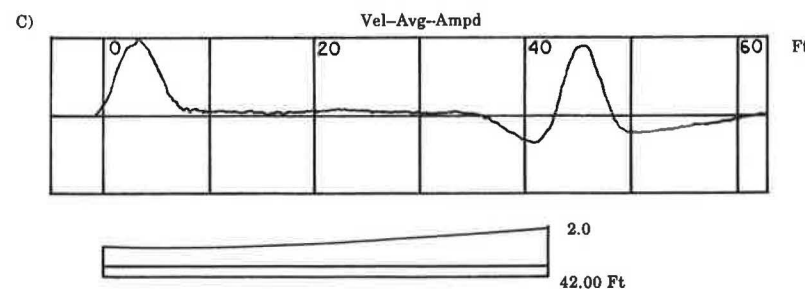
FIGURE 3 Typical results from piles with no integrity problems.

Assessments of structural pile integrity were based on the obtained records and their interpretation assuming a stress wave speed of 14.6 ft/msec. Typical data from apparently problem-free piles are shown in Figure 3. In general, the test records indicated that the piles were structurally sound. However, approximately half of the 78 piles had indications of possible minor cracks at roughly the pile midpoint. In making such interpretations, previous test results from two extracted piles lying on the ground were considered. One pile had a major crack 27 ft below the pile top. The record from this pile is shown in Figure 4. The pile was essentially broken but held together by the prestressing cables. The other pile had visible hairline cracks but no other apparent damage. Data from this pile were used as a control record. Pile records from the marina project were compared with this control record to aid interpretation. Such a comparison is shown in Figure 5, which includes the control record and typical records from piles with possible minor cracking.

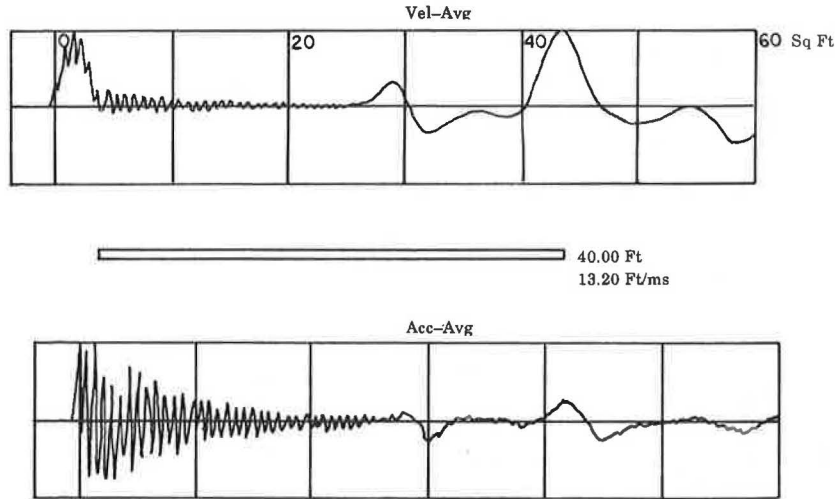
FIGURE 4 Extracted pile with major crack at 27 ft.

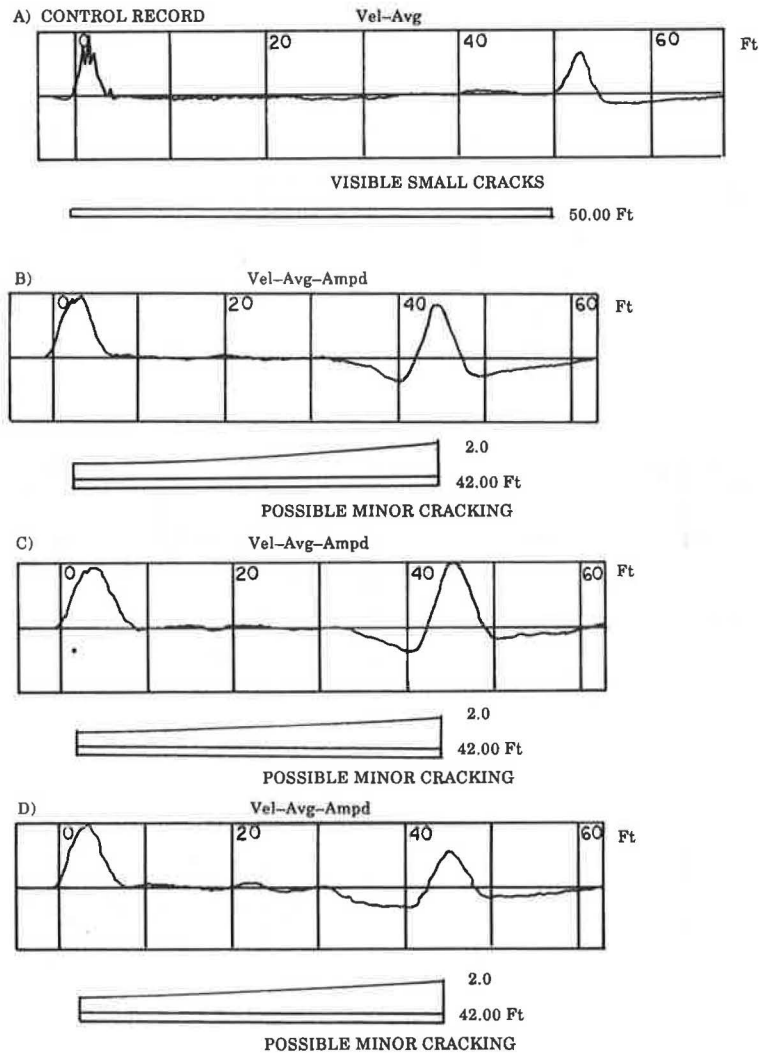
The client was informed that from a structural integrity standpoint, all piles were satisfactory. The tensile cracking may have been caused by the storm; however, the location of the cracking generally corresponded to the midpoint of the pile regardless of the depth at which frictional resistance first became apparent. Therefore, it was thought that the cracking had probably occurred during handling or installation of the pile rather than during the storm loading. It was noted that the zone of cracking was frequently above the mudline and in a highly corrosive environment. Consequently, the effect of the cracking on the long term integrity of a pile was unknown. Subsequent integrity testing over the lifetime of the marina could be used to monitor the suspect piles to determine whether significant corrosion was occurring. Because "baseline" records are already available, such an approach should be reliable.

FIGURE 5 Control record and typical records indicating possible minor cracking.

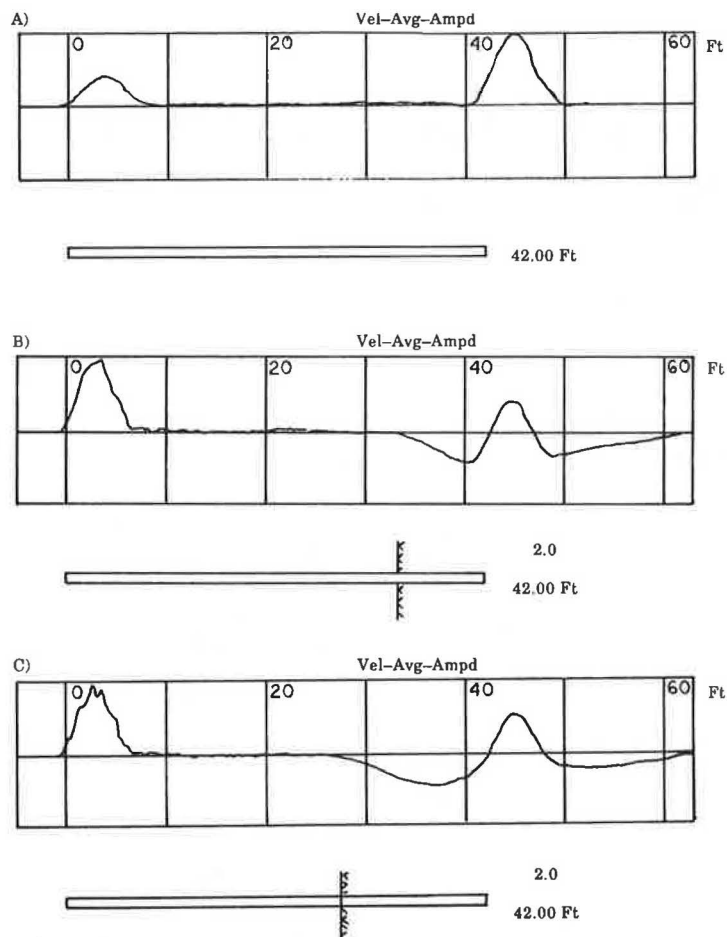
evidence of soil resistance (a relative decrease in velocity) beginning 7 to 14 ft above the pile toe. However, roughly 25 percent of the piles had very little frictional soil resistance. Figure 6 shows the difference between a pile with no apparent soil resistance and piles with resistance occurring at varying depths.

The apparent lack of soil resistance observed on many of the piles is thought to explain the relatively large lateral deflections that occurred, according to the marina personnel, under small loads. The lack of resistance could be a result of a lateral soil failure caused by excessive loading or erosion. Both possibilities could be related to the hurricane. The lack of resistance could also have been caused by design or construction errors. Regardless of the cause, it was recommended that the lateral capacity of the suspect piles be reevaluated

FIGURE 6 Typical records indicating varying amounts of soil resistance: A, no resistance; B, resistance below 34 ft; C, resistance below 28 ft.

through additional exploration and analysis and confirmed via lateral load testing.
