# Evaluation and Treatment of Slab Stepping on a Major Runway

DAVID K. HEIN, MICHAEL H. MACKAY, AND JOHN J. EMERY

Severe slab-stepping (slab-faulting) problems have been observed during the past 5 years in the takeoff areas of Runway 06R/24L, the main runway at Lester B. Pearson International Airport in Toronto. The magnitude of this slab stepping of the plain portland cement concrete pavement is such that complaints about roughness were being received and airport management was concerned that the functional service life of this critical facility was being reduced. A comprehensive field evaluation of the slab stepping was undertaken to determine its cause, extent, and severity to develop practical rehabilitation alternatives for Transport Canada to consider. This field program included the treatment, on a trial basis, of a short section of the runway using diamond grinding equipment to remove the slab stepping. In 1989 the trial grinding section was resurveyed and no significant slab stepping was observed. In 1991 a contract was let to complete full-scale precision diamond grinding of the concrete in the takeoff areas of Runways 06R and 24L and on Taxiways Bravo and Echo. Postgri

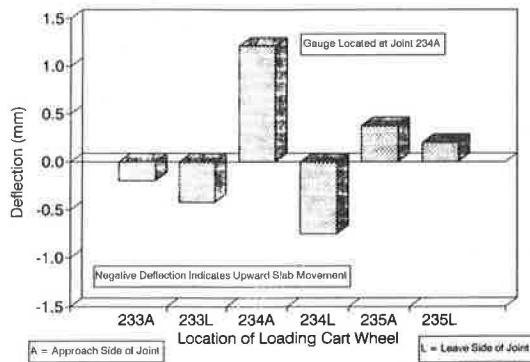
FIGURE 4 Joint deflection profile.

A typical plot of slab deflection versus the loading cart location is shown in Figure 4. Examination of the test results revealed that as the grader moved onto the slab, the leading edge of the slab deflected, causing the gauges at the trailing

edge of the slab to show an upward movement of the slab. As the loading cart moved across the slab, the deflection became positive, indicating a downward movement of the slab at the joint being monitored. Once the loading cart crossed the joint, there was an abrupt downward movement of the next slab and the first slab returned to its original position. Measurements taken at other temperature conditions indicated that the slab movement (rocking) only took place when the slabs were in an upward-curl position. The loading cart analyses and findings compared quite favorably with theoretical calculations of thermally induced curl for the concrete slab dimensions and temperature gradients.

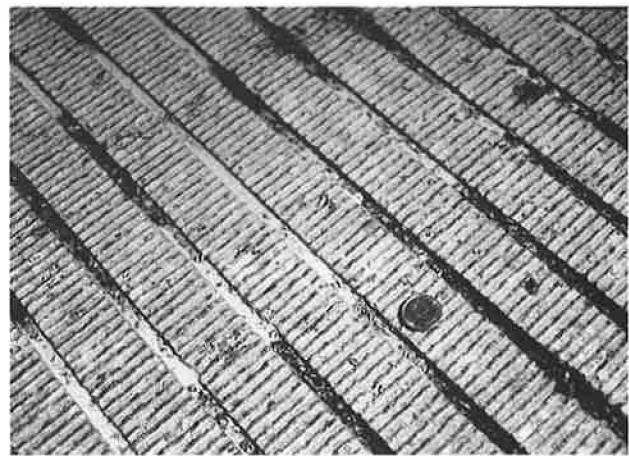
FIGURE 6 Concrete pavement surface texture after grinding.

To evaluate possible treatment measures for the slab-stepping problems, Transport Canada also required an evaluation of specialized diamond grinding equipment to restore the runway pavement to a relatively smooth condition. This trial consisted of grinding 14 slab panels (2 panels wide for a distance of 7 panels) using a Target PRM 3800 grinder obtained from Central Atlantic Contractors Inc. of Maryland (Figure 5). This equipment has a 1.0-m-wide grinding head with 60 diamond blades per 300 mm. The resulting concrete surface texture resembles corduroy, and the equipment is capable of very finely controlling the vertical depth of cut (Figure 6).

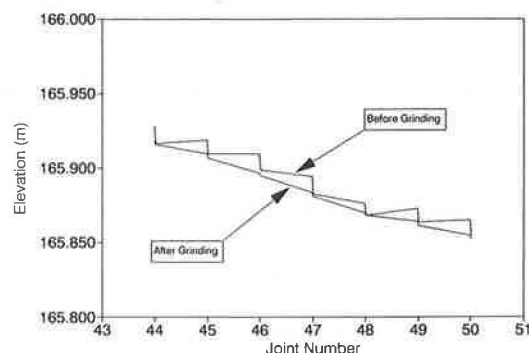
FIGURE 7 Pavement profile: trial grinding area.

The longitudinal profile before and after diamond grinding is shown in Figure 7. Clearly, the diamond grinding operation was able to satisfactorily remove the slab stepping and restore the runway pavement to a smooth condition.

On the basis of the results of the postgrinding evaluation, the precision grinding equipment was deemed to have the necessary longitudinal control to remove the stepping problem and produce a relatively flat surface. The grinder was observed to be able to remove only the high spots and neatly feather over the lower areas of the slab. Because of the relatively narrow width of the grinding head, transverse control is somewhat more difficult, relying heavily on the operator.

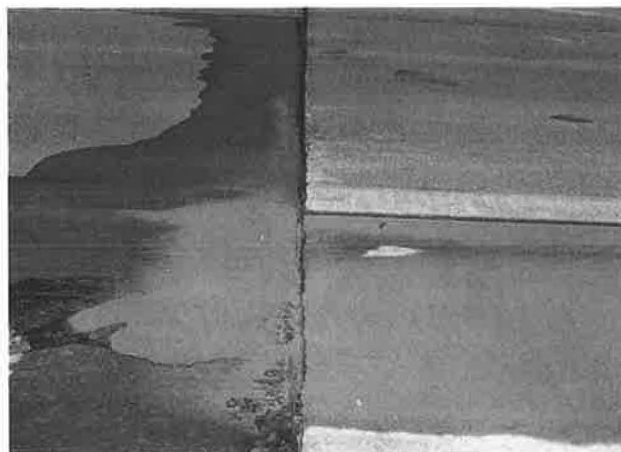
FIGURE 8 Grinding completed on Taxiway Echo.

and Echo. The precision grinding was completed by two Target PRM 3800 grinding machines subcontracted from a U.S. firm. The grinding was completed at about 200 m<sup>2</sup>/hr/machine. To restore the pavement profile, up to 15 mm of the concrete was removed (Figure 8). Note the magnitude of the stepping and depth of grinding. Upon completion of the grinding, the transverse grooving of the pavement was reinstated and all of the slab joints were resealed.

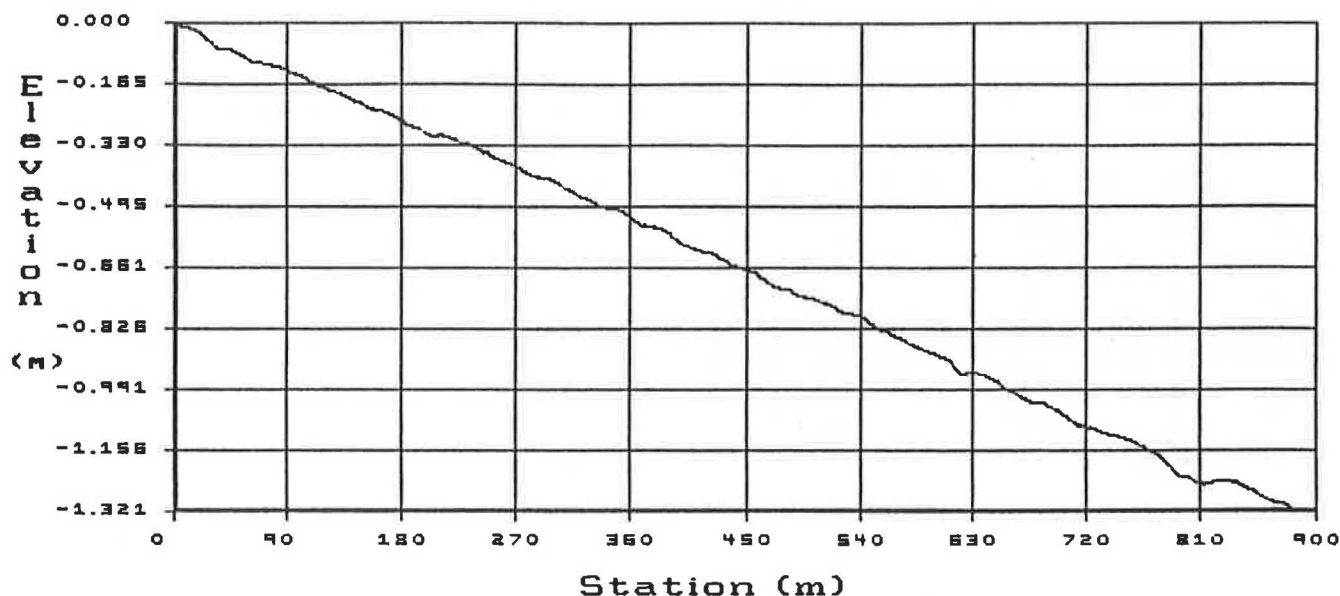
FIGURE 9 Pavement profile after grinding Runway 24L (offset: 3 mL).

The pavement profile was analyzed using the Runway Roughness Analysis Program (RRAP) (4). A plot of the post-grinding Runway 24L profile is shown in Figure 9. From the

figure, it can be seen that the pavement profile after full-scale diamond grinding is relatively smooth over its entire length.

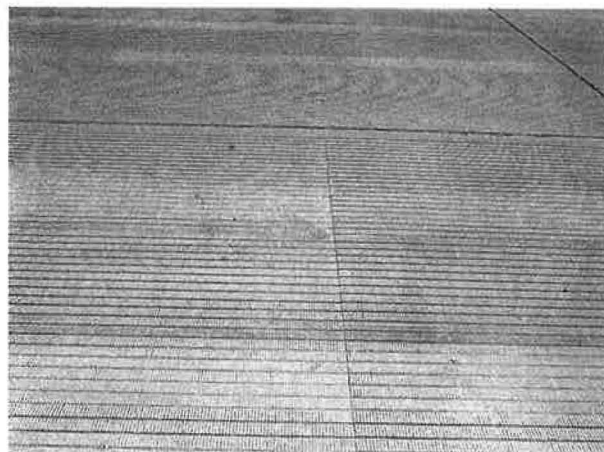
FIGURE 11 Completed pavement surface after grinding and grooving.

A relatively smooth pavement surface has been restored (see Figure 11). To assess the long-term effectiveness of precision grinding as a maintenance alternative, it has been recommended that the pavements be resurveyed every 2 to 3 years.
