Case Histories of Cold In-Place Recycled Asphalt Pavements in Central Oregon

D. F. ROGGE, R. G. HICKS, T. V. SCHOLZ, AND DALE ALLEN

Case history and performance data for cold in-place recycling (CIR) projects constructed and maintained by the Oregon Department of Transportation (ODOT) are presented. The first project was constructed in 1984. Performance data are presented through 1990.

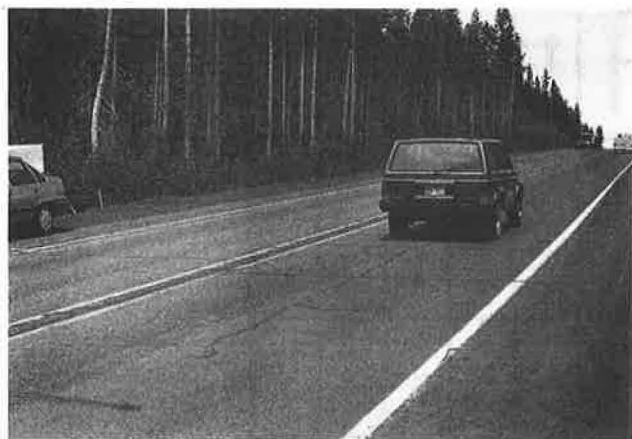
Visual inspection indicated that this project had a fair overall condition rating in both 1989 and 1990. The project has had signs of some fatigue (alligator) cracking and potholes, minor rutting and flushing, and has had some patching. It is expected to have a service life of 9 years without significant patching. This project has little truck traffic but heavy recreational traffic during the winter ski season. Figure 1 gives an indication of the surface condition of this project in 1990.

FIGURE 1 Sand Shed–Mt. Bachelor typical surface condition, May 1990.

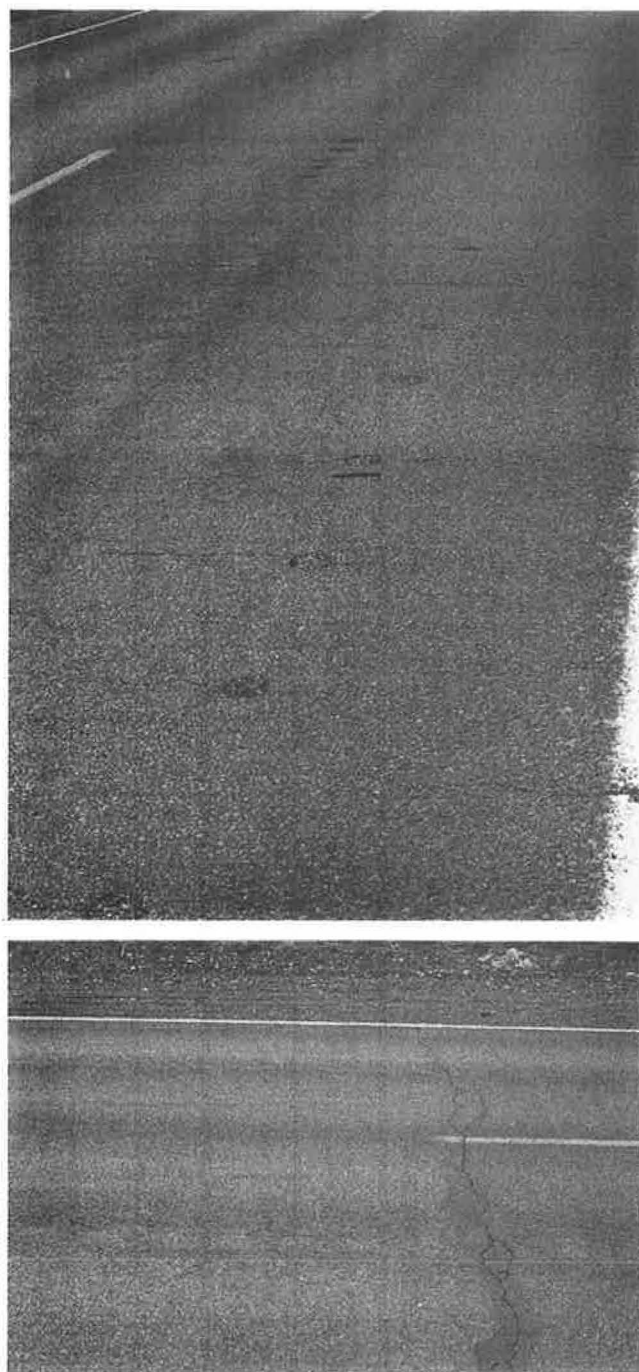
Figure 2 shows both the 1990 surface condition at the location of cores and an example of a full-width transverse crack on this project. Similar transverse cracks 1 year after a hot mix overlay would not be uncommon in this climatic region. ODOT engineering and maintenance personnel believe that recycling to a depth one-half to two-thirds of the pavement section is required to prevent reflective cracking. This project only recycled 1½ in. of an existing 4- to 5-in. AC pavement.

FIGURE 2 Drew's Gap–Lakeview surface condition, May 1990: *top*, at location of cores; *bottom*, typical transverse crack.

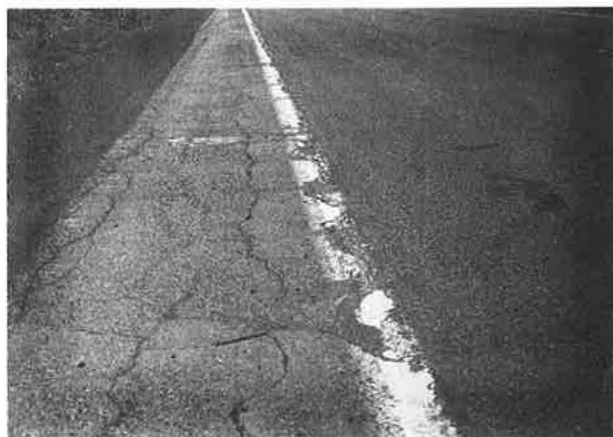
This project was rated good in 1989 and fair in 1990. It has experienced no significant patching to date and is expected to have a service life of 6 years. Figure 3 shows the contrast between the recycled travel land and the nonrecycled shoulder area.

FIGURE 3 Lava Springs–Sand Shed, May 1990. Nonrecycled shoulder on left and recycled travel lane on right.

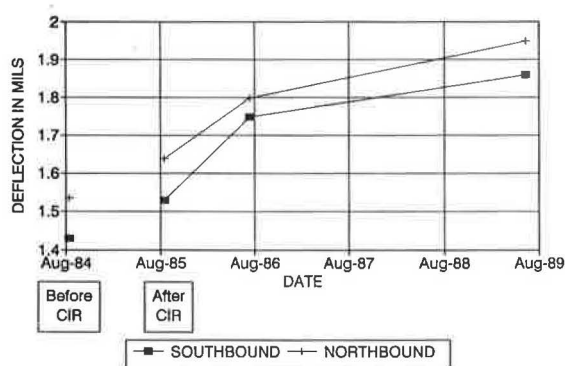
Figure 4 shows results of deflection measurements over time for the oldest CIR project, Sand Shed–Mt. Bachelor. Deflections have increased only slightly in the 5 years since construction. Deflection over time plots for other projects show similar curves.

FIGURE 4 Deflection over time, Sand Shed–Mt. Bachelor MP 17.5.
