Bud Peck Slide, Interstate 15 near Malad, Idaho

SUNIL SHARMA AND TRI BUU

In May 1983, the two northbound lanes on Interstate 15, approximately 8.6 mi north of Malad, Idaho, were destroyed; a case history of the embankment failure is described. Details about the site investigation, dewatering, and final permanent repair are discussed as is the monitoring program that has spanned 7 years. The failure, known as the Bud Peck slide, followed an abnormally wet season. The damaged highway slumped an average of about 20 ft over a 500-ft length. A temporary diversion allowed traffic to pass around the failed area while studies were being conducted to investigate the cause of the failure and possible remediation plans. A site investigation consisting of 17 borings and shallow test pits and the installation of five slope inclinometers, which also served as groundwater observation wells, was quickly performed to determine the mechanisms that might have caused the embankment failure. The data from the borings indicated that the embankment, constructed in 1970, was placed on a 2- to 3-ft sand blanket overlying a deep residual clay layer. The slope indicator data identified a slip plane 3 to 5

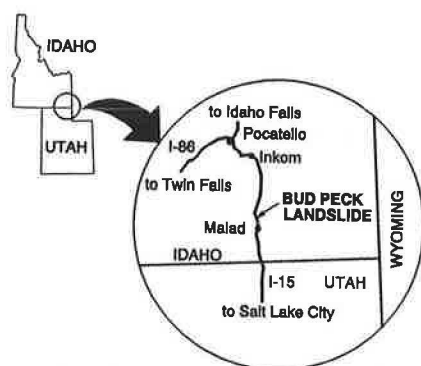
FIGURE 1 Site plan for Bud Peck slide, I-15, near Malad, Idaho.

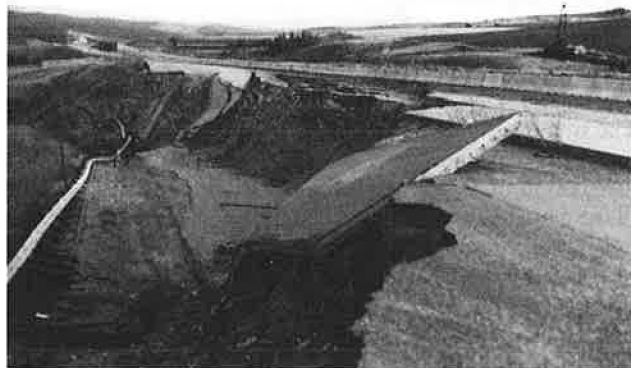
In July 1982, cracking was noted in the pavement of a 500-ft section of the two northbound lanes of Interstate 15, 8 mi north of Malad, Idaho (see Figure 1). This distress occurred in 1982 after an unusually wet season in which precipitation amounts were about 100 percent above normal. The pavement continued to crack and slump during 1982 and after another abnormally wet spring in 1983, it collapsed in early May 1983. Figure 2 shows a view, looking to the south, of the failed section of the embankment, as observed near Station 297+00 in May 1983. After the failure, the pavement for the two lanes dropped approximately 15 and 25 ft at the north and south ends, respectively.

FIGURE 2 View of failed embankment, near Station 297+00, May 1983.

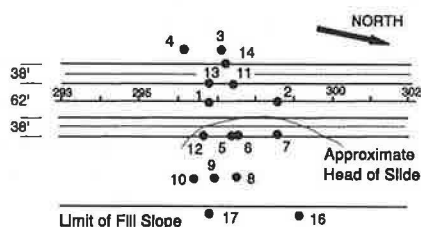
FIGURE 3 Location of test holes for site investigations.

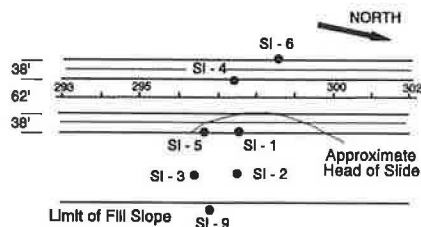
FIGURE 4 Location of slope indicators for site investigations.

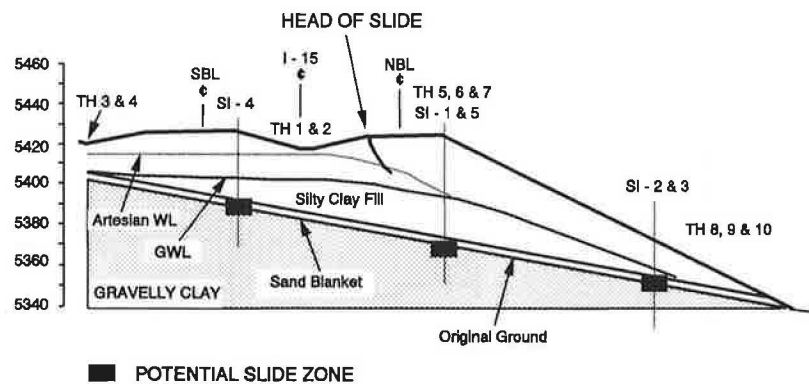
overlying the natural clay soils as shown in Figure 5. The silty clay fill was used to construct the embankment in 1970 and had an approximate unit weight of 120 lb/ft³ and estimated effective shear strength parameters of $\phi' = 25$ degrees and $c' = 0$.

The groundwater measurements as expected, revealed the effects of the higher than normal precipitation. The groundwater levels measured at the end of September 1982, are shown in the subsurface profile shown in Figure 5. Some temporary artesian conditions were also encountered for wells in the sand blanket under the southbound lanes. This condition was probably due to the inability of the sand blanket to adequately drain the infiltrating water. Thus water backed up in the slope, and its presence was confirmed by the artesian conditions found at the end of September 1982.

FIGURE 5 Subsoil profile at Station 297+00 (NBL = northbound lane; SBL = southbound lane; GWL = groundwater level; WL = water level; and TH = test hole).

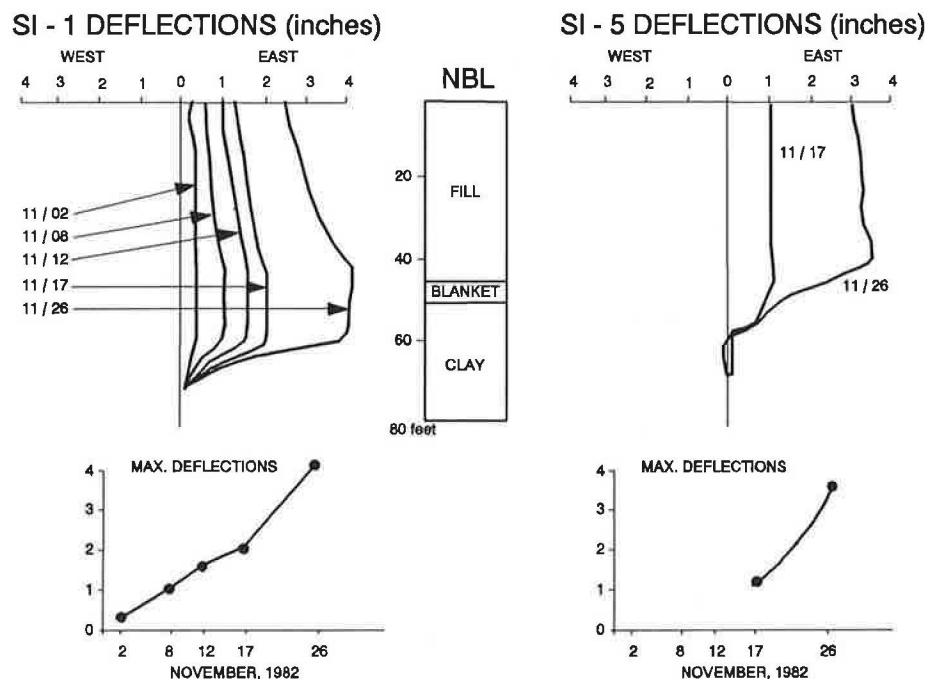
For the locations shown in Figure 4, the slope indicator data for readings obtained during November 1982 are shown in Figures 6 and 7. The data for locations SI-1 and SI-5 at the crest of the slide (Figure 6) indicate the existence of a potential failure plane below the sand-fill blanket. It appears that there is considerable movement 50 to 60 ft below the surface, or 5 to 10 feet below the sand blanket. At location SI-1 and SI-5 movements of up to 2 in. were measured between November 17 and 26, 1982. The increasing rate of movement for SI-1 and SI-5, as shown in Figure 6, suggests that the slope mass was unstable and appeared to be moving rapidly. Supporting evidence regarding the location of the failure plane was also provided by the slope indicator data for SI-2 and SI-3, located near the toe of the embankment, as shown in Figure 7. Unfortunately, the observations made at slope indicator sites, SI-2 and SI-3, were small and generally inconsistent as the base of the slope indicator does not appear to have been anchored into a stable zone.

FIGURE 6 Slope indicator data for SI-1 and SI-5 at crest of embankment.

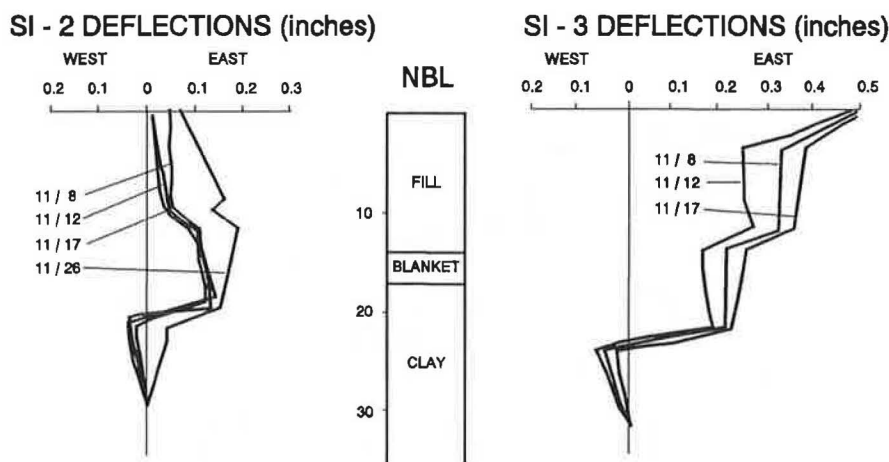
FIGURE 7 Slope indicator data for SI-2 and SI-3 at toe of embankment.

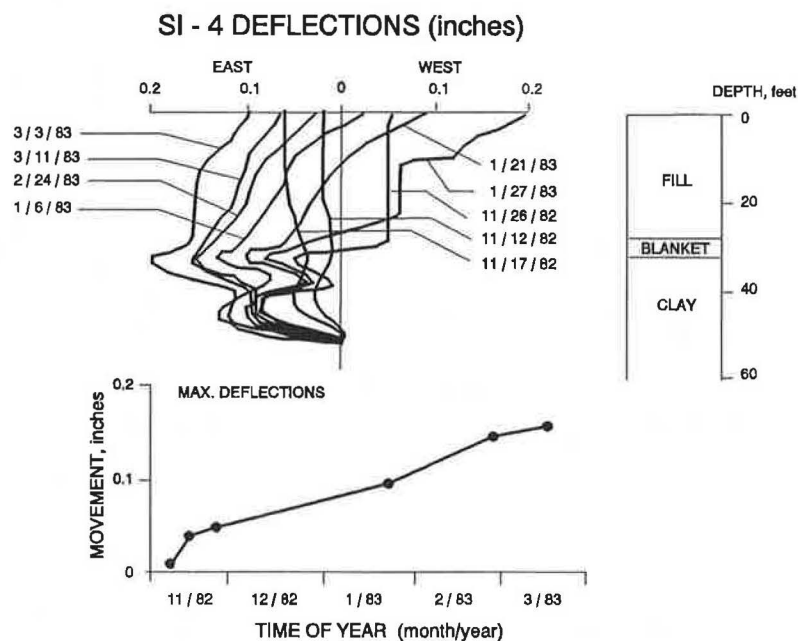
Two slope inclinometers, SI-4 and SI-6, were also installed to monitor movements below the southbound lanes. Data collected at these two locations are shown in Figures 8 and 9. The data from SI-4 (Figure 8) indicate small movements that suggest a sliding plane approximately 32 ft below the

FIGURE 8 Slope indicator data for SI-4, southbound lane.

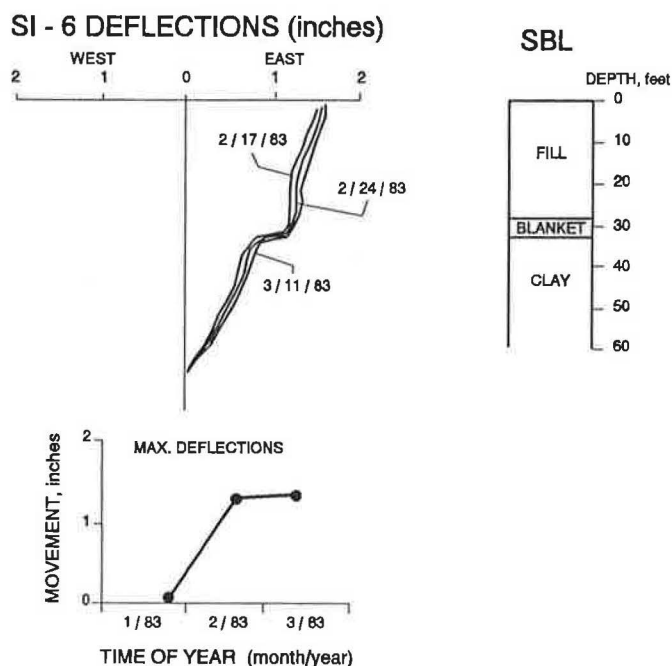
pavement surface. The data from SI-6 (Figure 9) indicated a movement of about 1.3 in. at the surface in early 1983, but the movement appeared to have stabilized after that initial slip. However, the actual movements at the slip plane are less than $\frac{1}{2}$ in. because again, the slope indicators were not anchored in a stable zone. Overall, these movements were small and the southbound lanes were considered to be fairly stable.

FIGURE 9 Slope indicator data for SI-6, southbound lane.

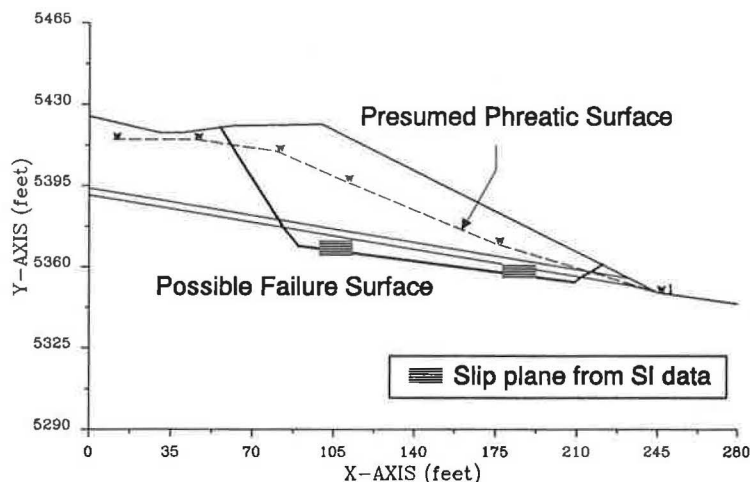
The stability of the embankment slope was investigated using the slope indicator and groundwater level data. With knowledge of the location of the slip plane and groundwater conditions, a limiting equilibrium analysis was used to find the failure mechanism and the residual shear strength along the potential failure plane. The results of the analysis are shown in Figure 10. By analyzing failure surfaces passing through the shear zone indicated by the slope indicator data, the shear strength parameters of the residual soil were back-calculated as $\phi' = 10.5$ degrees and $c' = 325$ psf for the critical surface shown in Figure 10. These parameters appear to be in reasonable agreement with the laboratory test results.

FIGURE 10 Potential failure surface for 1983 slide.

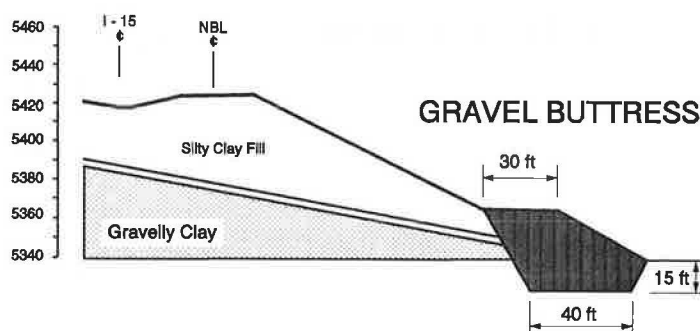
FIGURE 11 Repair of embankment with a granular buttress.

Two options were considered for repairing the failed embankment. The first option considered a granular-fill buttress at the toe of the existing embankment as shown in Figure 11. The second option required removal of the upper 20 ft of the existing, disturbed silty clay fill and restoration of the embankment to the original 2:1 slope with one of the following

Stability calculations were performed for the three options, assuming that the groundwater level would be located in the sand blanket and strength parameters of $\phi' = 10.5$ degrees and $c' = 325$ psf for the underlying gravelly clay. The minimum FS for the buttress was estimated as 1.5. For the replacement fill alternatives, the following FS values were computed as

In reviewing the costs of construction, the buttress would have required at least 50 percent more material than the other alternatives, even though a higher FS would have been obtained for stability. However, after monitoring the site for about 12 months, there were signs that a much larger portion of the hillside was moving, perhaps because of a very deep seated failure plane. Thus the buttress option was discarded as a possible long-term solution in favor of extensive dewatering, to stabilize the hillside, and the use of a lightweight fill to repair the embankment. The lightweight fill would also have minimized the impact of an external load on a potential deep-seated failure surface.

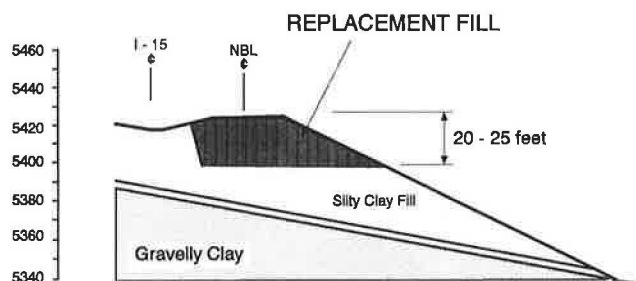
FIGURE 12 Repair of embankment with replacement fill.

fill materials (a) sand and gravel, (b) pumice fill, and (c) wood fibers (Figure 12).

Material	ϕ' (degrees)	c' (psf)	Compacted Unit Weight (pcf)	Factor of Safety
Sand and gravel	39	0.0	130	1.14
Pumice	41	0.0	75	1.29
Wood fibers	37	0.0	55	1.35

In comparing the remaining options, the pumice fill was found to be the most desirable and could be readily obtained from a source 40 mi away. The strength of the compacted

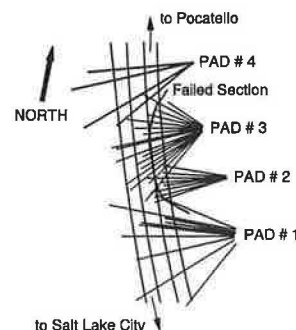
FIGURE 13 Location of horizontal drains.

The first contract was started in August 1983 and concentrated on dewatering the slope and embankment. This consisted of installing 42 horizontal drains from 4 separate pads near the toe of the embankment, as shown in Figure 13. Drainage was provided by slotted PVC pipe, 2 in. in inside diameter, laid at an approximate gradient of 5 percent in predrilled borings. The lengths of the drains ranged between 125 and 350 ft and were arranged to extensively penetrate the failed portion of the embankment. These drains were installed at a cost of \$100,000.

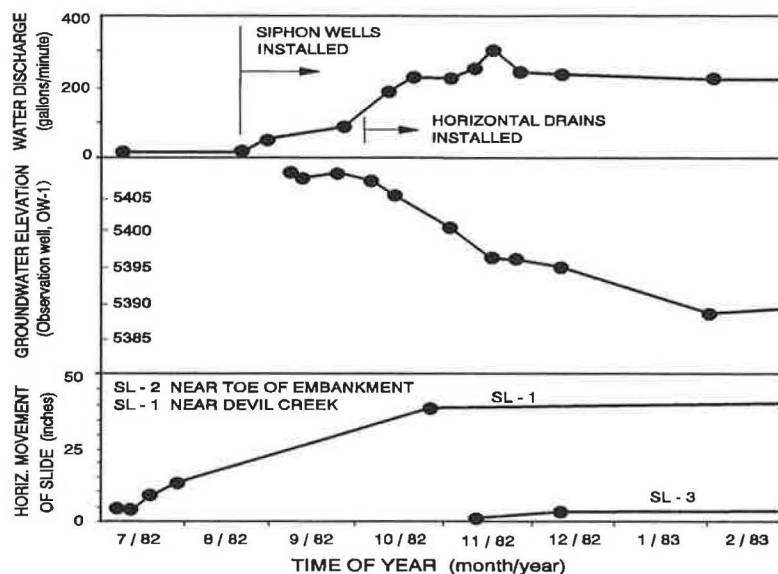
Initial flows of about 200 gal/min quickly lowered the groundwater level approximately 20 ft below the southbound lanes to Elevation 5,388 ft. With groundwater levels at this depressed level, embankment movements were finally arrested as shown by the survey line data presented in Figure 14. These data clearly show the influence of the horizontal drainage in

lowering the groundwater level at Observation Well OW-1 and the negligible movements measured from the two survey lines, SL-1 and SL-3.

FIGURE 14 Slope monitoring data for seepage, groundwater levels, and movement.
