# Field Performance of Open-Graded Drainage Layers

J. J. HAJEK, T. J. KAZMIEROWSKI, H. STURM, R. J. BATHURST,  
AND G. P. RAYMOND

The results of a field study carried out to investigate the performance of pavements incorporating open-graded drainage layers (OGDLs) are presented. OGDLs are used to ensure rapid and effective drainage of pavement structures and thus to improve pavement performance. Altogether, five paving projects built since 1975 and incorporating OGDLs are described and evaluated. The projects encompass flexible, composite, and rigid pavements, and include both asphalt-cement-treated and untreated OGDL materials. The evaluation was done in terms of (a) pavement performance evaluation, with emphasis, where possible, on comparing adjacent sections with and without OGDLs; (b) occurrence and severity of major pavement distresses investigated by coring and trenching; (c) assessment of in situ drainage done by observing movement of water within the pavement structure; and (d) laboratory analysis of excavated OGDL materials. The results of this study show that the existence of OGDLs alone does not guarantee a better pavement performance. This can be achieved only if the

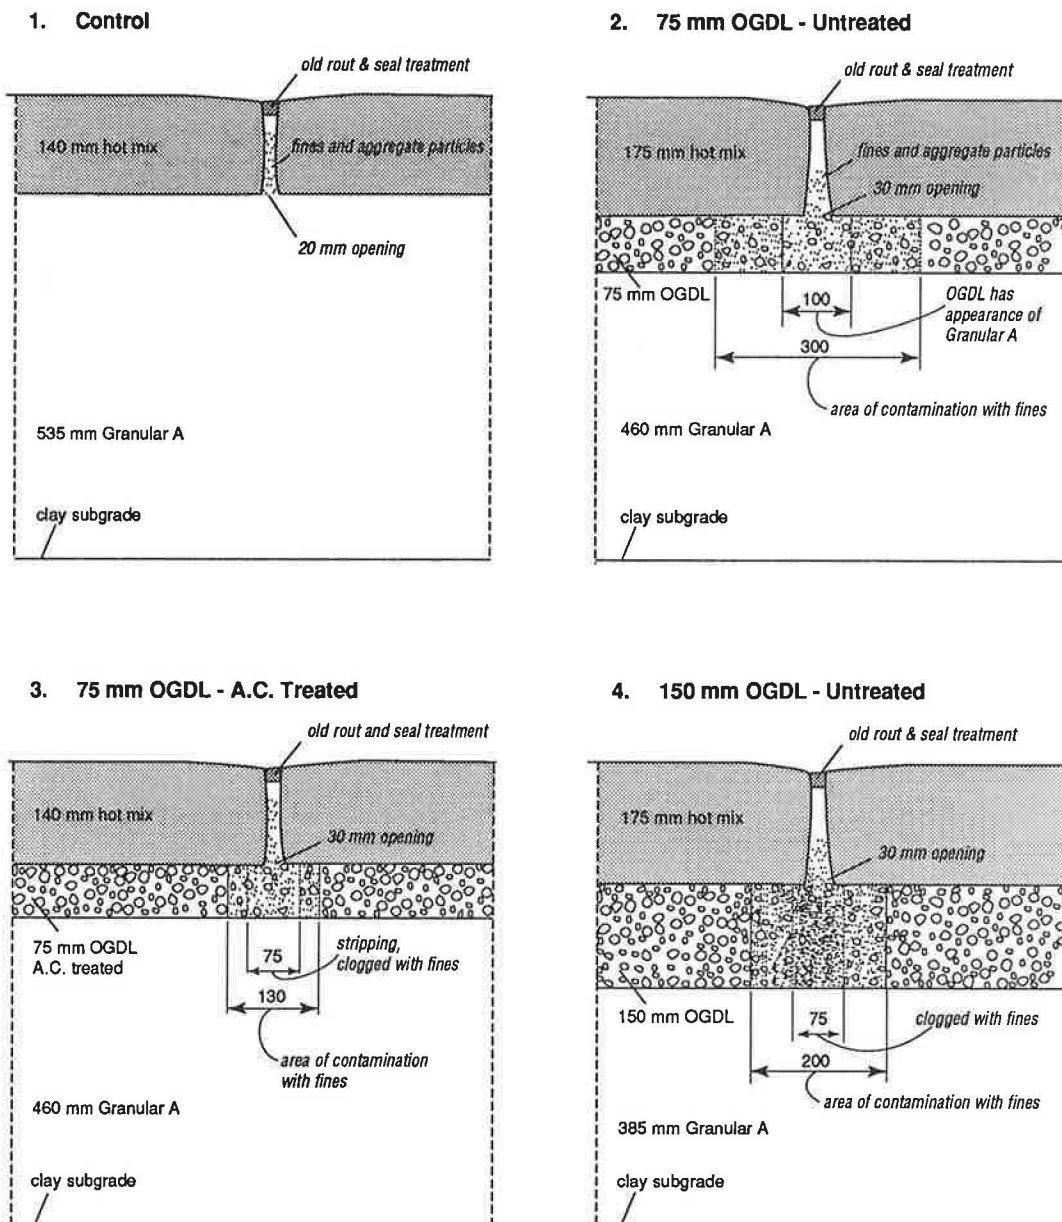
**FIGURE 1 Typical condition of full transverse cracks, Highway 56.**

A composite representative condition of transverse cracks based on coring and cutting is shown in Figure 1. It appears that the existence of OGDs had no significant influence on the frequency of transverse cracks or on the condition of transverse cracks in terms of crack opening, asphalt concrete stripping at the bottom of the asphalt concrete layer, or cupping. There was noticeable stripping of asphalt cement from the aggregate particles of the treated OGD material. A low

value of 1.3 percent AC was obtained from a sample taken below a fully developed transverse crack. Otherwise the type and the area of contamination with fines and the amount of fines in the OGDL materials were quite similar on all three OGDL sections.

**Permeability** Water was poured into the core holes and cuts, and the drop in the water level was observed. The areas of contamination shown in Figure 1 drained very slowly. Usually, there was no observable water drop in 10 min. Noncontaminated areas drained so fast that no water head could be maintained using a 25-L container.

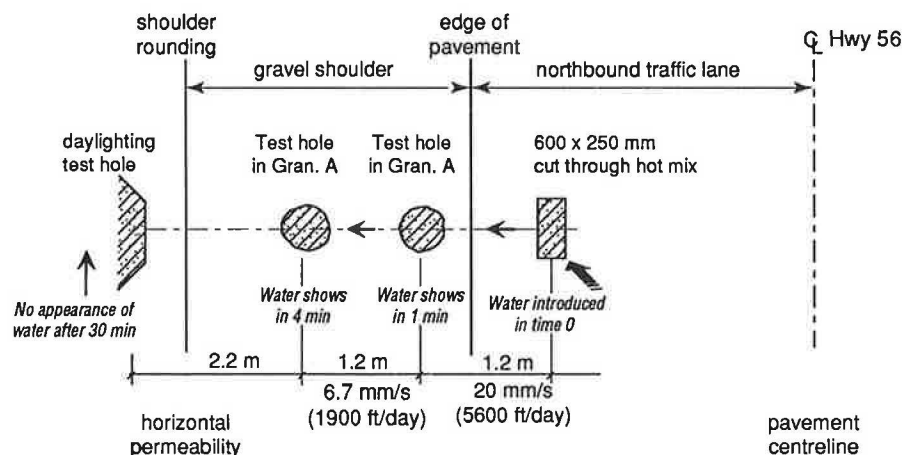
FIGURE 2 Investigation of crossfall drainage, Highway 56, Section 3.

**Crossfall Drainage** Water was poured into a 600- × 250-mm cut in the asphalt concrete, and the OGDL material and its propagation towards the ditch were observed using two additional openings between the cut and the ditch daylighting. As indicated by the results given in Figure 2, the crossfall drainage appeared to be sufficient at the location investigated, with an average horizontal permeability of 10 mm/sec (2800 ft/day). This exceeds the recommended minimum by a factor of 3.

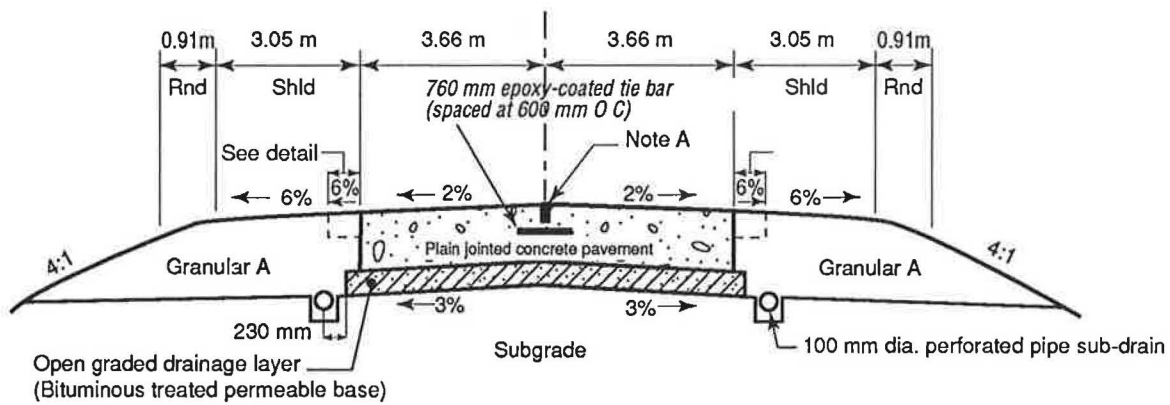
A/ OGDL section on Hwy 3N

The pavement structure of the four sections, built on a silty-clay subgrade, is summarized below and the arrangement of the OGDL section is shown in Figure 3.

Approximately 12 hr after a heavy rainfall, the OGDL was saturated with water at the locations investigated. There was no noticeable drop of the water level during an hour. It appears that the water ponding in the OGDL is caused by relatively impervious granular materials separating the OGDL from the lateral drains and ditch daylighting [Figure 3(a)]. Another factor contributing to ponding may be a low hydraulic gradient of the lateral subdrains, which are covered with a geotextile material protecting the perforated plastic subdrain from contamination.

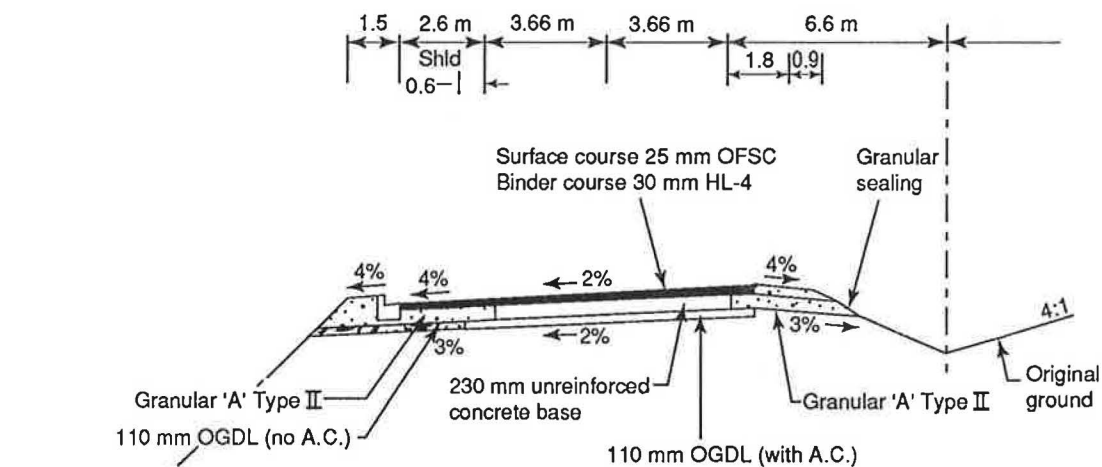
B/ OGDL section on E.C. Row Expressway

The original composite pavement design, shown in Figure 3(b), was constructed at both locations on E.C. Row Expressway. The OGDL material was placed on the full width of the roadbed with daylighting at ditch slopes. The AC-treated OGDL material was placed underneath the pavement and extended 600 mm beyond the edge of pavement; the untreated material was placed underneath the remaining width of the shoulder.

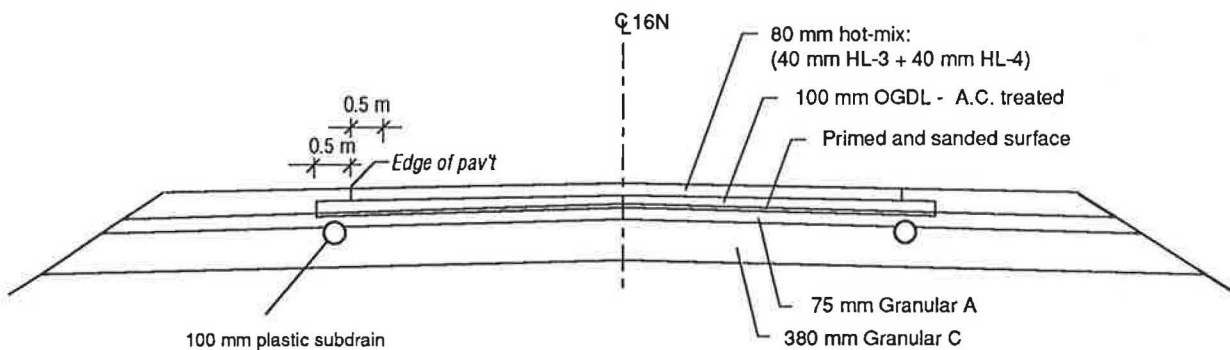
C/ OGDL section on Hwy 16N

Three different sections—an OGD section, a conventional section, and modified granular section—were built in 1984. The structure of the OGD section is shown in Figure 3(c). The conventional section consists of 130 mm of asphalt concrete, 150 mm of gravel base, and about 425 mm of sand subbase. The modified granular section consists of 120 mm of asphalt concrete, 75 mm of gravel base, and about 300 mm of sandy subbase. All unbound granular materials in this section were modified by removing most of the fine aggregate particles. Only the OGD section has lateral subdrains as shown in Figure 3(c).

The coring revealed undamaged OGD material even if the cores were taken at (longitudinal) cracks. The OGD material was usually well bonded to the bottom of the AC layer. The primed and sanded surface of the Granular A material [Figure 3(c)] appeared to be undamaged and in very good condition.

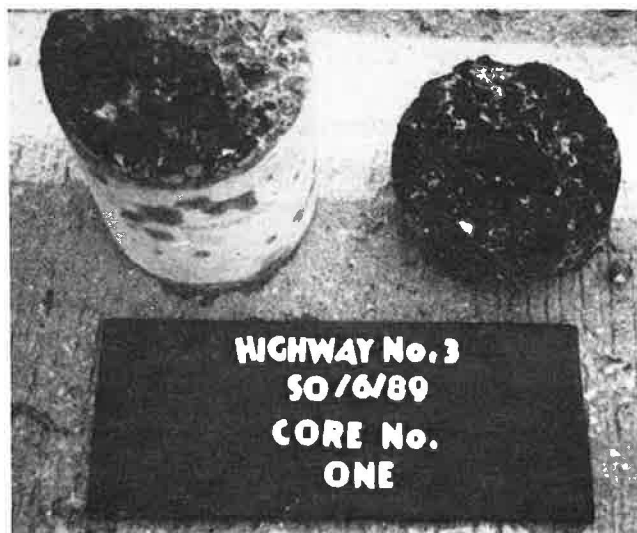
The cores taken at mid-slab (far from the joints) revealed a well-preserved OGDL material. About 80 percent of the material was recovered from the 175-mm bit cylinder in one piece and was bonded to the PCC. It was observed that the OGDL material in the core holes was flooded with water and that soon after the core was removed, the water level rose to within 50 mm of the pavement surface. The bottom 20-mm layer of the OGDL material was contaminated with subgrade (silty clay) and was loose showing signs of stripping. The AC content of the bottom portion of the core was 2.0 percent compared with 2.7 percent obtained for the top portion of the core.

**FIGURE 4** 150-mm core obtained from cracks or joints, Highway 3N. OGDL material basically in one place and partially bonded to surface layer.

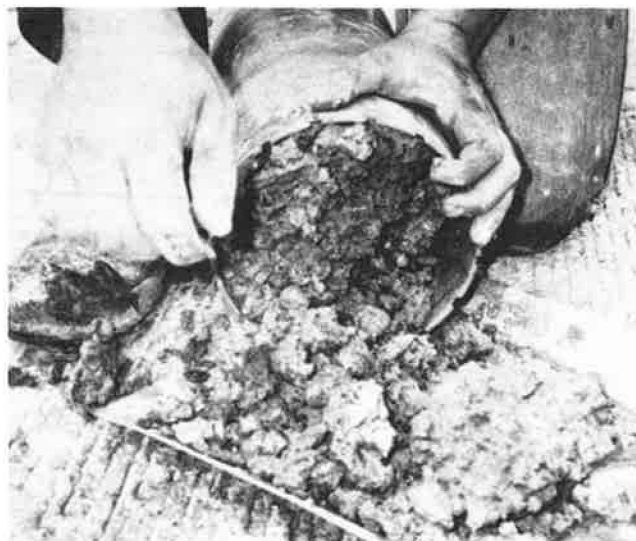
The cores taken at faulted transverse joints near the center of the lane and the outside wheelpath revealed loose, partly stripped OGDL aggregate (AC content ranging from 1.1 to 1.9 percent) heavily contaminated with subgrade material. The OGDL material in all core holes was flooded. There was no loss of material at the bottom on the PCC slabs. Figures 4 and 5 contrast the condition of the OGDL material obtained at a mid-slab location with that close to a faulted transverse joint.

**FIGURE 5** 150-mm core obtained at transverse joint, Highway 3N. OGDL material loose mixture of stripped OGDL aggregate particles and subgrade soil.

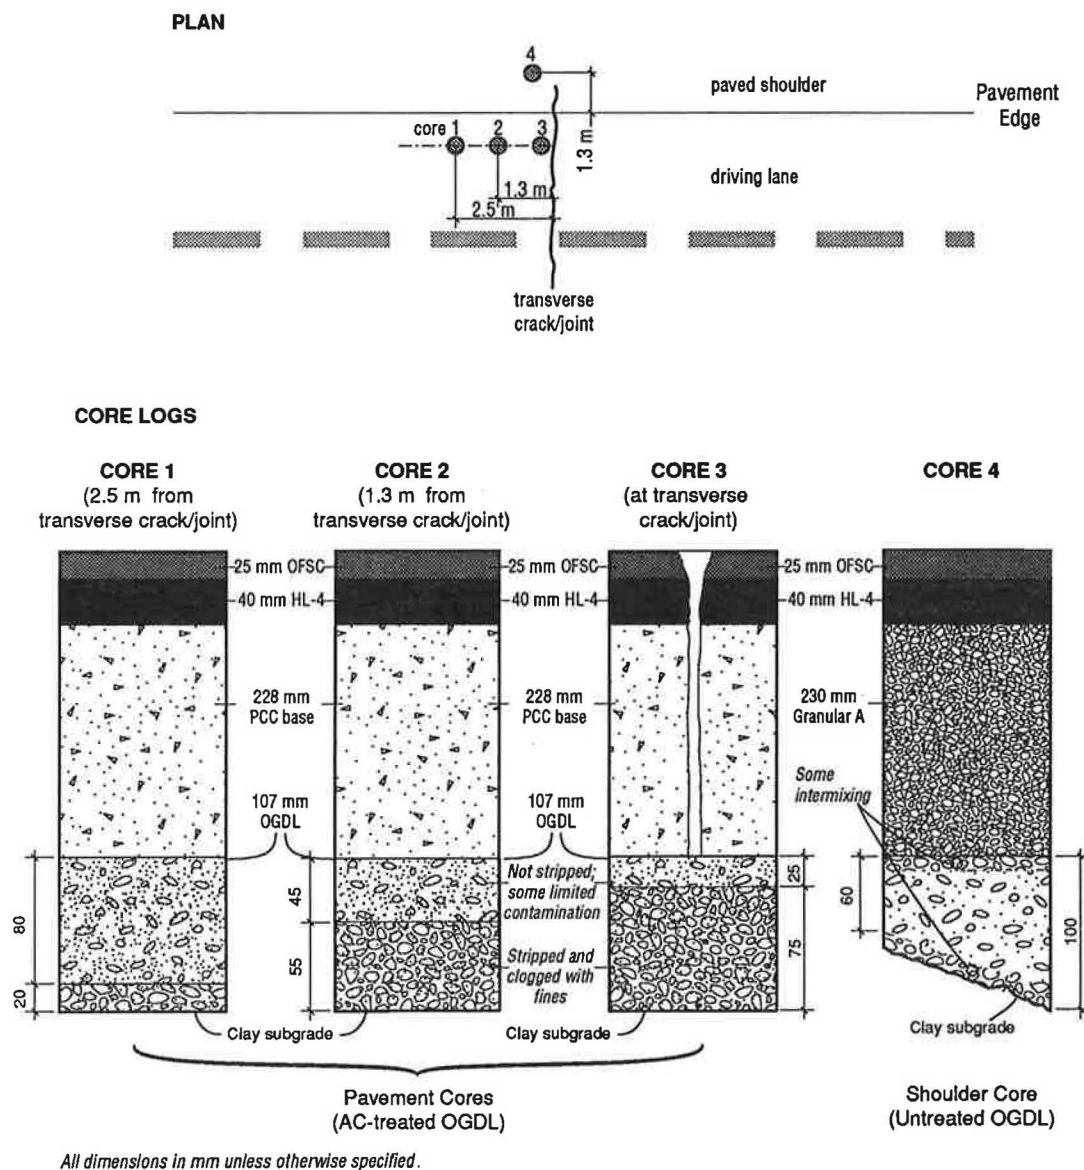
FIGURE 6 Condition of OGDL Material, E.C. Row Expressway.

The majority of cores were taken in the vicinity of transverse cracks. One core was taken near the middle of the (paved) right shoulder. The results of coring are shown in Figure 6. In many respects the results are similar to those observed on

Highway 3N. The OGDL material at locations far from transverse cracks was in a very good condition with little or no stripping and some contamination by the subgrade material at the bottom. The level of contamination and stripping increased with closeness to transverse cracks. There was no loss of PCC material at the bottom of the PCC base near the contraction joints.

**Crossfall Drainage** Water was poured into a 150-mm core hole drilled in the middle of the paved shoulder (Core 4, Figure 6). The rate of water dissipation was quite high (about 0.2 mm/sec), but because of the overall wet subgrade condition and the 3 percent longitudinal pavement grade, it was not possible to observe additional water seepage at the daylighted test hole or holes. The log of Core 4 in Figure 6 also shows uneven thickness of the untreated OGD material beneath the shoulder and some minor contamination.

1. Contamination from overlying granular shoulder materials and topsoil, and blocking by the layer of topsoil;
2. Uneven or inadequate thickness of the OGD, or both; an example of uneven thickness is shown in Figure 6 (for Core 4); and
3. Inadequate crossfall grade of the OGD.

The two OGD sections will benefit from an early routing and sealing of transverse cracks, which should prevent free water from entering the pavement structure.

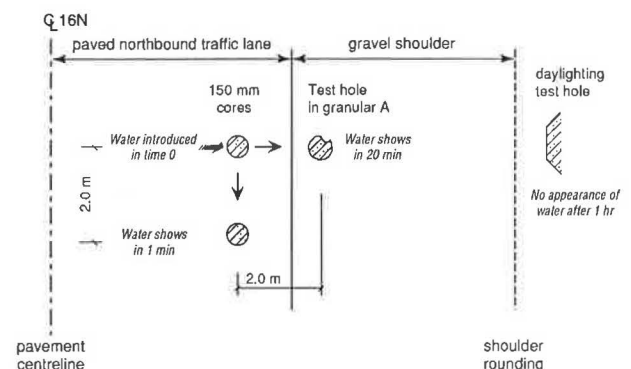
FIGURE 7 Investigation of crossfall drainage, Highway 16N.

**Crossfall Drainage** Water was poured into core holes in the pavement and its progression toward the ditch was observed by using test pits dug in the granular shoulder. The sketch of the experiment given in Figure 7 shows that the crossfall drainage was impeded. A direct connection between the OGD and the collection system is not provided. The OGD material is abutted by Granular A material, and the longitudinal subdrains are separated from the OGD by the primed and sanded surface of the Granular A layer. According to Figure 7, the water that traveled 2 m through the Granular A material on a 3 percent crossfall was detected in 20 min; the water that traveled the same distance through the OGD on a smaller slope was detected in 1 min.

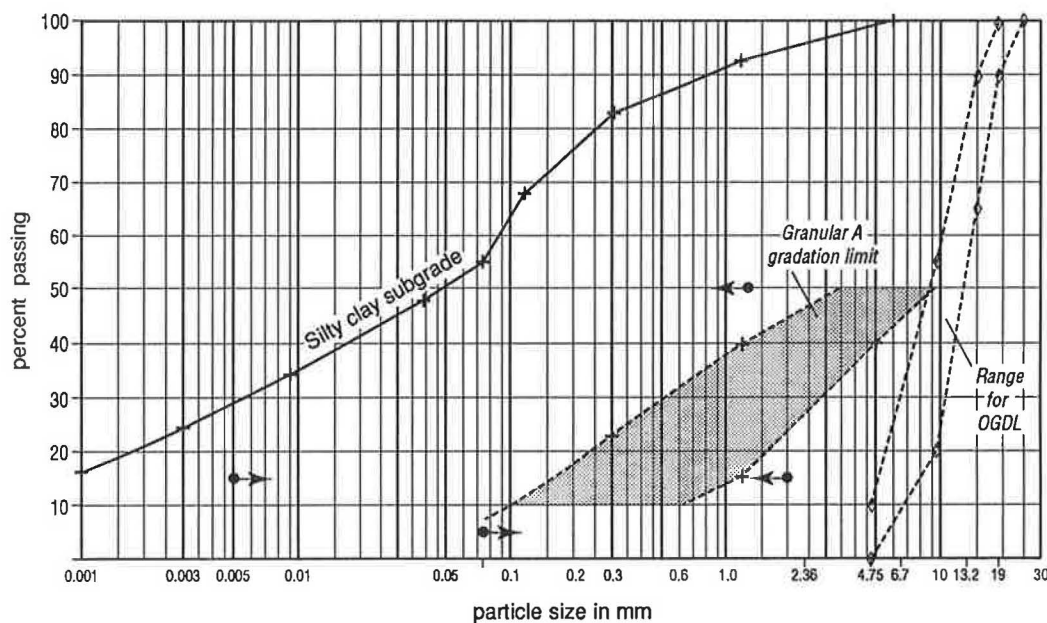
FIGURE 8 Filter requirements to protect OGD from intrusion of fines from subgrade.

subgrade are given in Figure 8. Also shown as arrows in Figure 8 are gradation criteria for a granular filter based on the report by Moulton (5). The gradation range of the OGD material is completely outside the filter criteria, and it is obvious that a filter layer should be provided to protect the OGD from clogging. Consequently, in the absence of a filter layer, the observed intrusion of fines in the field is to be expected.

Figure 8 also gives a gradation range for Granular A material, which satisfies the filter requirements for the protection of the OGD from intrusion of fines from the subgrade and can be thus considered a filter. It now remains to be checked if the OGD material needs protection from intrusion of fines from the Granular A material. This is done separately in the following section.
