Performance Level 2 Tests on the Missouri 30-in. New Jersey Safety-Shape Bridge Rail

JAMES C. HOLLOWAY, RONALD K. FALLER, BRIAN G. PFEIFER,
EDWARD R. POST,* AND DAN E. DAVIDSON

Safety-shape bridge rails are substandard if they are less than 32 in. high, according to Section 2.7.1.2.2 of the AASHTO *Standard Specifications for Highway Bridges*. However, a substandard bridge rail may remain in operation if it passes a safety performance evaluation by full-scale crash testing. Therefore, Nebraska and Kansas pooled their efforts with Missouri to determine whether a 32-in. standard New Jersey safety-shape bridge rail would still provide a satisfactory safety performance if a 2-in. overlay were placed on the adjacent bridge deck. To evaluate the performance of this bridge rail, the Midwest Roadside Safety Facility conducted three full-scale vehicle crash tests on the Missouri 30-in. New Jersey safety-shape bridge rail. Test MS30-1 was conducted with an 18,011-lb single-unit straight truck at 16.1 degrees at 52.5 mph. Test MS30-2 was conducted with a 1,759-lb small automobile at 20.0 degrees at 62.5 mph. Test MS30-3 was conducted with a 5,460-lb pickup truck at 20.0 degrees at 63.5 mph.

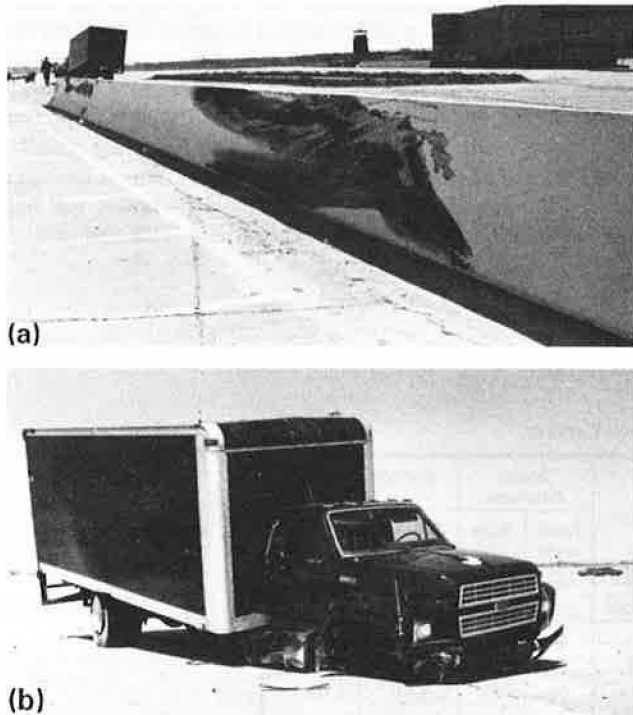
FIGURE 4 Damage to (a) bridge rail and (b) test vehicle, Test MS30-1.

Bridge rail damage is shown in Figure 4(a). Concrete spalling occurred at the point of impact as a result of the right front wheel crushing into the bridge rail. Spalling also occurred along the top of the rail as a result of the undercarriage of the vehicle sliding along the top of the rail. No visible lateral movement of the rail occurred as a result of the collision. Tire marks were visible on the face of the rail for a length of about 17 ft after impact.

Vehicle damage is shown in Figure 4(b). Most of the damage occurred to the undercarriage. The front axle assembly was disengaged from its original position. The right rear wheels were damaged, and the drive shaft was separated from the transmission. There was no intrusion or deformation of the occupant compartment.

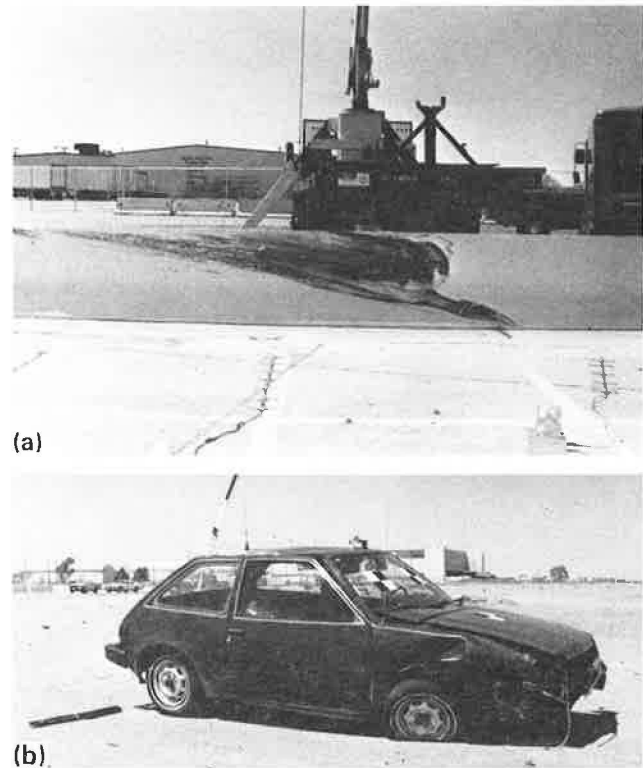
FIGURE 7 Damage to (a) bridge rail and (b) test vehicle, Test MS30-2.

The minor bridge rail damage is shown in Figure 7(a). The marks on the bridge rail indicated that the vehicle was in contact for approximately 12 ft. No visible lateral movement of the bridge rail occurred.

Vehicle damage is shown in Figure 7(b). The damage was mainly to the right front corner, consisting of wheel, bumper, fender, and axle damage. Slight buckling of the roof was also apparent. No intrusion or deformation of the occupant compartment occurred.

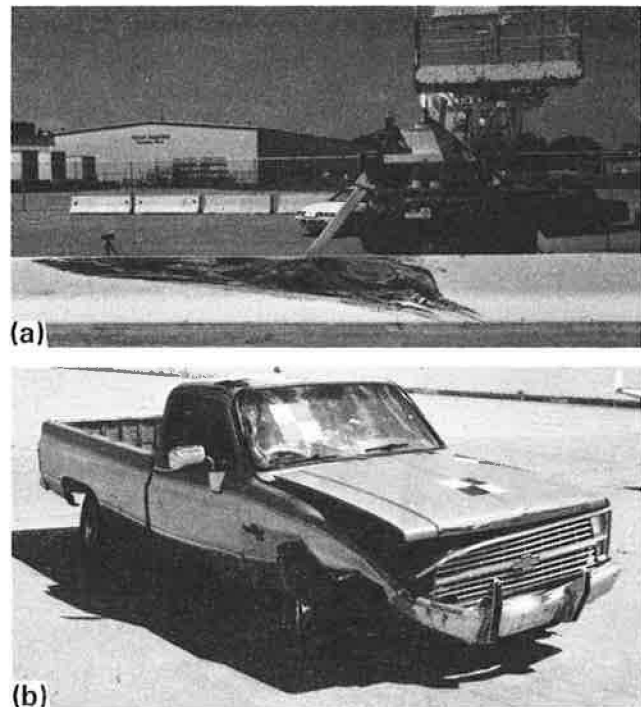
FIGURE 10 Damage to (a) bridge rail and (b) test vehicle, Test MS30-3.

Bridge rail damage is shown in Figure 10(a). Damage was minimal. Tire marks and scrapes accounted for the majority of the damage. The marks on the rail were approximately 12 ft long. No visible lateral movement of the bridge rail occurred as a result of the collision.

Vehicle damage is shown in Figure 10(b). The damage was mainly to the right front corner of the vehicle. The passenger side door and rear wheel were also slightly damaged. The lower right corner of the windshield was also broken. There was no intrusion or deformation of the occupant compartment.
