Damage to Aircraft Parking Ramps from Jet Oils and Auxiliary Power Units

MICHAEL C. McVAY, CHARLES W. MANZIONE, AND JAMES G. MURPHY

The precise cause for concrete damage observed in the vicinity of parked B-1 and F/A-18 aircraft has been determined. The combination of downward-directed auxiliary power unit (APU) blast and spilled aircraft oils are responsible for the scaling observed at these sites. Laboratory tests confirmed that ester-based lubricating oils and hydraulic fluids are chemically reacting with the hydroxyl component from the calcium hydroxide or the calcium silicate hydrate in the concrete and destroying the bond. The cyclic heating of the pavement by the APU greatly accelerates the reaction and facilitates the mixing and refluxing of aircraft fluids with the aqueous calcium hydroxide present. Laboratory techniques are demonstrated that duplicate the chemical reactions occurring in the field and allow for quick and accurate assessment of new materials before field testing. In addition, hydrolysis of lubricating oils and hydraulic fluids was replicated in a controlled laboratory experiment within 5 weeks, eroding a 10-cm (4-in.) concrete slab that was kept partially

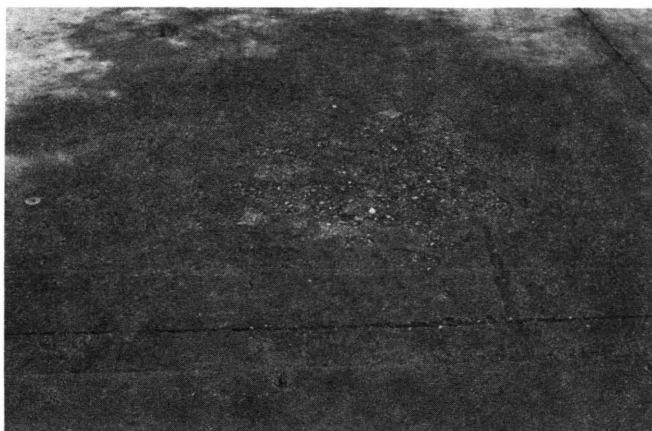
Figure 1 is typical of the scaled concrete surface; the steel plate in the foreground is one of scores placed at Cecil Field to temporarily prevent further damage. Figure 2 is a close-up of a scaled piece of concrete that was easily flipped with fingertips. Initially, because of large amounts of exposed ag-

FIGURE 1 Concrete damage related to APU.

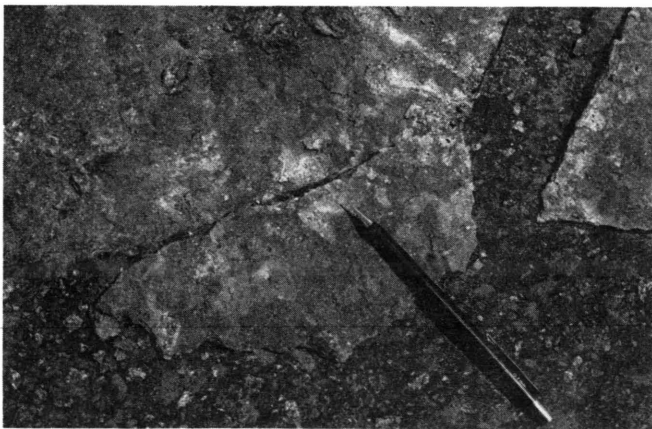
FIGURE 2 Scaling typical in older pavements.

XRD spectrometry of both sides of the scaled concrete specimens at Wright Laboratory revealed the presence of quartz and calcium carbonate, but not of calcium hydroxide. It appeared that the calcium hydroxide had been converted to limestone by the carbon dioxide made available as a by-product of burned hydrocarbons in the jet exhaust. As shown earlier in Figure 2, some of these scalings had aggregate embedded in them.

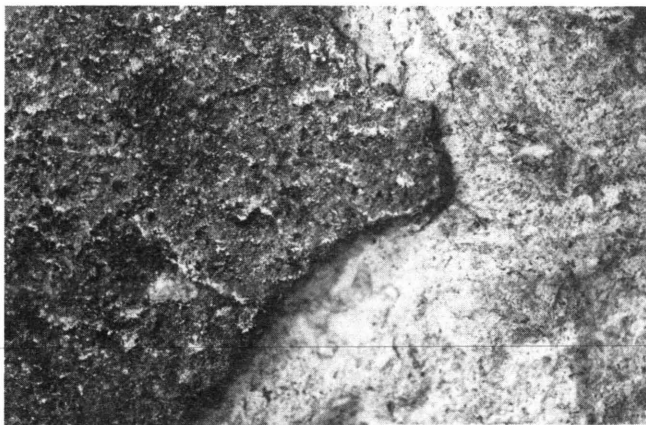
gregate, it appeared the concrete aprons were delaminating at the paste-aggregate interface (Figure 3). However, the size of the scale and the entrapment of aggregate in scalings such as this suggested that the problem was not related to surface finishing. Full-depth cores 15 cm (6 in.) in diameter and 38 cm (15 in.) long were taken from the damaged areas; these cores revealed lubricant penetration from 1 to 2 cm (0.40 to 0.75 in.). Cores taken outside the zone of APU impingement, but within the fluid spill area, showed no surface damage and less oil penetration.

FIGURE 3 Delamination of concrete below carbonated surface.

older pavements investigated during this study were scaling instead of eroding. This scaling always appeared to originate from weakened planes beneath the surface layer of concrete. As stated earlier, IR and phenolphthalein tests showed that the calcium hydroxide on the surface of these old pavements had already been depleted through contact with carbon dioxide to form a thin layer of calcium carbonate that did not react with spilled oils under the aircraft.

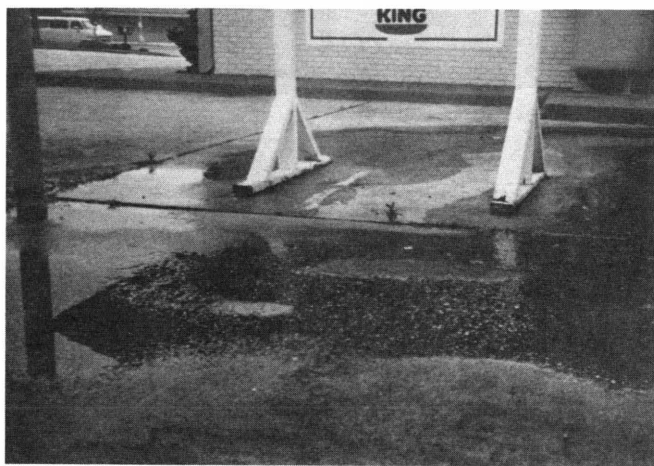
An inspection of concrete eroded by spilled vegetable oils at neighborhood fast-food stores (Figure 4) indicated that hydrolysis of fatty oils by the hydroxyl ion does not have to have heat to occur. However, as seen in Figures 2 and 3, the

FIGURE 4 Hydrolysis of vegetable oils by newer pavement.
