Rehabilitation Procedures for Faulted Rigid Pavement

LUIS JULIAN BENDAÑA AND WEI-SHIH YANG

Engineering Research and Development Bureau, New York State Department of Transportation, State Campus, Albany, N.Y. 12232.

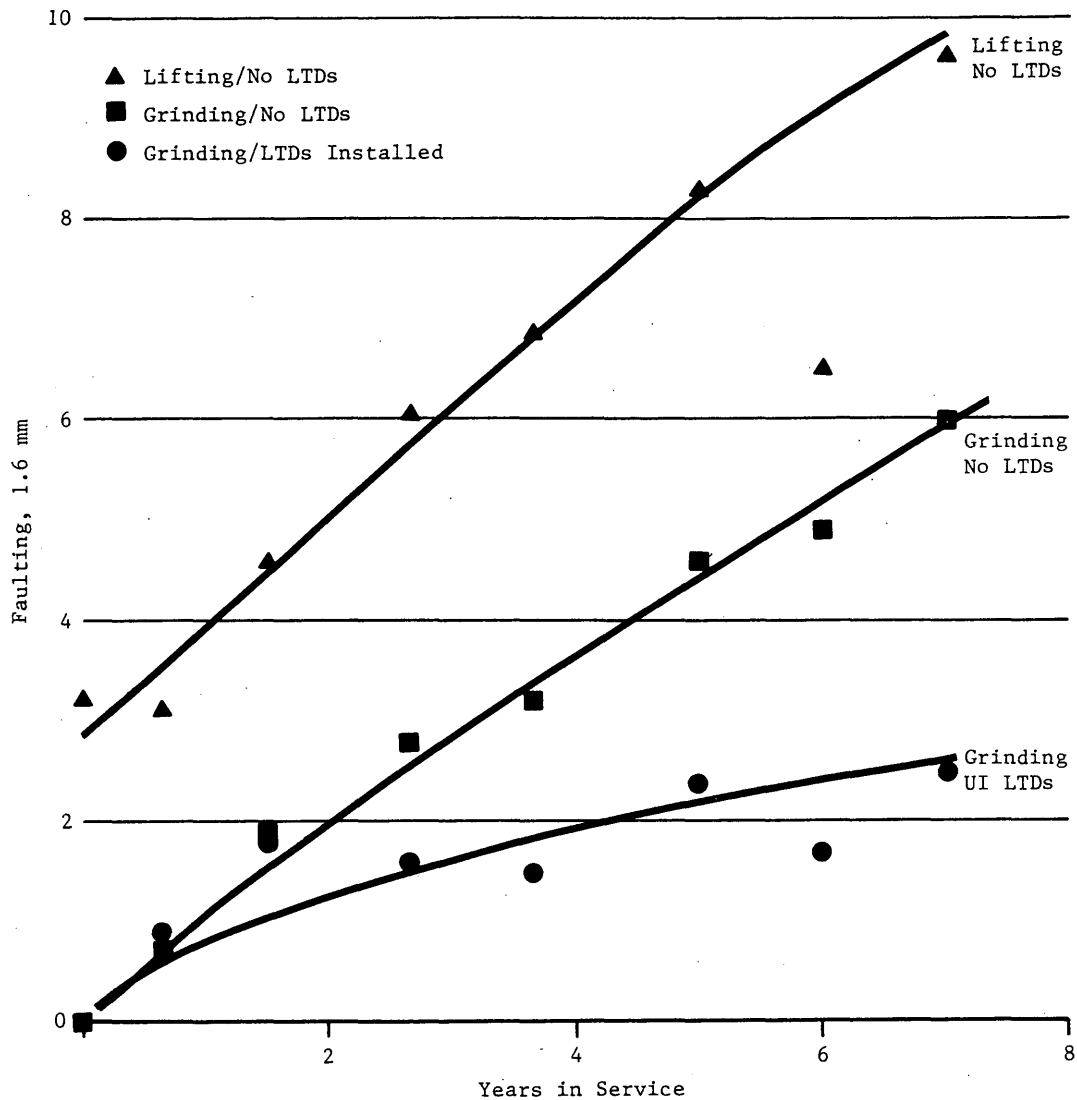
FIGURE 6 Contract 1 faulting with and without LTDs.

Because faulting was the major cause for the poor functional performance of I-84, all rehabilitation techniques studied were focused on its correction. Because of concern that too much concrete would be removed by grinding, it was decided to limit grinding to sections where average faulting was less than 2.5 cm and to lift joints that had greater faulting. However, for some joints exceeding this limit, grinding was permitted for uniform sections. Grinding and lifting effectively reduced the magnitude of faulting but failed to restore load transfer. Figure 6 shows faulting from 1980 to 1987 before and after

grinding. Grinding removed all faulting in 1980, but by 1985 average faulting was larger than before grinding. Fault return at joints that were lifted was about equal to that at joints that were ground. Final faulting at lifted joints was greater than that at ground joints, lifting having left some faulting (both positive and negative) that contributed to greater fault return.

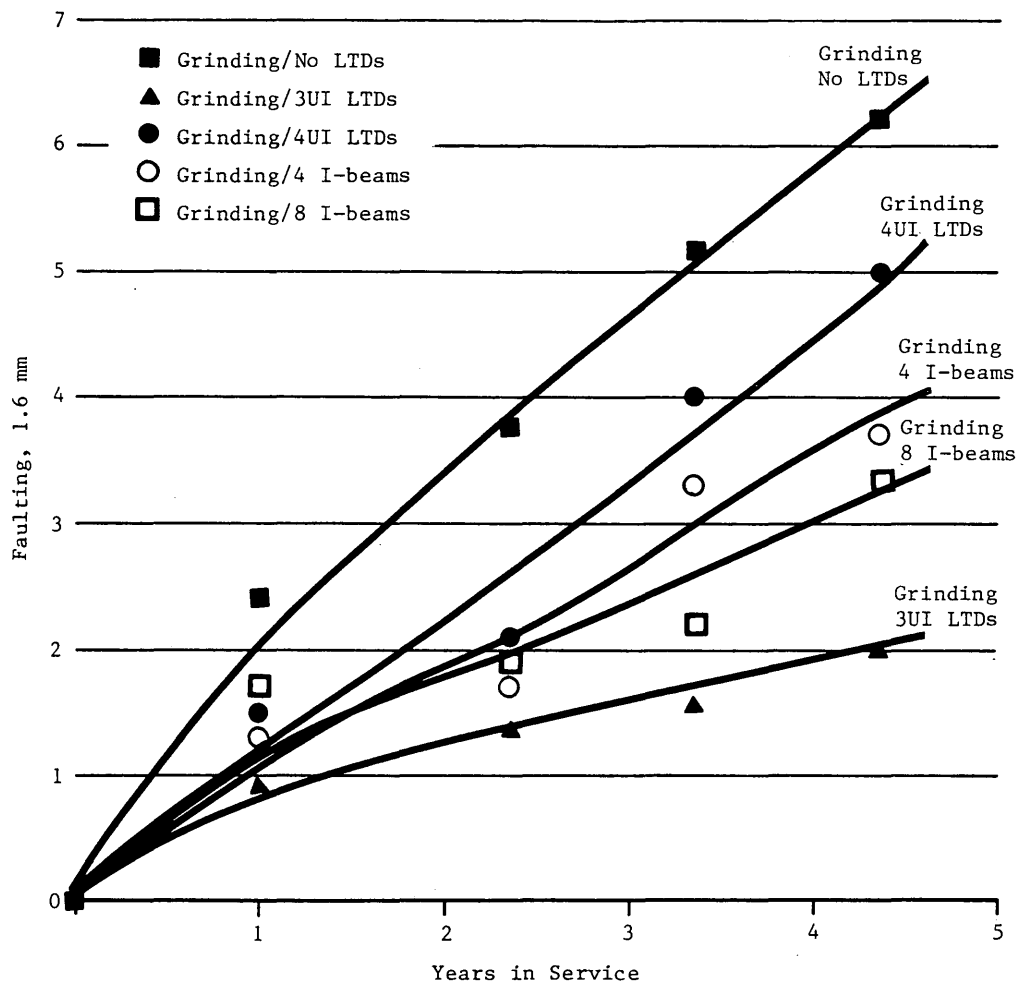
FIGURE 7 Contract 3 faulting with and without LTDs.

Statistical analysis of Contract 3 faulting data showed no significant difference between 3UIE and 3UIS joints, which were thus combined for analysis into a single 3UI group. Four LTD groups could then be compared: 3UI, 4UI, four I-beam, and eight I-beam. Figure 7 summarizes faulting before and after grinding. In a comparison of the 3UI and 4UI joints, the former performed better, with an annual fault return of less than 0.8 mm. Paradoxically, the 4UI performed worse, with an annual fault return of 1.9 mm. Inadequate compaction of polymer concrete and improper aggregate gradation were two construction and materials problems noted, which caused poor performance of the 4UI joints.

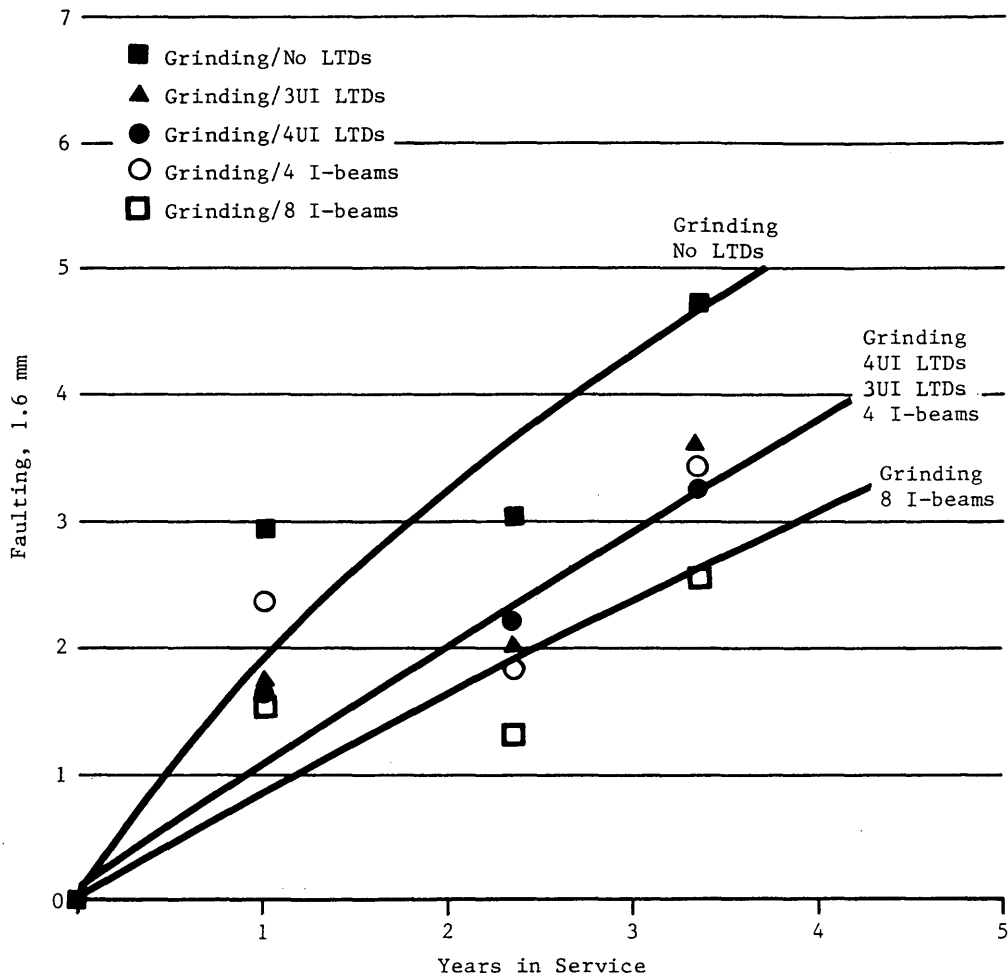
FIGURE 8 Contract 4 faulting with and without LTDs.

In Penn-Conn Contract 4, as at Ludingtonville (Contract 3), no significant difference was observed between the epoxy and steel Illinois LTDs, and they were combined into a single 3UI group. Penn-Conn faulting data for 3UI and 4UI were compared using a *t*-test; no significant difference was found. These two types had annual fault returns of about 1 mm after more than 3 years of service. Penn-Conn faulting data are shown in Figure 8.
