# Nine Years of Microsurfacing in Oklahoma

# C. Dwight Hixon and David A. Ooten

Microsurfacing was introduced in Oklahoma in 1983 through a FHWA demonstration project. Through 1991, more than 1900 lane-km (1,200 lane-mi) had been treated using the microsurfacing technique. Three microsurfacing projects were part of an indepth study. These projects were monitored by obtaining rut measurements, surface friction tests, cracking measurements, deflection measurements, and condition surveys for at least 3 years after microsurfacing. Several other projects were examined to monitor special uses. These include microsurfacing over fabric, microsurfacing as an interlayer, using alternative aggregate, microsurfacing over portland cement concrete (PCC), and using synthetic latex. Microsurfacing has proven effective in filling ruts, reducing the amount of original rutting by 40 percent, and substantially increasing the friction characteristics of the pavement. It has also shown a moderate resistance to reflective cracking and does not increase the load-supporting ability of a pavement. Microsurfacing works well as a leveling course and as an interlayer but has not normally maintained a bond wh

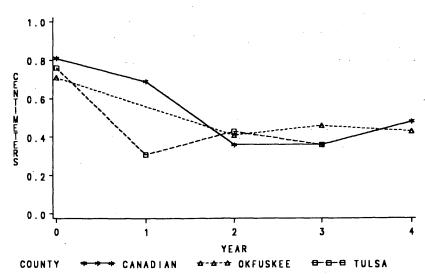
FIGURE 1 Average rutting on in-depth study sites (1 cm = 0.39 in.).

Rut depth measurements were made every 200 ft throughout the length of each project. Reduced rutting was maintained throughout 4 years of service (Figure 1). Rutting after 4 years on the Okfuskee and Canadian projects was approximately 60 percent of the original rut depth.

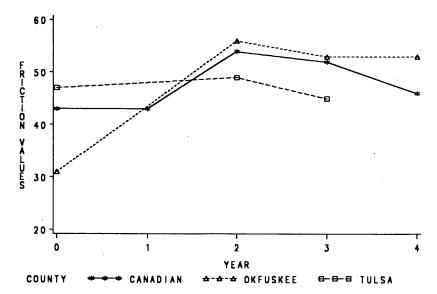
FIGURE 2 Average friction values on in-depth study sites.

In all cases, microsurfacing showed an improvement in friction values (Figure 2). The Tulsa project did show a reduction 3 years after treatment, but the value is still well above 35 after 9 years. The values for Okfuskee and Canadian after 4 years of service were still above the original level.

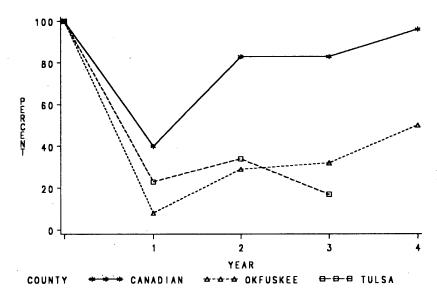
FIGURE 3 Percent cracking after microsurfacing on in-depth study sites.

The amount of cracking was improved significantly: a 50 percent reduction on the Okfuskee project, and an 83 percent reduction on the Tulsa project (Figure 3). Three of the six test sections on the Canadian project had 100 percent reflective cracking after 4 years; the other three sections ranged from 20 to 85 percent reflective cracking.

The Canadian project had a condition rating of 85 before microsurfacing. After 4 years of service, it had a condition rating of 82. The flaws noted on the last rating for this project included depression cracking (evident from Figure 3) and patching.

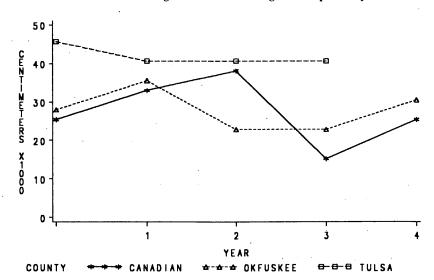
FIGURE 4 Average Benkelman beam deflection on in-depth study sites (1 cm = 0.39 in.).

Benkelman beam surveys were conducted for three successive years on the Tulsa project and for four successive years on the Okfuskee and Canadian projects. Measurements were obtained every 200 ft over the entire extent of the project. Although microsurfacing improved the load-carrying ability for the Tulsa project, it did not improve it for the other two (Figure 4).

Deflection testing, as these tests indicate, is more of a reflection on the original pavement condition, because microsurfacing is not intended to significantly affect pavement strength. No explanation can be given for the significant improvement for Okfuskee in Year 2 and Canadian in Year 3.
