Field Service Life Performance of Deep Polymer Impregnation as a Method for Protecting Bridge Decks from Corrosion

BRIAN D. PROWELL, RICHARD E. WEYERS, PHILIP D. CADY, AND
IMAD L. AL-QADI

Two sound concrete bridge decks were impregnated with methyl methacrylate to a depth of 76 to 102 mm (3 to 4 in.) and polymerized in situ. Both bridges were in sound condition with no surface spalling at the time of impregnation. After 15 and 5 years, respectively, the small- and full-scale field trial sections were evaluated for their corrosion abatement performance. The evaluation program included delamination survey, chloride content, corrosion potentials, petrographic analysis of core section, and corrosion rate measurements. The small-scale field trial has undergone dramatic differences in performance between the control and impregnated sections, with spalling and very high corrosion rates occurring in the control section. One year after evaluation (bridge impregnation age is now 15 years), the bridge deck containing the small-scale section was replaced. The impregnated section and a nonimpregnated section were salvaged for continuous monitoring. The full-scale field trial was reevaluated a

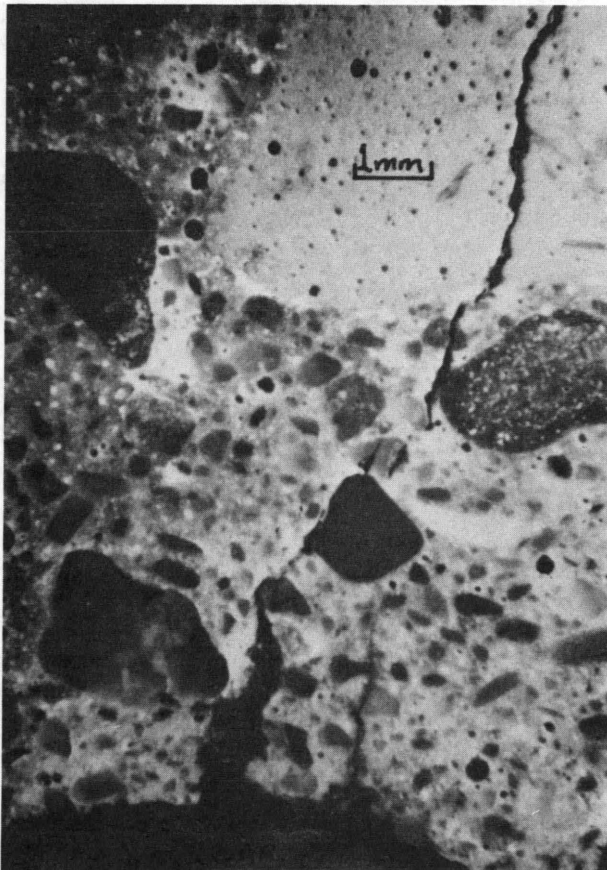
The primary interest in the examination was the corrosion of the reinforcing steel since the purpose of deep impregnation is to prevent or arrest the corrosion process. Table 10 presents the summary of the corrosion performance examinations. The microscopic examination of polished and fractured sections revealed details of the corrosion state of the deck. With the exception of the Conn. Core, corrosion products were observed around the reinforcing steel. Cores A and D from the nonimpregnated area showed evidence of slight corrosion. All four cores from the impregnated area showed evidence of corroding reinforcing steel. However, the corrosion products were impregnated with polymer. Thus, the deep impregnation process successfully arrested active corrosion cells in all four of the cores. Figure 1 presents a microphotograph of impregnated Core J, showing a vertical crack caused by corrosion of the rebar. The microscopic investigation presents di-

Core No.	Impreg. Area	Cracking Observed			Rebar Corr.	Cover mm.	Corr. of Rebar
		Drying Shrink	Micro Shrink	Subsidence			
A	No	No	No	No	No	56	Slight
D	No	No	No	No	No	33	Slight
Conn	No	Few	No	No	No	36	No
F	Yes	Two	No	Yes	No	38	Y/Arrested
H	Yes	Few	No	No	No	38	S1/Arrested
I	Yes	(a)	No	(a)	(a)	30	Y/Arrested
J	Yes	No	Minor	No	Yes	36	Y/Arrested

(a) Two cracks originating from rebar -- cannot discern if shrinkage, subsidence, or rebar corrosion related, but definitely pre-exist impregnation.

FIGURE 1 Core J, Bethlehem bridge rebar corrosion and associated vertical crack.
