Design and Construction of Two Low Retaining Wall Systems Restrained by Soil Nail Anchors

COLIN ALSTON AND R. E. (ERNIE) CROWE

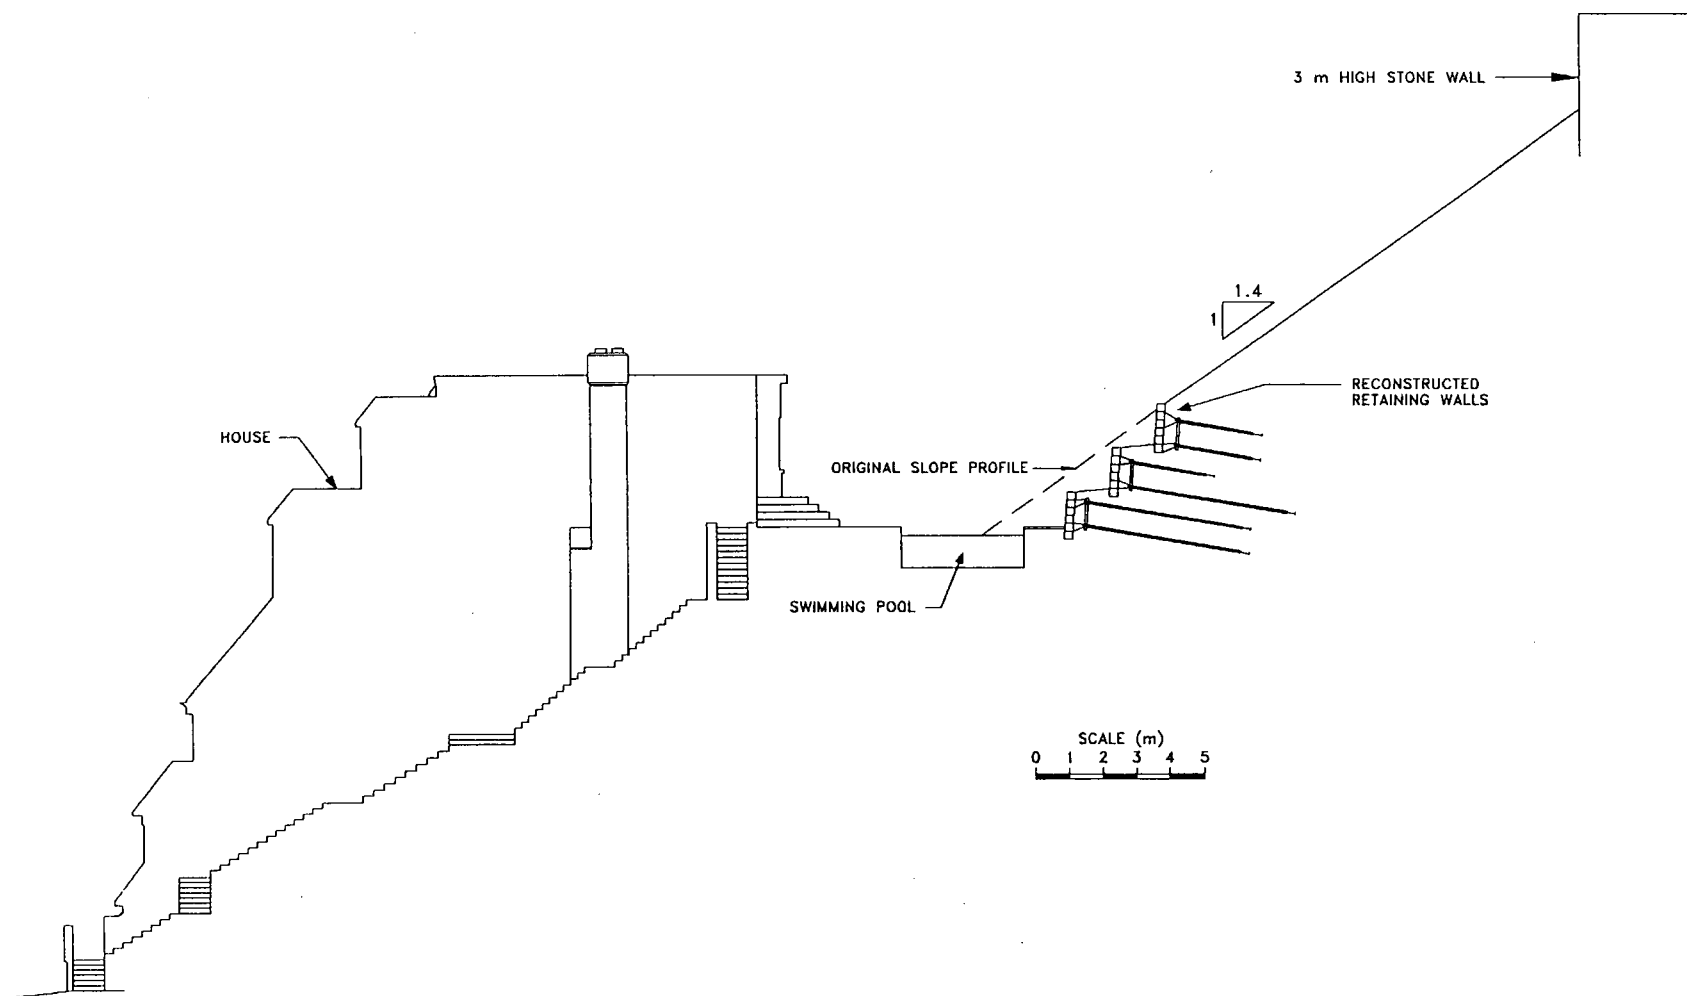
FIGURE 1 Section through hillside, Old Mill Drive site.

At the Old Mill Drive site, a naturally formed valley slope was benched to provide the rail track bed for the (defunct) Toronto Belt Line railway at the turn of the century; the bench is about 10 m wide and is situated at about mid-height of the slope. Both the upper and lower slopes (above and below the bench) had rested at a steep angle of 1V:1.4H for several decades; tree growth patterns indicated that the slopes experience creep movements of the near-surface soil horizons.

At this site, as part of the development of a large custom home, cuts had been made into the upper slope of the steep hillside to accommodate the construction of a swimming pool and adjacent patio at the level of the bench. These steeply inclined cuts had been developed as a landscaping feature with a series of three terraces, as shown in Figure 1. The vertical face of each terrace was finished with a low (1.2-m-high) dry stone retaining wall. The horizontal restraint provided to these dry stone retaining walls consisted of a few stone headers that projected beyond the rear face of each terrace wall by about 0.5 m. Not surprisingly, the dry stone walls showed considerable movement and, at the time of inspection by the authors, appeared to be at incipient toppling failure. Had these walls failed, the stability of the entire hillside would have been compromised.

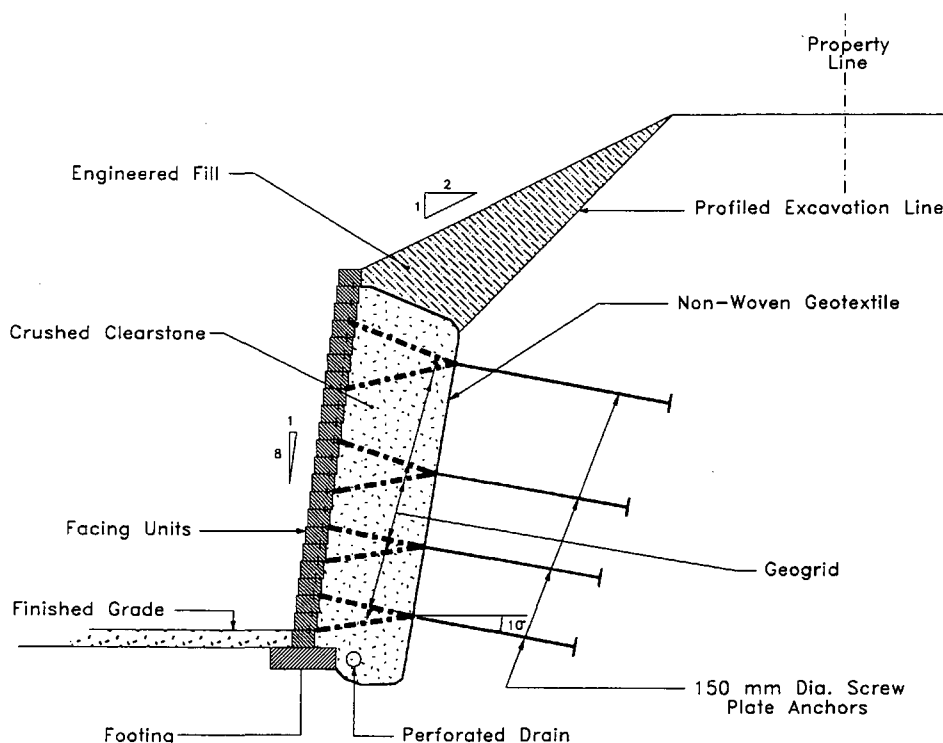
FIGURE 2 Section through reprofiled slope, Dufferin Street site.

The second case history (Dufferin Street site) describes the design and construction of a low retaining wall that was required to retain ground on an adjacent, higher property. At the time of the authors' first involvement with the site, the slope to be retained had been profiled to a near-vertical unsupported slope 3 to 4 m high that was topped by a 1:1 slope that was up to 3 m high above the near-vertical slope (total slope height was 7 m): the property line with the adjoining property was located near the crest of the cut slope. The authors became involved in this project when the geotechnical engineer who had authorized the initial profiling of the slope refused to extend certification of the stability (safety) of the slope after the cut had been exposed to the elements for 2 weeks. Thus, a design that was appropriate to the site conditions had to be prepared and implemented within a few days. Economic consideration (i.e., the high cost of obtaining a temporary property easement on the adjoining property) prohibited the extension of excavations beyond the property boundary. A profile through this portion of the site that shows the physical constraints of the property boundary and the cut slope, as well as the position of the wall and reprofiled slope, is shown in Figure 2.

At this site, the profile shown in Figure 2 had been cut prior to wall design, on the assumption that a retaining wall could be designed to fit this geometry. After the cut profile had been allowed to stand for several weeks (no constructable design had been produced in that time), the geotechnical engineer responsible for certifying the slope declined to extend his certification. The design requirements of the retaining wall at this site were, therefore, that a retaining system be installed that did not require any modification of the profiled slope and that, furthermore, could be installed safely from the ground at the base of the slope. At this stage, the authors were contacted and asked to design and effect the construction of a retaining wall that met the site requirements. It is also pertinent to the design that the owner of the development was not able to accept any changes in the footprint of land occupation at the base of the slope, which would have enabled the slope profile to have been left as it was and other retaining wall systems considered. The design solution that was developed to provide the horizontal restraint to the wall, and to accommodate the site requirements, involved the installation

namely, a system of geogrids connecting the fascia to the anchors through steel angles spanning between the earth anchors and a prism between the soil bank and the fascia filled with self-compacting clear stone material (Figure 2). Figure 10 also illustrates this project.

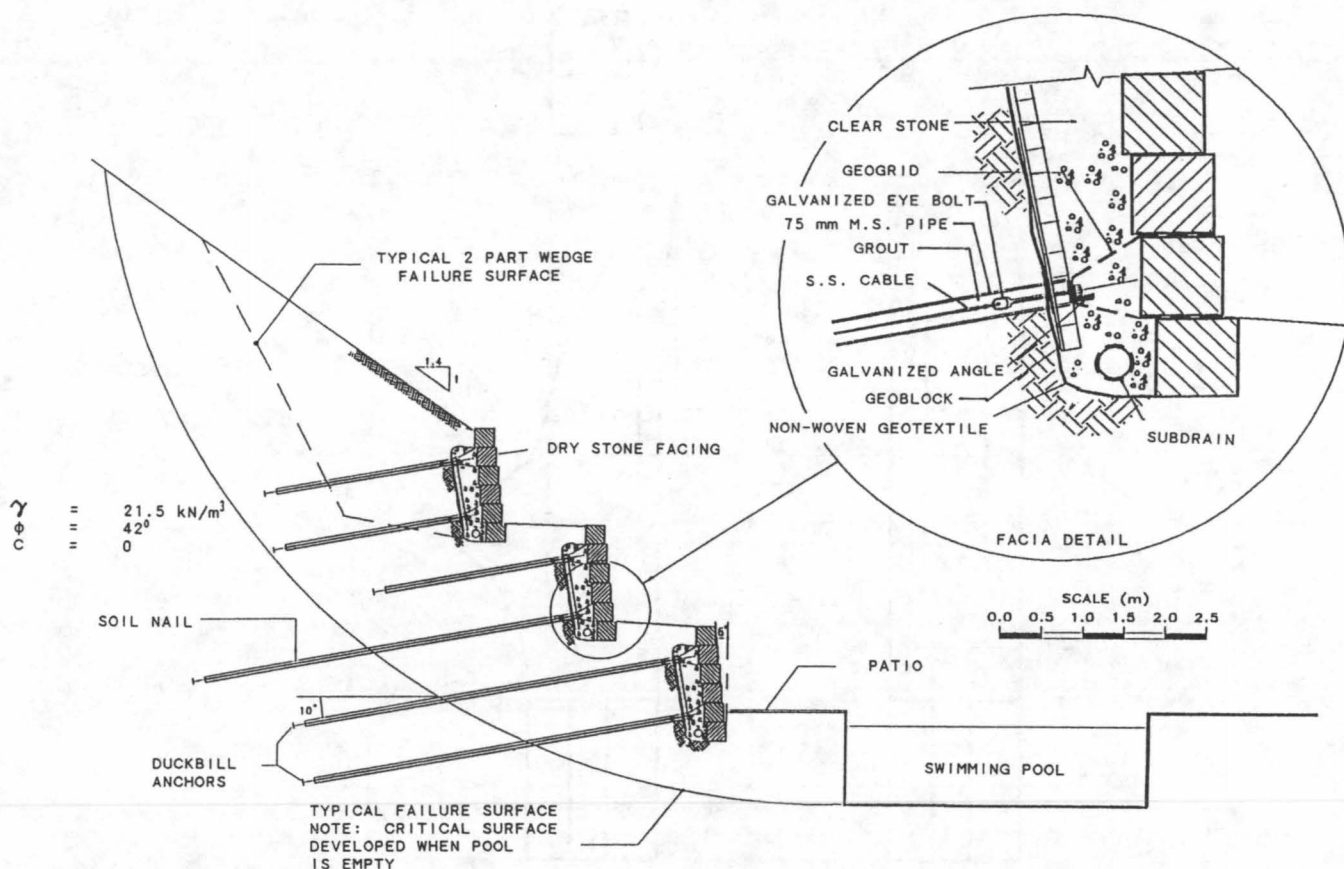
FIGURE 6 Section through terraced soil nail-reinforced retaining walls, Old Mill Drive site.

After a feasible installation method was determined for a soil nail system for the site, design of slope reinforcement was then able to proceed according to conventional design methods (1-6). Local stability of the three low-terraced retaining walls was carried out using a two-part wedge analytical method. The global stability of the terrace system was undertaken using conventional circular arc failure surfaces and limit equilibrium methods, with the lower three ranks of soil nails providing sufficient restraining forces to stabilize the hillside, as is illustrated in Figure 6.

Earth pressures acting on the soil face between the ranks of soil nails were transferred to the nails by a series of rectangular polymeric blocks ("Geoblocks"), which in turn were connected to the soil nails by steel angles that spanned adjacent nails horizontally. To provide an acceptable visual appearance, the stone facing was reconstructed in front of the support system; the facia was connected to the spanning angles, and thereby the nails, with geogrid reinforcing (multi-

strand polyester geogrid, long-term allowable design load 65 kN/m) (7). The stone facia and the soil face were separated by a prism of clear stone material encased in filtration geotextile (filtration opening size < 90 μ m, fabric weight > 240 g/m²); this element of the system also provided for drainage. The detail of the facia is shown in Figure 6.

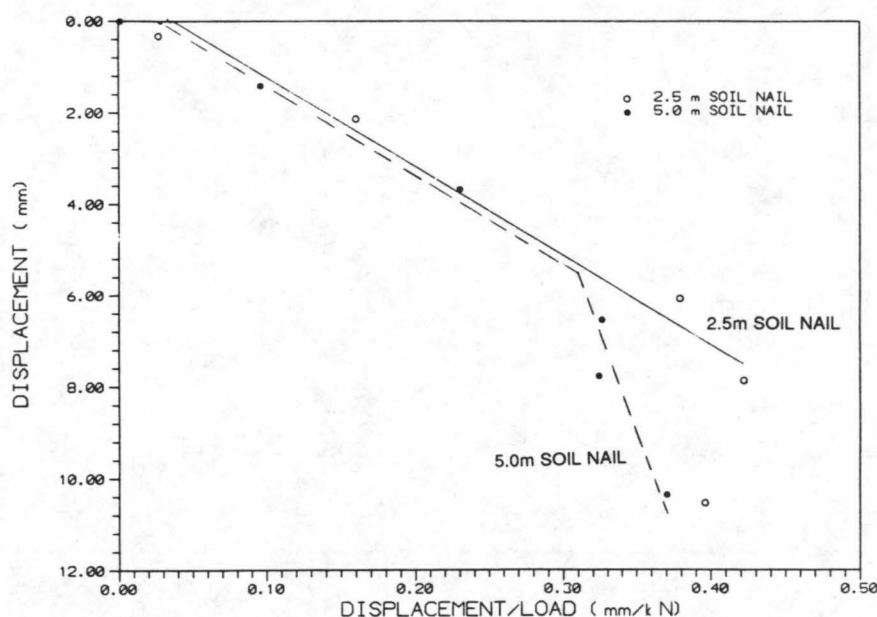
FIGURE 11 Summary of tensile tests on soil nails, Old Mill Drive site.

Thus, ultimate tensile loads of 19 and 84 kN were estimated for the 2.5- and 5-m-long soil nails, respectively, installed at the Old Mill Drive site. These results indicate an ultimate value of average adhesion between the steel casing and the enclosing very dense sandy silt to be 41 and 80 kPa, respectively. The average overburden loads on the short and long nails are about 33 and 66 kPa, respectively. Considering the reinforcing elements (soil nails) to be similar to horizontal piles for analytical purposes, these values of adhesion may be compared with values calculated by the method of Broms (12). The comparison is poor if a steel-to-soil contact is assumed for analysis, but the measured adhesion is very close to that which would be estimated if a grout-soil contact face were assumed.

The tensile load tests showed minimum factors of safety of 3.0 and 2.1 for the Old Mill Drive and Dufferin Street sites, respectively.

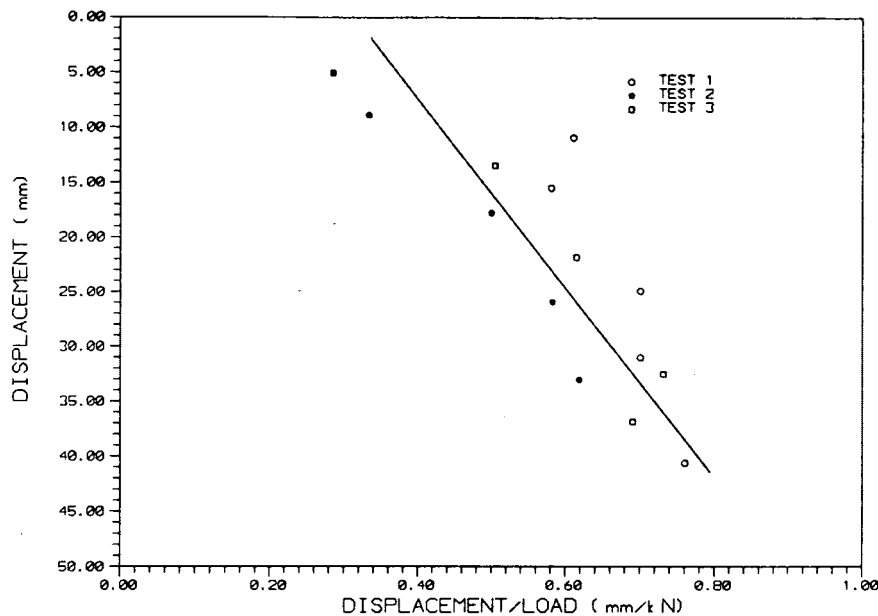
FIGURE 12 Summary of tensile tests on screw plate anchors, Dufferin Street site.

The average ultimate load capacity of the 150-mm-diameter helical plate anchors installed at the Dufferin Street site, estimated by the Chin method, was found to be about 90 kN. This value of holding capacity may be compared to a value

of about 140 kN that would be estimated using the holding capacity-versus-installation torque relationship developed by the A. B. Chance Company (13). The fissured character of the soil probably accounts for this decrease in measured pull-out capacity compared with the manufacturer's estimate.
