Backfill Placement Methods Lead to Flexible Pipe Distortion

TIMOTHY J. MCGRATH AND ERNEST T. SELIG

Achieving good results in compacting fill around flexible culverts requires a proper matching of pipe, backfill type, and backfill placement and compaction methods. In the construction of a nuclear power plant, the circulating water lines were designed as 3600-mm-diameter, filament-wound glass-fiber reinforced plastic pipe of low stiffness. Because of a high groundwater table and concern that liquefaction might occur during a seismic event, the specifications called for compaction of all site backfill, including backfill for the circulating water pipe, to 85 percent relative density. After construction, the pipe was found to be deflected upward beyond project limits. The pipe shape was distorted, and the joints were delaminated. Investigation showed that the backfill was compacted with large self-propelled vibratory rollers operated to achieve the required density with insufficient monitoring of the pipe condition. The emphasis on meeting the compaction requirement was demonstrated by the fact that 171 density tests were conducted at the sides of the pipe and within one diameter wid

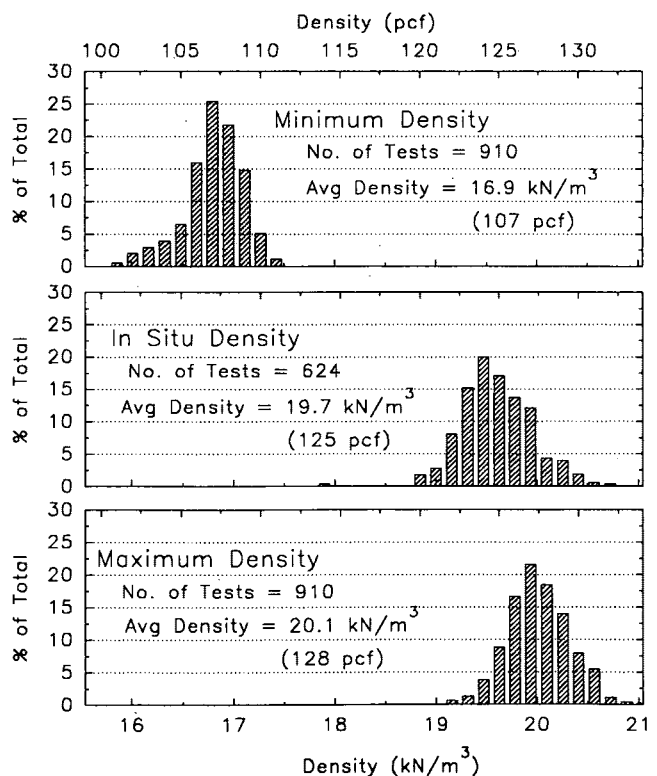
FIGURE 1 Results of all available reference and in situ density test results.

Overall, records of 910 laboratory determinations of maximum and minimum relative density and 624 determinations of in situ density were available. Of these tests, 171 were conducted within one diameter of the pipe springline, at elevations between the crown and invert. The mean relative density from these tests near the pipe was 86.7 percent, and the standard deviation was 13.2 percent. Of the 171 tests, 26 test results were greater than 100 percent relative density, and 47 test results were between 90 and 100 percent. Figure 1 shows the maximum, minimum, and in situ density for the entire data base of test results. Figure 2 shows the results of tests conducted close to the pipe in terms of percent relative density as reported by the testing agency. In analyzing the data it was not possible to reliably separate the tests that were considered failed by the testing agency from those that were considered acceptable. Thus the in situ test results in Figures 1 and

2 include both. Because of this, the final, mean, in situ density is most likely higher than suggested by the figures.

The maximum, minimum, and in situ densities for all backfill tests during overall project construction were presented in Figure 1. The resulting variability for relative density for tests taken

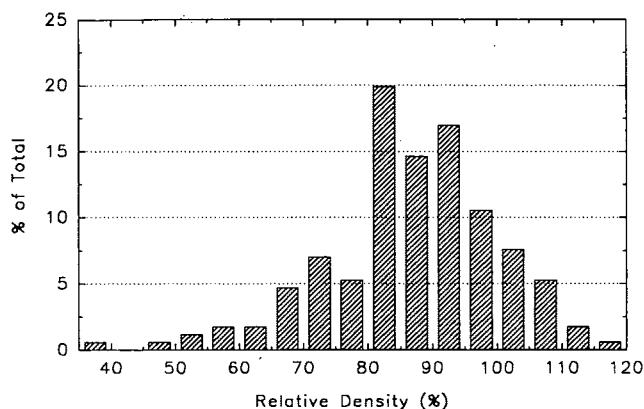
FIGURE 2 Results of relative density determinations near pipe.

around the pipe was presented in Figure 2. Figure 2 shows an average density of 87 percent, with 58 percent of the tests greater than the required 85 percent relative density specified, even when failed and acceptable test results are considered. The final in situ density would likely be higher than 90 percent relative density if the failed tests could be discounted.

The figures show that the 85 percent relative compaction requirement was clearly achievable, although it was perceived by many to be the source of the upward deflection problem. The problem was actually the result of the large compaction equipment operating too close to the pipe. It is frequently thought that to obtain a high amount of compaction large equipment must be used; however, analysis shows that this is not the case (3). Size and weight of compaction equipment relate to the productivity of the compaction process far more than to level of compaction achieved. In this case the required density could have been achieved by the use of small equipment near the pipe to reduce the forces applied to the pipe during compaction. This issue is discussed further in the following section.

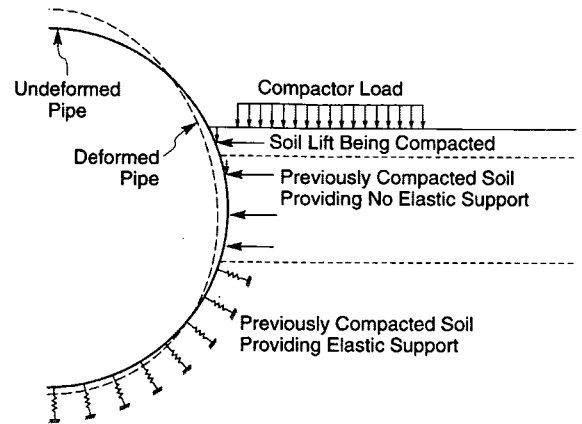
FIGURE 3 Computer model used to analyze compaction effects.

Flexible pipe can be deformed by compaction forces; however, the high stresses caused by compaction equipment dissipate very rapidly with increasing space between the pipe and the equipment. On this project there were reports that the compaction equipment was being operated very close to the pipe. To investigate the effect of this, the authors developed a simple computer model to represent compaction effects. The model used a ring to represent the pipe and springs to represent the surrounding soil, as shown in Figure 3. The pressures applied to the pipe were based on the Boussinesq distribution shown in Figure 4. Figure 4 shows two curves representing the pipe at 150 and 600 mm (6 and 24 in.) from the compaction equipment. The figure shows that the vertical soil stresses at the pipe-soil interface, when the compaction equipment is 150 mm (6 in.) from the pipe, are 5 to 10 times the pressures resulting when the equipment is held 600 mm (24 in.) from the pipe. Horizontal pressures were computed by applying a factor of 0.4 to the vertical pressures. The principal assumptions of the model were that the backfill layer currently being compacted would undergo significant lateral strains that could deform the pipe, whereas prior lifts, having already been compacted, provide a reduced lateral force on the pipe.

On the basis of a paper by Duncan and Seed (4), 55 percent of the lateral pressures produced under peak compaction loads were assumed to remain in the layer being compacted. In previous

layers the residual lateral pressures are assumed to vary gradually from 27 to 0 percent of peak over the several previous lifts. This model had to be run iteratively for each backfill layer to be certain that springs resisting outward motion were only acting in compression. The resulting deformations were then accumulated for each layer. The deformed shape of the pipe resulting from the two conditions, 150 and 600 mm (6 and 24 in.) between pipe and compactor, are shown in Figure 5. The upward deformation when the compactor was 150 mm (6 in.) from the pipe was 6.9 percent of the pipe diameter, or almost three times the 2.5 percent deflection resulting from a 600-mm (24-in.) separation. Although it is not a rigorous treatment of the complex pipe-soil interactions taking place during backfill compaction around buried pipe, this computer model clearly demonstrates the sensitivity to deformations when large equipment is operated too close to the pipe.

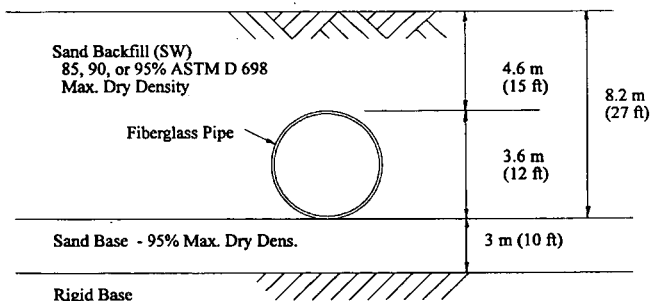
FIGURE 6 Configuration of pipe installation for SOILCON analysis.

is the analysis made with most currently available finite element soil structure interaction computer models. Using the program SOILCON (5), the pipe installation was modeled as shown in Figure 6. This models a 3600-mm pipe with 4.6 m of cover over the crown. Using this model and considering three types of backfill (SW at 85, 90, or 95 percent maximum dry density, ASTM D698) the pipe deflections were monitored as fill was placed beside and over the pipe. The results are shown in Figure 7. When only the weight of soil is considered, upward deflection occurs only for the densest soil (95 percent maximum dry density), and even in that case the upward displacement is less than 0.5 percent.
