Durability of Geotextiles Used in Reinforcement of Walls and Road Subgrade

BILL POWELL AND JOHN MOHNEY

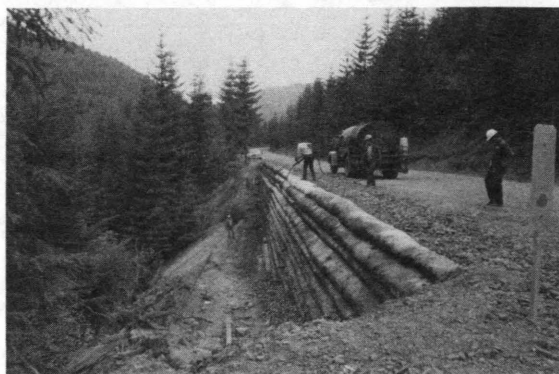
any signs of distress after 18 years of use. The emulsified asphalt used to protect the front face has deteriorated and small holes in the fabric face are starting to appear. Although the holes are on the face, there are no deformities or loss of materials on the wall face. In time the face will be repaired by shotcrete sprayed on the surface.

FIGURE 1 Geotextile wall, with exposed material being sprayed with emulsified asphalt after construction.

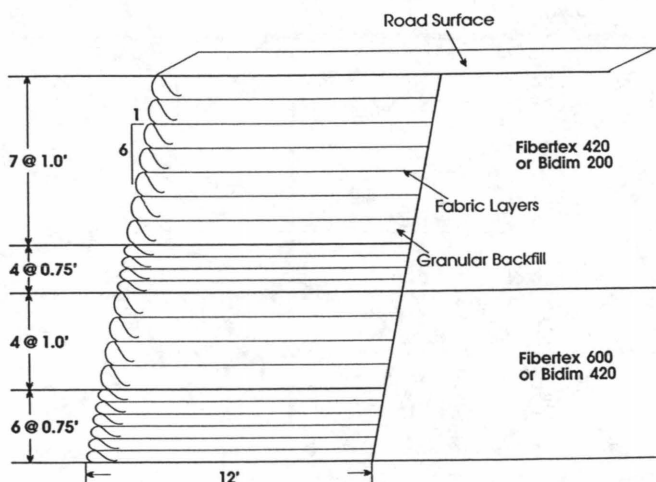
FIGURE 2 Cross-section of fabric wall.

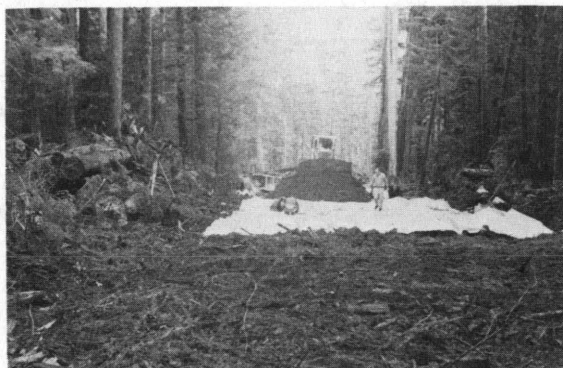
FIGURE 4 Dozer spreading rockfill on geotextile.
