Behavior of Reinforced Concrete Slab Bridges During and After Repair

BAHRAM M. SHAHROOZ, RICHARD A. MILLER, V. K. SARAF, AND
B. GODBOLE

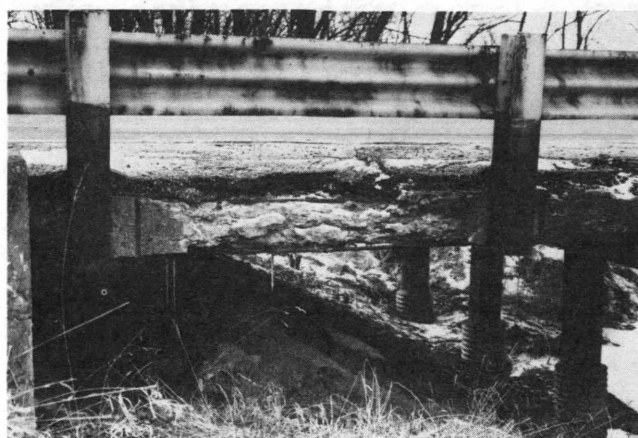
Despite being slightly newer (41 years old), Bridge 2 had experienced more damage than Bridge 1. The concrete in the shoulders had deteriorated appreciably, resulting in exposed reinforcing bars, as seen in Figure 2. Each pier line consisted of five HP 12 \times 53 with a pile cap. This bridge served as the specimen with "moderate damage."

FIGURE 2 Damage in shoulder of Bridge 2.

load case 2) was only 10 percent larger when the shoulder had been cut. The deteriorated shoulder in this bridge (Figure 2) did not contribute to the original prerepair stiffness, and its removal did not apparently alter the response. After a 7-day curing of the new shoulder, Phase 2 of repair involved chipping of the deck locally, as shown in Figure 5. The deflections for this phase were much smaller than those measured before repair. When the deteriorated shoulder was replaced, the stiffness must have been improved sufficiently so that the response was not adversely affected by local variable depth removal of the slab. For grid lines farther away from the edge [grid line 2, which was 2.7 m (9 ft) from the edge], the deflection profiles did not change between various stages of repair, and the effects of removing and replacing the deteriorated shoulder were not pronounced. Upon completion of repair the bridge exhibited a substantially larger stiffness. The maximum deflection of the repaired bridge was reduced by 40 percent.

Each driving lane of Bridge 2 was repaired in two stages. In Stage 1 a 0.6-m (2-ft) width of the shoulder was cut completely along the entire length of the bridge. This was necessary because the shoulders had deteriorated rather significantly. During the shoulder removal the workers were careful not to cut the bars perpendicular to the traffic lanes because this steel was used to tie the new shoulder to the slab. New longitudinal reinforcing bar was placed and a new shoulder made up of class S concrete was poured to a depth of 32 mm (1.25 in.) below the final surface. After a 7-day curing time Phase 2 of the repair, which involved variable depth removal, was started. The slab at the approach slabs

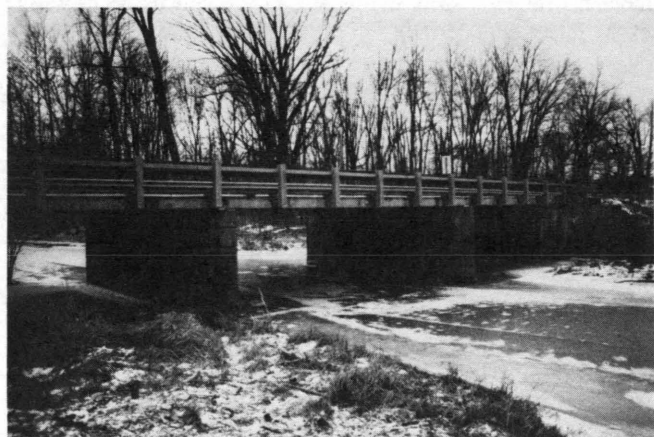
Bridge 1 was 46 years old at the time of testing. The abutments and piers were reinforced concrete walls (Figure 1). Site inspections did not reveal any visible signs of damage except for some rusted reinforcing bars that could be seen on the bottom face. Bridge 1 was tested as the specimen with "minor damage."

FIGURE 1 Overview of Bridge 1.

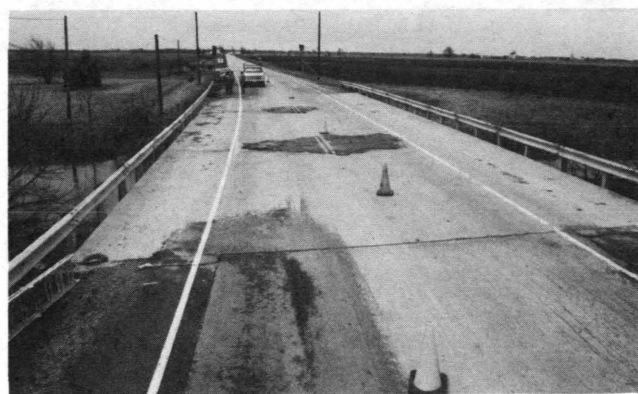
The piers in 30-year-old Bridge 3 had seven steel-encased concrete piles [406-mm (16-in.)-diameter piles] and a pile cap. Damage had occurred along one of the shoulders, and primary reinforcing bars were exposed along the edge. In addition the bridge deck had experienced significant damage over both piers covering regions of approximately 3.7 m (12 ft) \times 3.4 m (11 ft) and 3.7 m (12 ft) \times 5.5 m (18 ft). As seen in Figure 3 these areas had been patched with asphalt. The damage in this bridge was classified as "extensive."

FIGURE 3 Patched regions over pier lines in deck of Bridge 3.

Bridge 3 was also repaired in two phases in the same manner as Bridge 2, but a 0.9-m (3-ft) width of the shoulder had to be cut. The entire width of the slab (under repair) over the piers was chipped to a depth that varied between 76 mm (3 in.) and 102 mm (4 in.). Figure 6 shows the extent of chipping. As with the other bridges the variable depth removal was patched with microsilica concrete, and a microsilica overlay was placed on the deck.

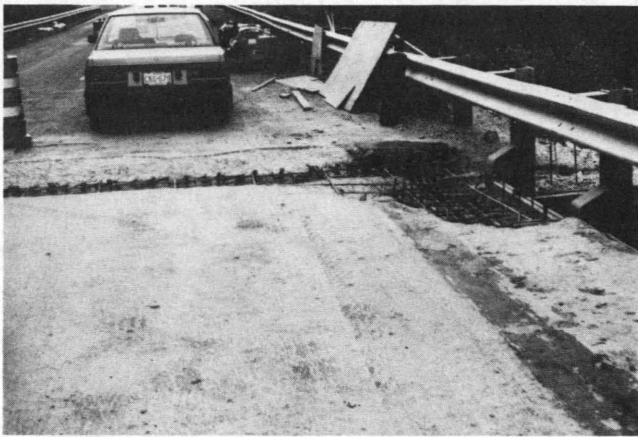
Because the bridges had experienced different levels of damage, the amount of chipping required varied. For Bridge 1 the slab near the abutments was cut through its depth, as shown in Figure 4. However the good quality of the concrete over the piers did not necessitate chipping of the deck.

FIGURE 4 Cuts through deck of bridge 1 at abutments.

maximum central deflection became 36 percent larger. This observation is expected by recognizing that the deck had been cut away from the approach slab and full-depth cuts through the slab had been made along the abutments (Figure 4). The largest deflection anywhere on the deck occurred during repair under load case 1. This deflection corresponded to that of the central span along grid line 1 [0.9 m (3 ft) from the edge], and it was 3.4 mm (0.135 in.), or $L/3,100$, where L is the span length. This value is indeed very small. As seen in Figure 8 the overall stiffness of the repaired bridge was improved, leading to a 15 percent reduction in the midspan deflection along grid line 2.

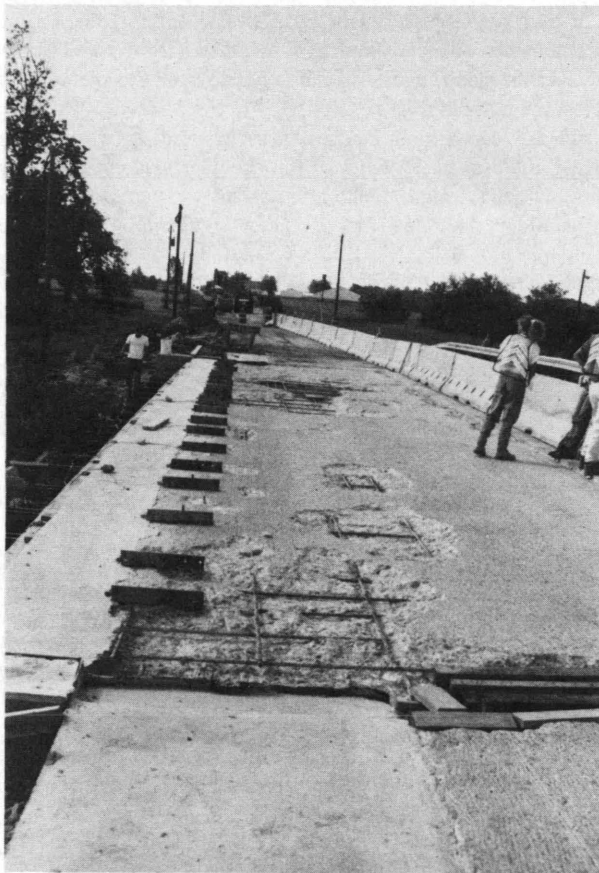
was cut to a depth of 152 mm (6 in.), and the deck was chipped to a depth varying from 51 mm (2 in.) to 102 mm (4 in.). As a result many of the bars were exposed, as can be seen in Figure 5. The variable depth removal was patched with microsilica concrete, and after allowing the patches to cure the microsilica overlay was placed.

FIGURE 5 Condition of slab in Bridge 2 after variable depth removal.

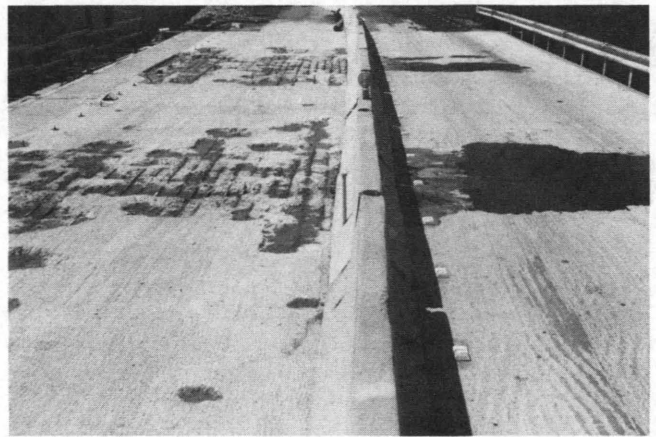
FIGURE 6 Condition of slab in Bridge 3 after variable depth removal.

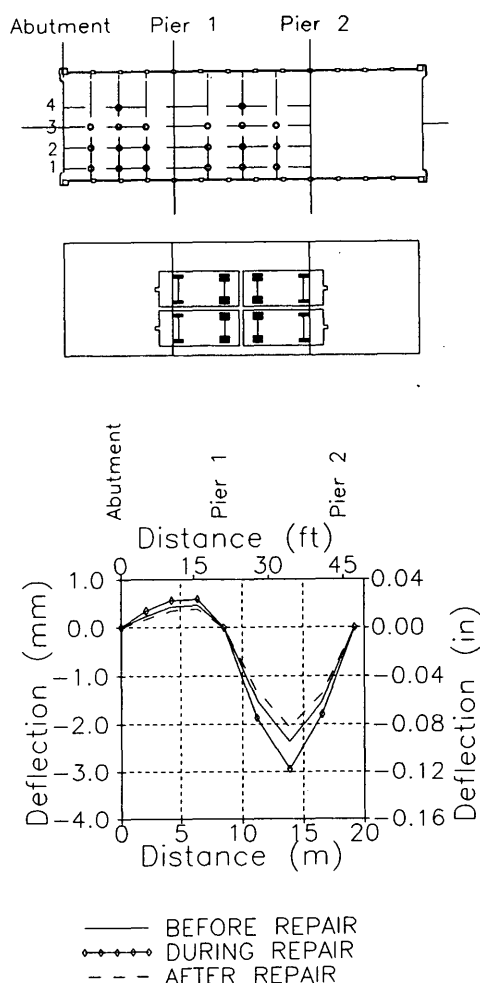
Figure 8 illustrates the deflection profiles along grid line 2 [2.7 m (9 ft) from the edge] for load case 1, which caused the maximum deflection in the central span. The bridge was more flexible during repair than it was in the prerepair condition; for example, the

FIGURE 8 Deflection profiles for Bridge 1, grid line 2.

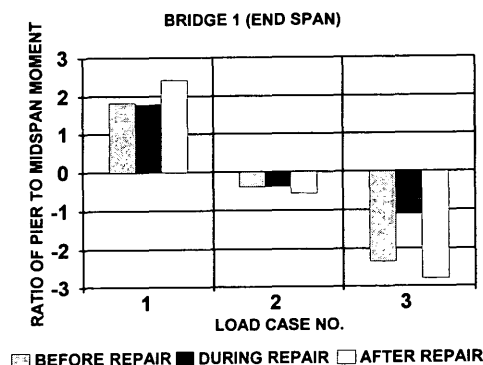
The ratio of the negative moment (measured close to the pier) to the positive moment (in the middle of the end span) is compared for different stages in Figure 9. During repair, when the trucks were positioned to produce maximum moment at the pier (load case 3), the portion of the total static live-load moment resisted by the bottom reinforcement at the midspan became 58 percent larger. However the increased live-load moment was well below the available moment capacity. Truck load tests provide information only about the distribution of live loads, and it is not possible to quantify from these tests the changes that were due to dead loads. However the live loads were several times larger than the standard design loads, and the magnitudes of the live loads were close to the calculated magnitude of the dead load. The small values of the measured strains under live loads suggest that any increased dead-load moments would also be small.

Subsequent to the completion of the repair the ratio of the negative moment over the pier to the positive moment in the spans increased, which indicated that a larger portion of the total moment was being resisted by the negative reinforcement. The participation of the negative reinforcement in the end span increased by an average of 14 percent. Hence the repair method was beneficial in restoring the continuity over the piers.

FIGURE 9 Ratio of pier to midspan moment for Bridge 1.

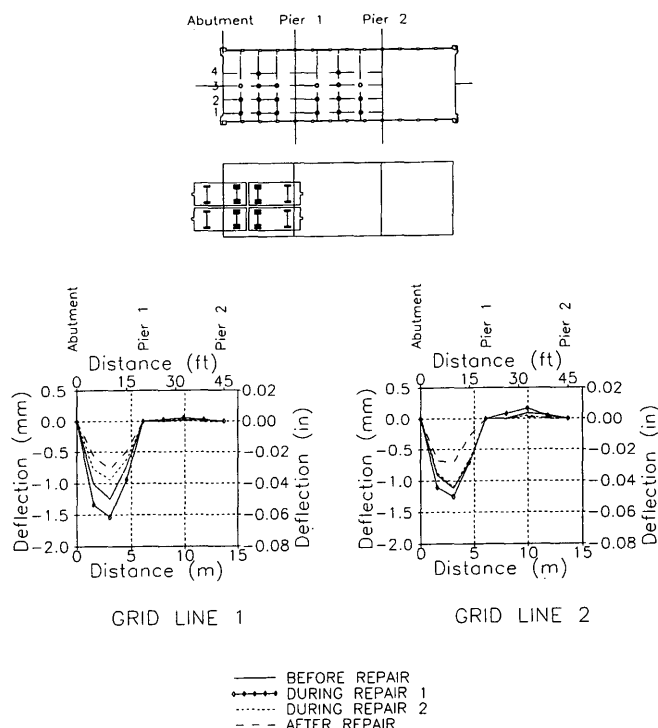
As seen in Figure 10 the slab deflection under load case 2 along grid line 1 [0.9 m (3 ft) from the edge] became larger, as expected, when the 0.6-m (2-ft)-wide portion of the slab had been cut along the entire length (phase one of repair). However the deflection profile was not significantly different from that measured before removal of the shoulder. The maximum end span deflection (under

FIGURE 10 Deflection profiles for Bridge 2.

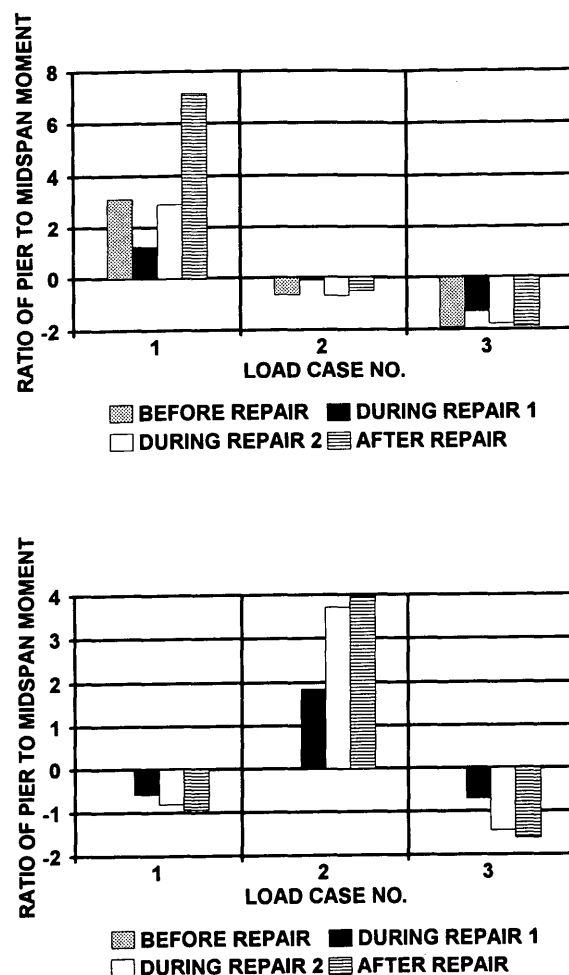
An examination of the ratio of pier to midspan moment shown in Figure 11 supports the preceding observations. (Before repair, instruments for monitoring concrete surface strains in the middle of the central span were not installed. Hence the ratio of pier to midspan moment could not be computed for this span.) During the first phase of repair a large redistribution of the applied moment to the positive reinforcement was apparent. The participation of the bottom reinforcement under load case 1 was approximately 60 percent larger than the value before repair, but it was still smaller than the available positive moment capacity. For Phase 2 the ratios were not appreciably different from those measured before repair. After pouring the new shoulder the behavior was no longer influenced by chipping of the deck. This observation is consistent with the measured deflection profiles. At the conclusion of the repair a larger portion of the total applied moment could

FIGURE 11 Ratio of pier to midspan moment for Bridge 2, end span (top) and midspan (bottom).

be resisted by the negative reinforcement at the piers; that is, the bridge acted more as a continuous system. The negative reinforcing steel in the end span participated 16 percent more than the prerepair value, and the top reinforcing bars in the central span resisted 35 percent more moment than during phase one of repair. The repair method was successful insofar as it improved the stiffness and increased the participation of the negative reinforcement at the piers are concerned.

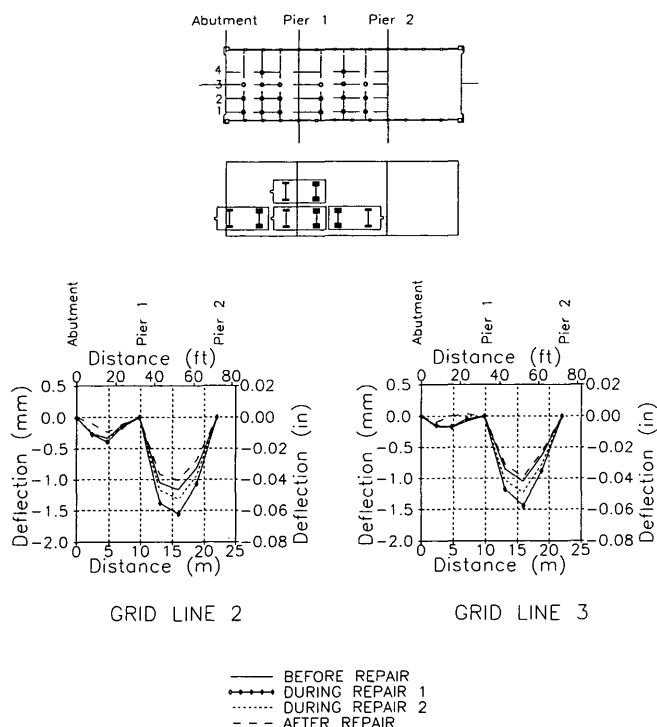
The deflection profiles under load case 3 (to produce maximum moment at the pier) are shown in Figure 12. When a 0.9-m (3-ft) width of the shoulder had been cut (phase one) the bridge experienced 40 percent larger deflection in the central span along grid line 2 [1.2 m (4 ft) from the edge]. In contrast for the same phase the maximum deflection for Bridge 2 was increased only by 20 percent (Figure 10). Unlike Bridge 2 the loss of stiffness from the shoulder removal influenced the deflection profiles of Bridge 3 across the width. For example along grid line 3 [3.2 m (10.5 ft) from the edge] the maximum midspan deflection for the first phase

FIGURE 12 Deflection profiles for Bridge 3.

of repair became 35 percent larger (Figure 12), whereas in the case of Bridge 2 the effects of cutting the shoulder diminished rapidly away from the edge (Figure 10). These differences indicate that the shoulder in Bridge 3 was originally effective in resisting the loads, and its removal reduced the overall stiffness substantially. This is easily seen by examining the deterioration of this bridge. The deterioration over the piers was mostly confined to the driving lanes and did not really extent into the shoulders.

When a new shoulder had been poured and the deck had been chipped locally over a larger portion, mostly around and over the piers (phase two of repair), the deflections became larger than those measured before repair. The effects of local chipping of the deck were of such a magnitude that the stiffness became smaller than the original prerepair value, even though a new shoulder had been poured. Upon completion of the repair the deflections became expectedly smaller. However the maximum deflection was only 2 percent less than the prerepair value. This is in contrast to the cases for Bridges 1 and 2, for which the postrepair maximum deflections were 11 and 40 percent, respectively, less than their counterparts before repair. The repair method was apparently not as successful in restoring the stiffness of Bridge 3.

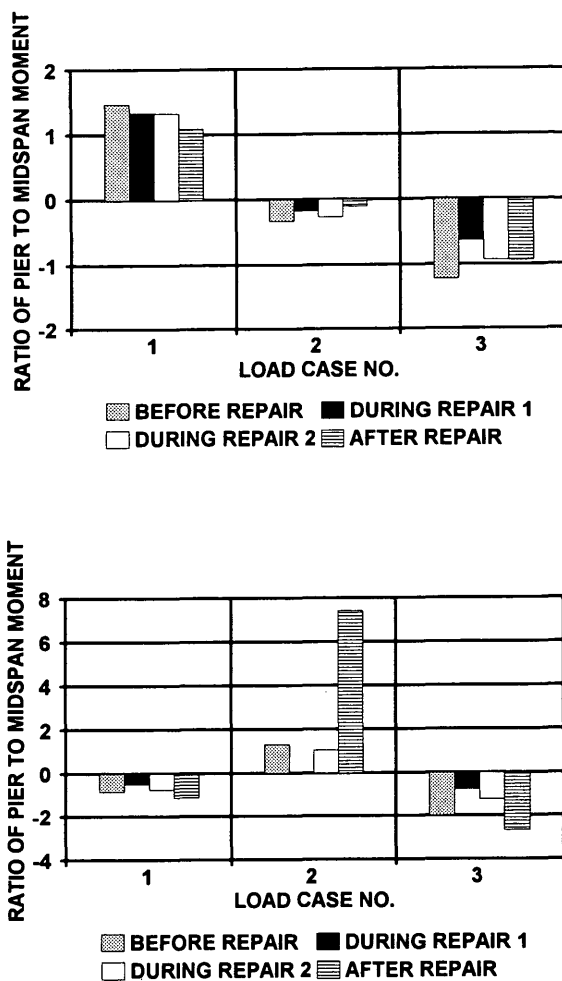
As evidenced from Figure 13 the repair procedures resulted in a reduction of moment transfer over the pier; that is, the ratio of pier to midspan moment became smaller. After the shoulder was cut, approximately 22 and 31 percent more moment was being resisted by the bottom reinforcement in the end and the middle span, respectively. Replacement of the shoulder increased the participation of the top reinforcement over the pier in resisting the total applied moment, yet it was smaller than the original level because of extensive chipping of the deck. Approximately 6 to 17 percent less moment than the original moment could be resisted by the negative (bottom) reinforcement.

FIGURE 13 Ratio of pier to midspan moment for Bridge 3, end span (top) and midspan (bottom).

ment in the central span resisted a larger portion of the applied moment during both phases of repair. These observations are in contrast to those found for Bridge 2 (Figure 11). Although the repair method increased the contribution of the negative (top) reinforcement in the midspan by about 30 percent, the test results indicated a permanent redistribution of live-load moments to the bottom reinforcement in the end span. The contribution of the top reinforcement was about 25 percent less than the value before repair. As mentioned previously truck load tests do not permit assessment of the redistribution of dead-load moments, but the small strains that were measured suggest that the total redistributed moments owing to dead and live loads would also be less than the available moment strengths.
